## Profile/Photo Observation Report

Street:	<b>JUNIPER CT</b>	Flow Control:	<b>Not Controlled</b>
City:	<b>Hobart, IN</b>	Year Renewed:	
Location:	<b>Other</b>	Tape/Media #:	
Purpose:	<b>Not Known</b>	Dia/Height:	<b>8"</b>
Use:	<b>Sanitary</b>	Material:	<b>PVC</b>
Drain Area:	<b>NA</b>	Lining:	
Category:	<b>NA</b>		
Comment:

Location Details:		Direction of Survey:	<b>Upstream</b>
US MH:	<b>M-1004-055</b>	DS MH:	<b>M-1004-096</b>
		Total Length Surveyed (ft):	<b>120.3</b>

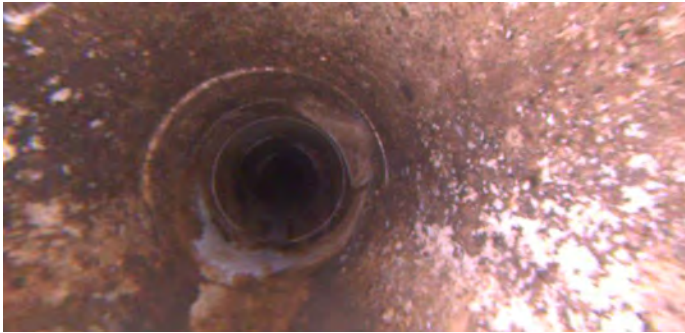
Code:	<b>MWL</b>
Description:	<b>Water Level</b>

Distance (ft):	<b>.0</b>
Structural Grade:	<b>0</b>
O&M Grade:	<b>0</b>
Clock Start/From:	
Clock To:	
1st Value:	
2nd Value:	
Value Percent:	<b>5.000</b>
Continuous Index:	
Within 8" of Joint:	<b>NO</b>
Remarks:

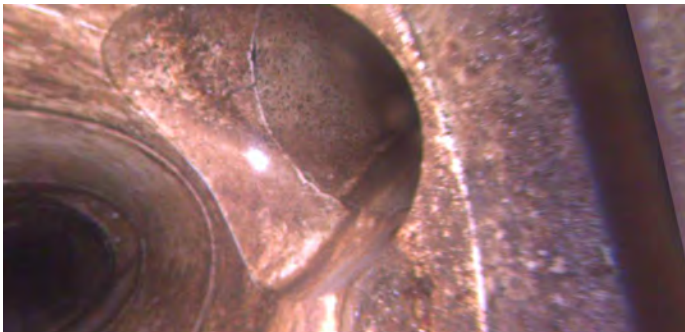
Code:	<b>TF</b>
Description:	<b>Tap Factory</b>

Distance (ft):	<b>1.1</b>
Structural Grade:	<b>0</b>
O&M Grade:	<b>0</b>
Clock Start/From:	<b>2</b>
Clock To:	
1st Value:	<b>4.000</b>
2nd Value:	
Value Percent:	
Continuous Index:	
Within 8" of Joint:	
Remarks:

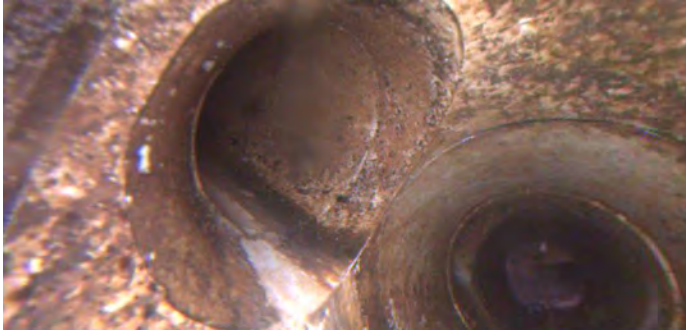
Code: **TF**  
Description: **Tap Factory**

Distance (ft): **3.7**  
Structural Grade: **0**  
O&M Grade: **0**  
Clock Start/From: **2**  
Clock To:  
1st Value: **4.000**  
2nd Value:  
Value Percent:  
Continuous Index:  
Within 8" of Joint:  
Remarks:

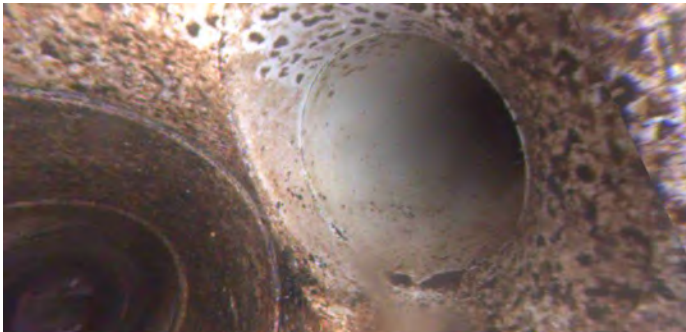
Code: **TF**  
Description: **Tap Factory**

Distance (ft): **4.9**  
Structural Grade: **0**  
O&M Grade: **0**  
Clock Start/From: **10**  
Clock To:  
1st Value: **4.000**  
2nd Value:  
Value Percent:  
Continuous Index:  
Within 8" of Joint:  
Remarks:

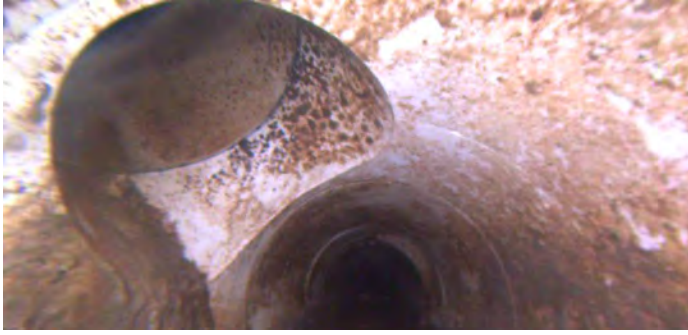
Code: **TF**  
Description: **Tap Factory**

Distance (ft): **29.8**  
Structural Grade: **0**  
O&M Grade: **0**  
Clock Start/From: **11**  
Clock To:  
1st Value: **4.000**  
2nd Value:  
Value Percent:  
Continuous Index:  
Within 8" of Joint:  
Remarks:

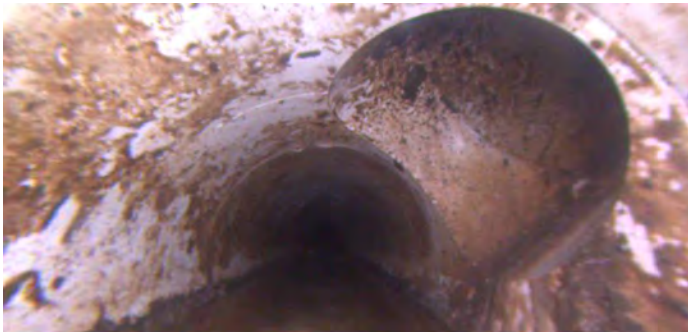
Code: **TF**  
Description: **Tap Factory**

Distance (ft): **31.1**  
Structural Grade: **0**  
O&M Grade: **0**  
Clock Start/From: **2**  
Clock To:  
1st Value: **4.000**  
2nd Value:  
Value Percent:  
Continuous Index:  
Within 8" of Joint:  
Remarks:

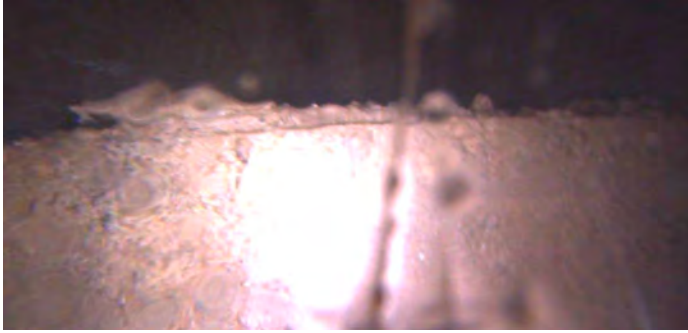
Code:	<b>AMH</b>
Description:	<b>Manhole</b>
Distance (ft):	<b>120.3</b>
Structural Grade:	<b>0</b>
O&M Grade:	<b>0</b>
Clock Start/From:	
Clock To:	
1st Value:	
2nd Value:	
Value Percent:	
Continuous Index:	
Within 8" of Joint:	<b>NO</b>
Remarks:	<b>M-1004-055</b>
