Profile/Photo Observation Report

| Street: | Barberry Dr. | Flow Control: | Not Controlled |
| City: | Hobart, IN | Year Renewed: | |

| US MH: | M-1004-057 | DS MH: | M-1004-058 |

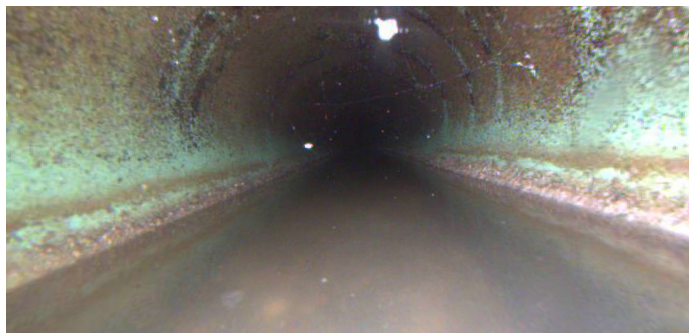
Code: **AMH**
Description: **Manhole**

Distance (ft): **.0**
Structural Grade: **0**
O&M Grade: **0**
Clock Start/From:
Clock To:
1st Value:
2nd Value:
Value Percent:
Continuous Index:
Within 8" of Joint: **NO**
Remarks: **M-1004-058**

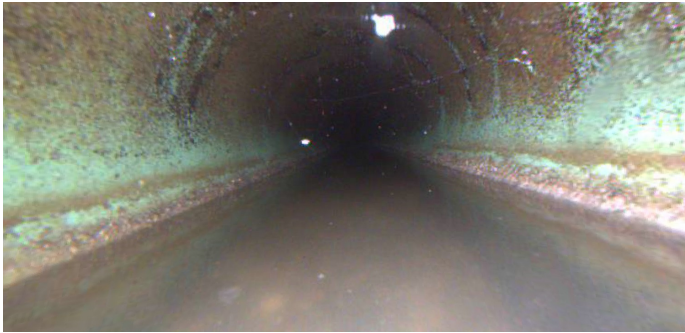
| Code: | MWL |
| Description: | Water Level |

| Value Percent: | 20.000 |

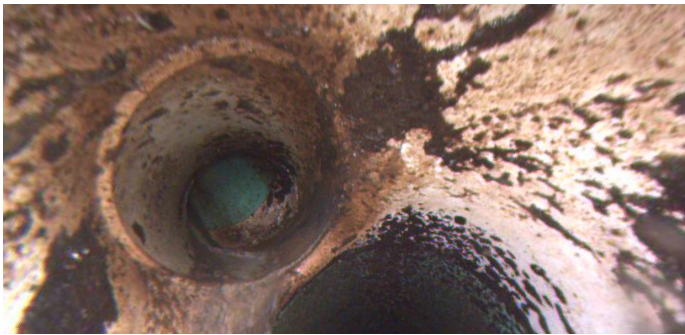
| Code: | TFA |
| Description: | Tap Factory Active |

| Distance (ft): | 11.7 |
| Clock Start/From: | 11 |
| 1st Value: | 4.000 |

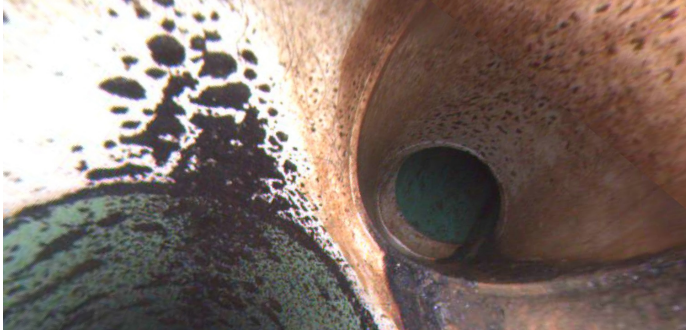
Code: **TF**
Description: **Tap Factory**

Distance (ft): **66.8**
Structural Grade: **0**
O&M Grade: **0**
Clock Start/From: **2**
Clock To:
1st Value: **4.000**
2nd Value:
Value Percent:
Continuous Index:
Within 8" of Joint:
Remarks:

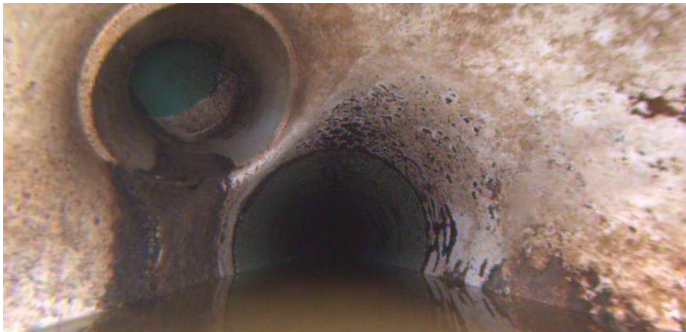
Code: **TF**
Description: **Tap Factory**

Distance (ft): **89.1**
Structural Grade: **0**
O&M Grade: **0**
Clock Start/From: **10**
Clock To:
1st Value: **4.000**
2nd Value:
Value Percent:
Continuous Index:
Within 8" of Joint:
Remarks:

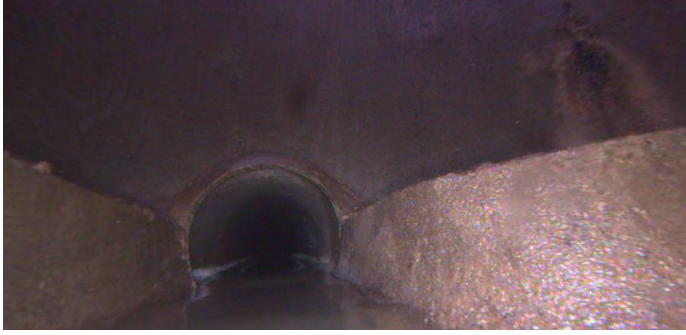
| Code: | AMH |
| Description: | Manhole |
| Distance (ft): | 144.5 |
| Remarks: | M-1004-057 |
