## Profile/Photo Observation Report

Street:	<b>Hillcrest Ave.</b>	Flow Control:	<b>Not Controlled</b>
City:	<b>Hobart, IN</b>	Year Renewed:	
Location:	<b>Other</b>	Tape/Media #:	
Purpose:	<b>Not Known</b>	Dia/Height:	<b>10"</b>
Use:	<b>Sanitary</b>	Material:	<b>PVC</b>
Drain Area:	<b>NA</b>	Lining:	
Category:	<b>NA</b>		
Comment:

Location Details:		Direction of Survey:	<b>Upstream</b>
US MH:	<b>M-1004-062</b>	DS MH:	<b>M-1004-063</b>
		Total Length Surveyed (ft):	<b>109.8</b>

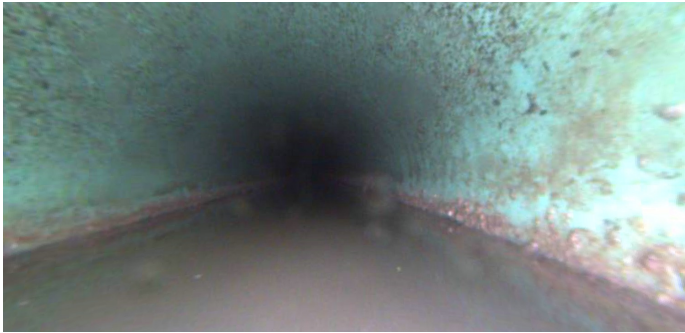
Code:	<b>MWL</b>
Description:	<b>Water Level</b>

Distance (ft):	<b>.0</b>
Structural Grade:	<b>0</b>
O&M Grade:	<b>0</b>
Clock Start/From:	
Clock To:	
1st Value:	
2nd Value:	
Value Percent:	<b>40.000</b>
Continuous Index:	
Within 8" of Joint:	<b>NO</b>
Remarks:

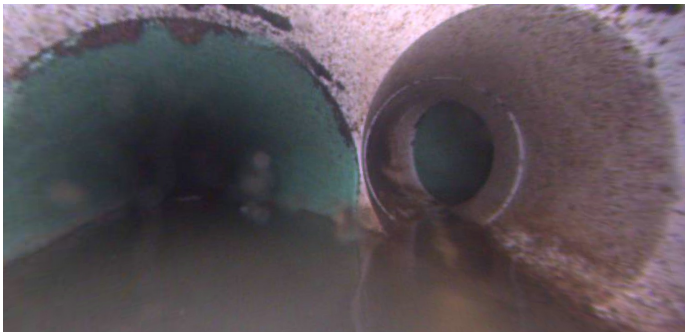
Code:	<b>TFA</b>
Description:	<b>Tap Factory Active</b>

Distance (ft):	<b>54.5</b>
Structural Grade:	<b>0</b>
O&M Grade:	<b>0</b>
Clock Start/From:	<b>3</b>
Clock To:	
1st Value:	<b>4.000</b>
2nd Value:	
Value Percent:	
Continuous Index:	
Within 8" of Joint:	
Remarks:

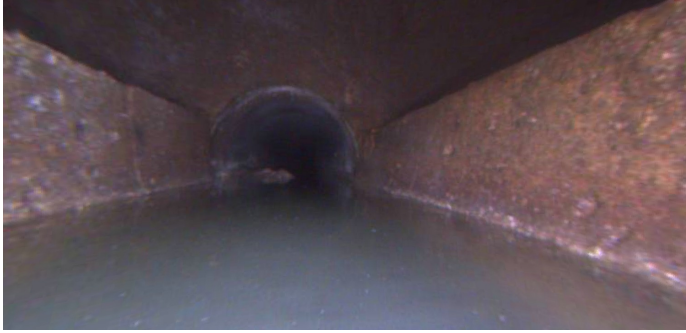
Code:	<b>AMH</b>
Description:	<b>Manhole</b>
Distance (ft):	<b>109.8</b>
Structural Grade:	<b>0</b>
O&M Grade:	<b>0</b>
Clock Start/From:	
Clock To:	
1st Value:	
2nd Value:	
Value Percent:	
Continuous Index:	
Within 8" of Joint:	<b>NO</b>
Remarks:	<b>M-1004-062</b>
