Profile/Photo Observation Report

| Street: | POPLAR LN | Flow Control: | Not Controlled |

| US MH: | M-1004-067 | DS MH: | M-1004-068 |

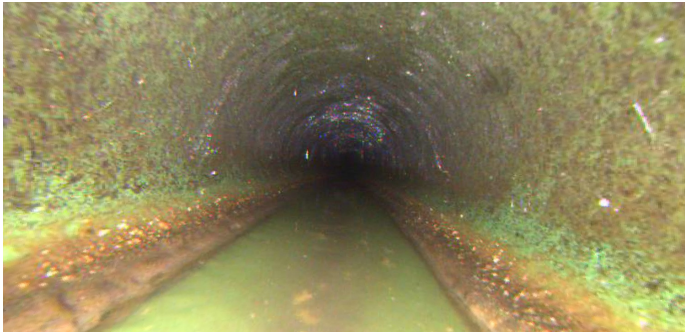
| Code: | MWL |
| Description: | Water Level |

| Distance (ft): | .0 |
| Value Percent: | 10.000 |

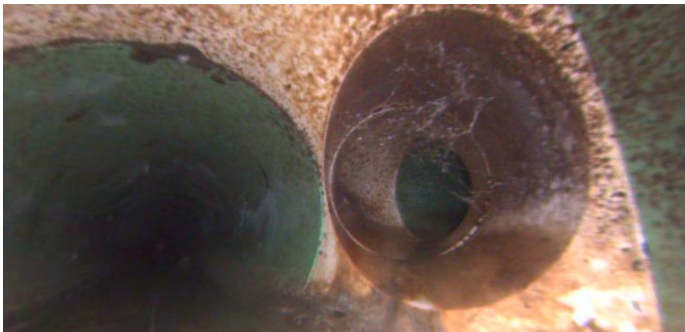
| Code: | TF |
| Description: | Tap Factory |

| Distance (ft): | 38.7 |
| Clock Start/From: | 9 |
| 1st Value: | 4.000 |

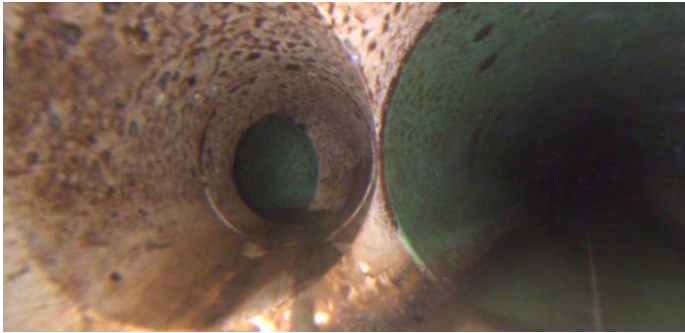
Code: **TF**
Description: **Tap Factory**

Distance (ft): **45.1**
Structural Grade: **0**
O&M Grade: **0**
Clock Start/From: **3**
Clock To:
1st Value: **4.000**
2nd Value:
Value Percent:
Continuous Index:
Within 8" of Joint:
Remarks:

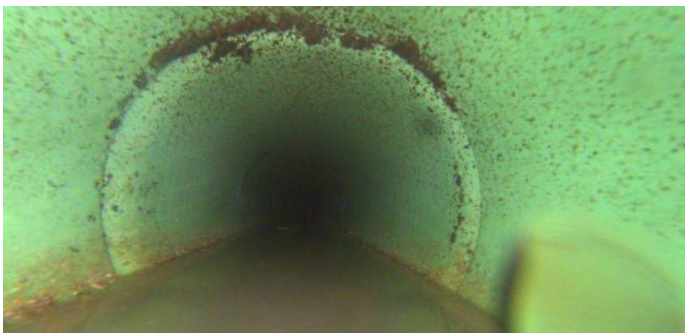
Code: **MWL**
Description: **Water Level**

Distance (ft): **94.9**
Structural Grade: **0**
O&M Grade: **0**
Clock Start/From:
Clock To:
1st Value:
2nd Value:
Value Percent: **20.000**
Continuous Index:
Within 8" of Joint: **NO**
Remarks:

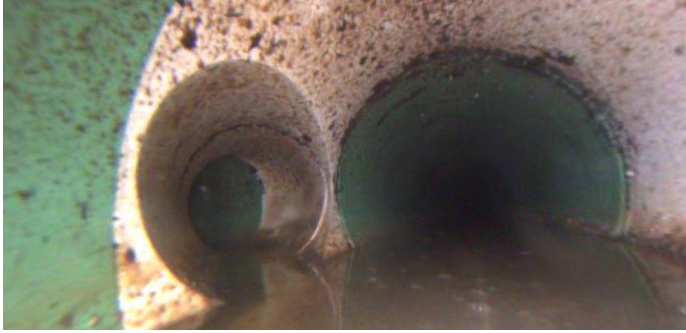
Code: **TFA**
Description: **Tap Factory Active**

Distance (ft): **106.0**
Structural Grade: **0**
O&M Grade: **0**
Clock Start/From: **3**
Clock To:
1st Value: **4.000**
2nd Value:
Value Percent:
Continuous Index:
Within 8" of Joint:
Remarks:

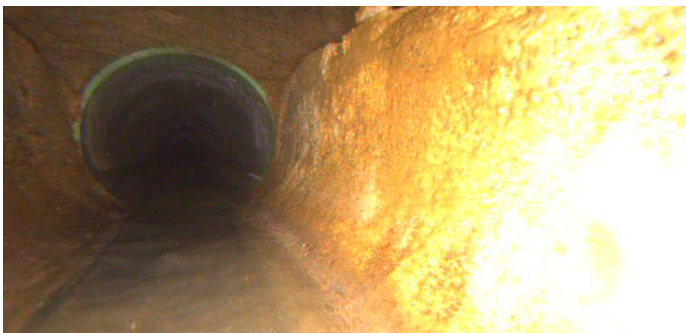
Code: **AMH**
Description: **Manhole**

Distance (ft): **111.0**
Structural Grade: **0**
O&M Grade: **0**
Clock Start/From:
Clock To:
1st Value:
2nd Value:
Value Percent:
Continuous Index:
Within 8" of Joint: **NO**
Remarks: **M-1004-067**
