Profile/Photo Observation Report

Date:	04/11/2018	Weather:		Coding:	PACP 6.0
Pipe Length (ft):	159.4	Owner:	NA	Pre Clean:	Not Known
P.O.#:		Surveyor:	Jen Costello	PSR:	P-1004-076-075
Customer:		Clean Date:	01/01/1900	Shape:	C

Street:	Tulip Ln.	Flow Control:	Not Controlled
City:	Hobart, IN	Year Renewed:	
Location:	Other	Tape/Media #:	
Purpose:	Not Known	Dia/Height:	8"
Use:	Sanitary	Material:	PVC
Drain Area:	NA	Lining:	
Category:	NA		
Comment:	NULL - MH-M-704-063 Debris at entrance

Location Details:		Direction of Survey:	Downstream
US MH:	M-1004-075	DS MH:	M-1004-076
		Total Length Surveyed (ft):	154.5

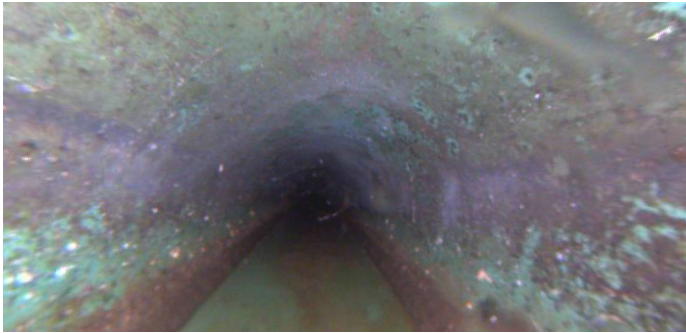
Code:	MWL
Description:	Water Level

Distance (ft):	.0
Structural Grade:	0
O&M Grade:	0
Clock Start/From:	
Clock To:	
1st Value:	
2nd Value:	
Value Percent:	10.000
Continuous Index:	
Within 8" of Joint:	NO
Remarks:

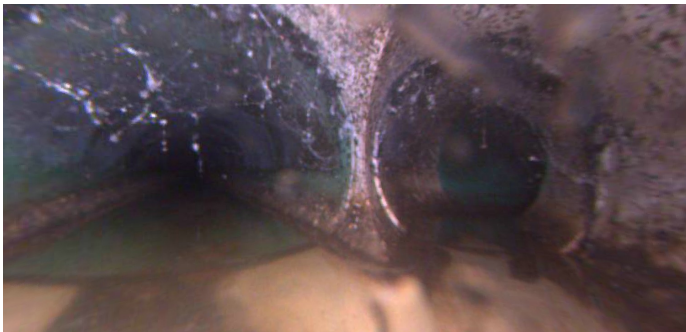
Code:	TFA
Description:	Tap Factory Active

Distance (ft):	3.3
Structural Grade:	0
O&M Grade:	0
Clock Start/From:	3
Clock To:	
1st Value:	4.000
2nd Value:	
Value Percent:	
Continuous Index:	
Within 8" of Joint:	
Remarks:

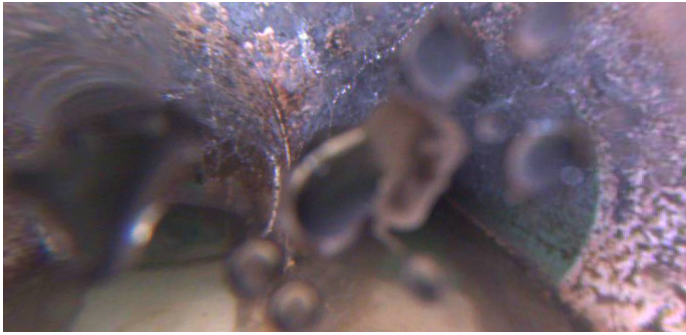
Code: **TFA**
Description: **Tap Factory Active**

Distance (ft): **16.4**
Structural Grade: **0**
O&M Grade: **0**
Clock Start/From: **9**
Clock To:
1st Value: **4.000**
2nd Value:
Value Percent:
Continuous Index:
Within 8" of Joint:
Remarks:

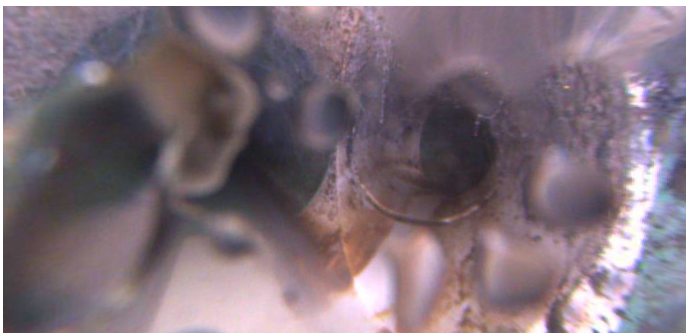
Code: **TFA**
Description: **Tap Factory Active**

Distance (ft): **49.6**
Structural Grade: **0**
O&M Grade: **0**
Clock Start/From: **3**
Clock To:
1st Value: **4.000**
2nd Value:
Value Percent:
Continuous Index:
Within 8" of Joint:
Remarks:

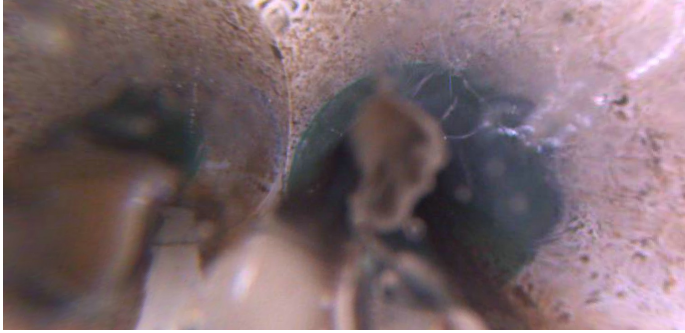
Code: **TFA**
Description: **Tap Factory Active**

Distance (ft): **112.8**
Structural Grade: **0**
O&M Grade: **0**
Clock Start/From: **9**
Clock To:
1st Value: **4.000**
2nd Value:
Value Percent:
Continuous Index:
Within 8" of Joint:
Remarks:

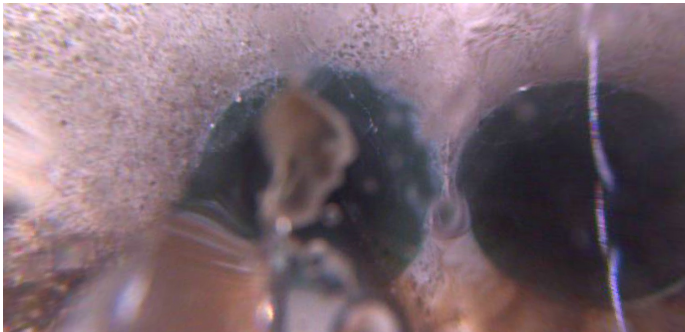
Code: **TF**
Description: **Tap Factory**

Distance (ft): **126.0**
Structural Grade: **0**
O&M Grade: **0**
Clock Start/From: **3**
Clock To:
1st Value: **4.000**
2nd Value:
Value Percent:
Continuous Index:
Within 8" of Joint:
Remarks:

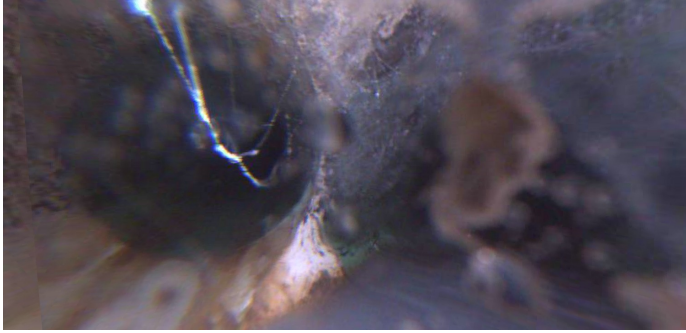
Code: **TF**
Description: **Tap Factory**

Distance (ft): **139.5**
Structural Grade: **0**
O&M Grade: **0**
Clock Start/From: **9**
Clock To:
1st Value: **4.000**
2nd Value:
Value Percent:
Continuous Index:
Within 8" of Joint:
Remarks:

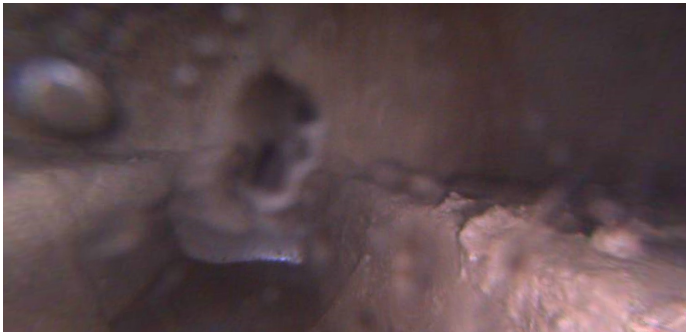
Code: **AMH**
Description: **Manhole**

Distance (ft): **154.5**
Structural Grade: **0**
O&M Grade: **0**
Clock Start/From:
Clock To:
1st Value:
2nd Value:
Value Percent:
Continuous Index:
Within 8" of Joint: **NO**
Remarks: **M-1004-076**
