## Profile/Photo Observation Report

Date:	<b>01/08/2023</b>	Weather:		Coding:	<b>PACP 7.0</b>
Pipe Length (ft):	<b>131.0</b>	Owner:	<b>City of Hobart</b>	Pre Clean:	<b>Heavy Cleaning</b>
P.O.#:	<b>YES502259</b>	Surveyor:	<b>S. Bucklin</b>	PSR:	<b>P-1004-077-078</b>
Customer:	<b>City of Hobart</b>	Clean Date:	<b>10/29/2022</b>	Shape:	<b>C</b>

Street:	<b>Hemlock Drive</b>	Flow Control:	<b>Not Controlled</b>
City:	<b>Hobart, IN</b>	Year Renewed:	
Location:	<b>Easement/Right of Way</b>	Tape/Media #:	
Purpose:	<b>Routine Assessment</b>	Dia/Height:	<b>8"</b>
Use:	<b>Sanitary Sewage Pipe</b>	Material:	<b>PVC</b>
Drain Area:		Lining:	<b>None</b>
Category:	<b>NA</b>		
Comment:

Location Details:		Direction of Survey:	<b>Upstream</b>
US MH:	<b>M-1004-078</b>	DS MH:	<b>M-1004-077</b>
		Total Length Surveyed (ft):	<b>133.2</b>

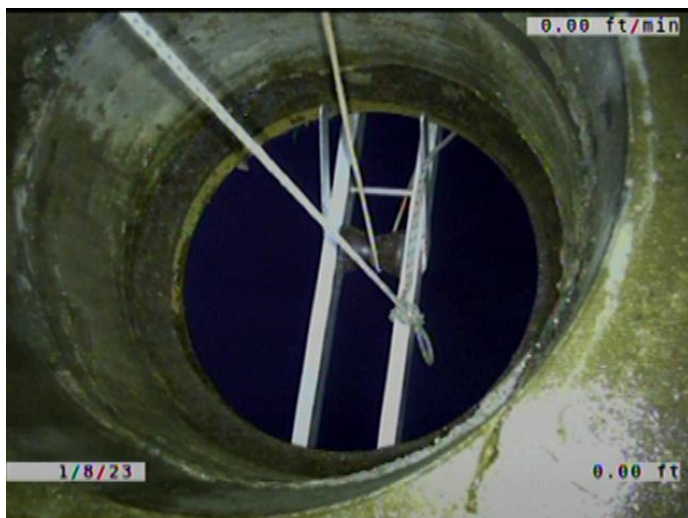
Code: **AMH**  
 Description: **Manhole**

Distance (ft): **.0**  
 Structural Grade: **0**  
 O&M Grade: **0**  
 Clock Start/From:  
 Clock To:  
 1st Value:  
 2nd Value:  
 Value Percent:  
 Continuous Index:  
 Within 8" of Joint: **NO**  
 Remarks: **M-1004-077**

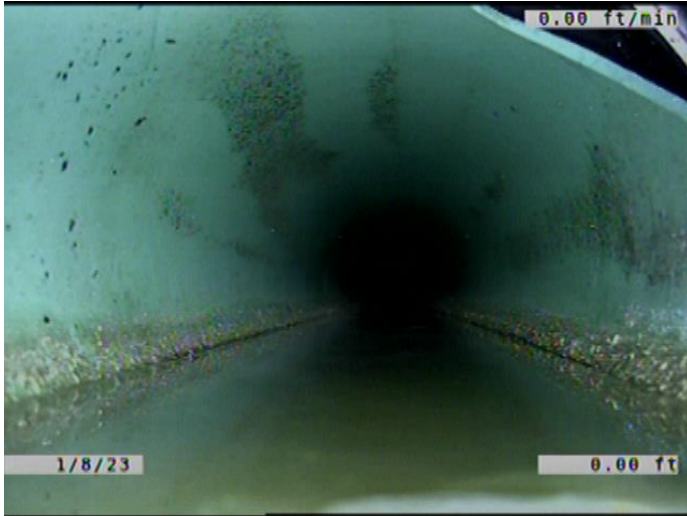
Code:	<b>MWL</b>
Description:	<b>Miscellaneous Water Level</b>
Distance (ft):	<b>.0</b>
Structural Grade:	<b>0</b>
O&M Grade:	<b>0</b>
Clock Start/From:	
Clock To:	
1st Value:	
2nd Value:	
Value Percent:	<b>10.000</b>
Continuous Index:	
Within 8" of Joint:	<b>NO</b>
Remarks:

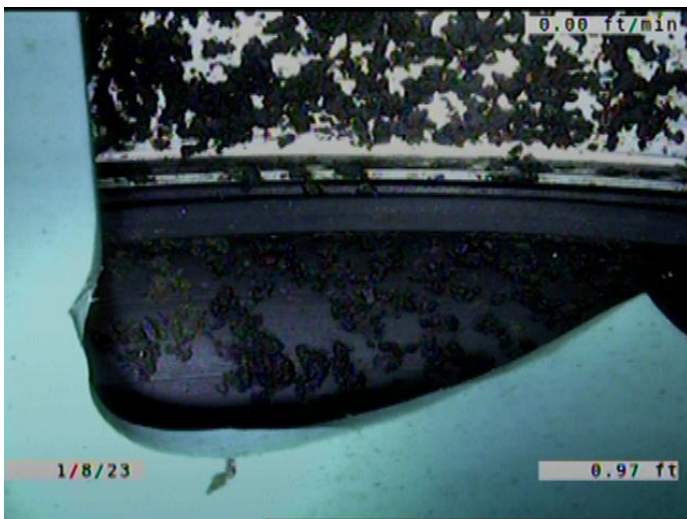
Code:	<b>SMW</b>
Description:	<b>Surface Damage Missing Wall</b>
Distance (ft):	<b>1.0</b>
Structural Grade:	<b>5</b>
O&M Grade:	<b>0</b>
Clock Start/From:	<b>12</b>
Clock To:	<b>3</b>
1st Value:	
2nd Value:	
Value Percent:	
Continuous Index:	
Within 8" of Joint:	<b>YES</b>
Remarks:

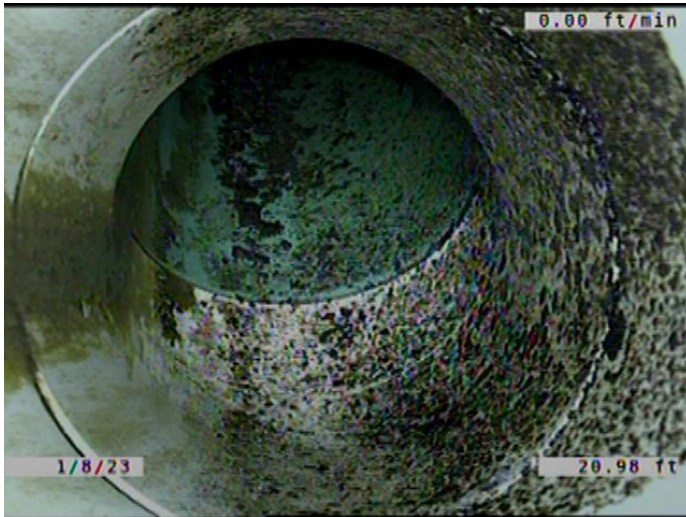
Code: **TF**  
 Description: **Tap Factory**

Distance (ft): **21.0**  
 Structural Grade: **0**  
 O&M Grade: **0**  
 Clock Start/From: **9**  
 Clock To:  
 1st Value: **6.000**  
 2nd Value:  
 Value Percent:  
 Continuous Index:  
 Within 8" of Joint: **YES**  
 Remarks:

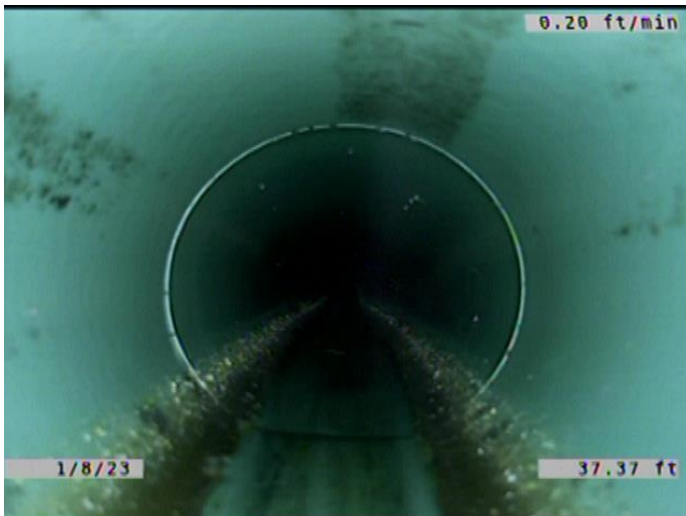
Code: **MWLS**  
 Description: **Miscellaneous Water Level Sag**

Distance (ft): **37.4**  
 Structural Grade: **2**  
 O&M Grade: **0**  
 Clock Start/From:  
 Clock To:  
 1st Value:  
 2nd Value:  
 Value Percent: **5.000**  
 Continuous Index: **S01**  
 Within 8" of Joint: **NO**  
 Remarks:

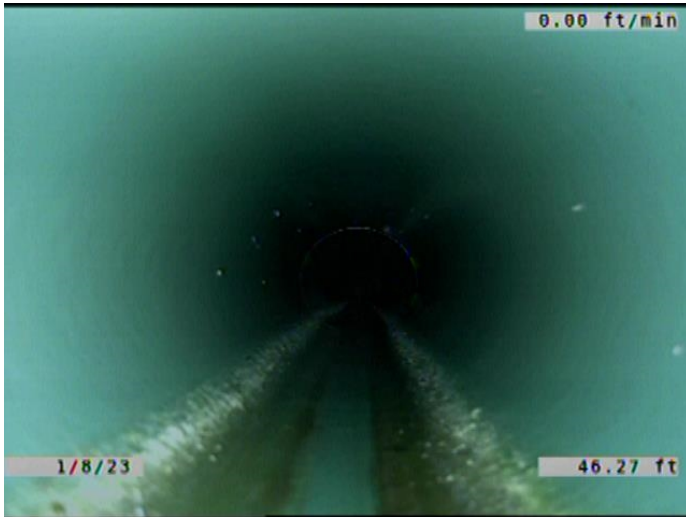
Code: **MWLS**  
Description: **Miscellaneous Water Level Sag**

Distance (ft): **46.3**  
Structural Grade: **2**  
O&M Grade: **0**  
Clock Start/From:  
Clock To:  
1st Value:  
2nd Value:  
Value Percent: **5.000**  
Continuous Index: **F01**  
Within 8" of Joint: **NO**  
Remarks:

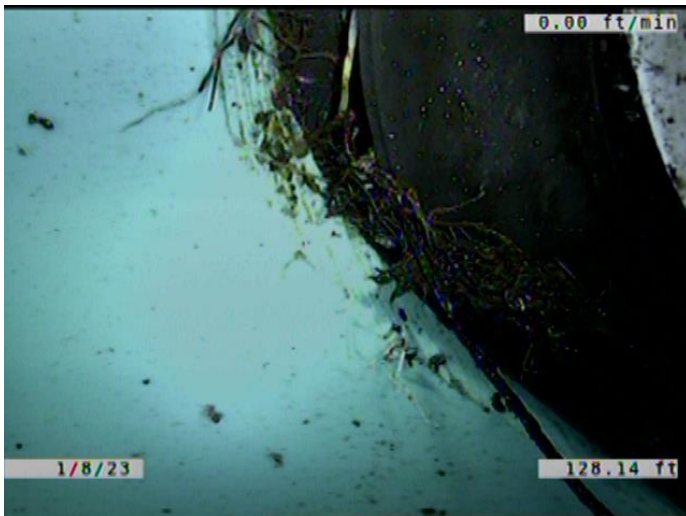
Code: **RFC**  
Description: **Roots Fine Connection**

Distance (ft): **128.1**  
Structural Grade: **0**  
O&M Grade: **1**  
Clock Start/From: **1**  
Clock To: **2**  
1st Value:  
2nd Value:  
Value Percent:  
Continuous Index:  
Within 8" of Joint: **NO**  
Remarks:

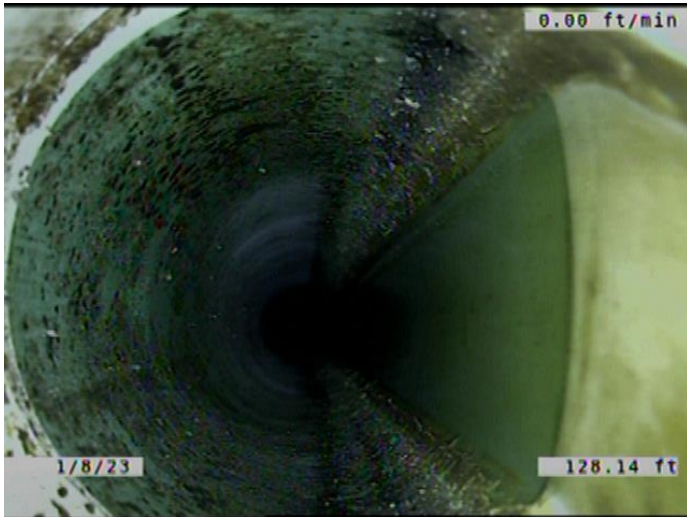
Code: **TB**  
Description: **Tap Break-in/Hammer**

Distance (ft): **128.1**  
Structural Grade: **0**  
O&M Grade: **0**  
Clock Start/From: **3**  
Clock To:  
1st Value: **6.000**  
2nd Value:  
Value Percent:  
Continuous Index:  
Within 8" of Joint: **NO**  
Remarks: **CONSTANTLY RUNNING WATER.**

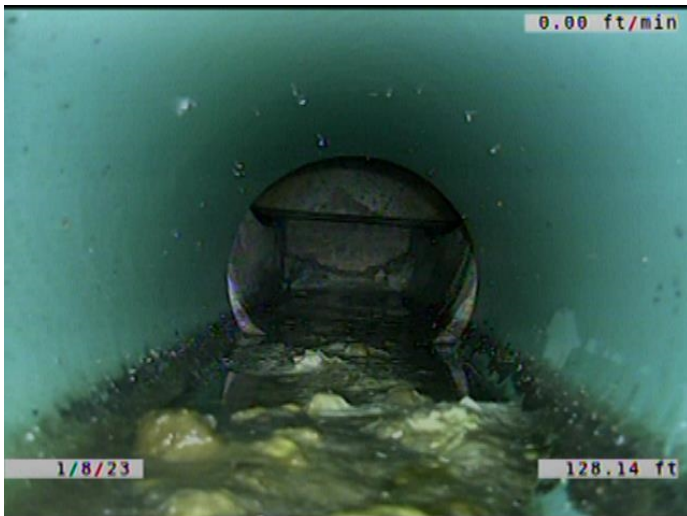
Code: **DSF**  
Description: **Deposits Settled Fine**

Distance (ft): **128.1**  
Structural Grade: **0**  
O&M Grade: **2**  
Clock Start/From: **5**  
Clock To: **7**  
1st Value:  
2nd Value:  
Value Percent: **5.000**  
Continuous Index: **S02**  
Within 8" of Joint: **YES**  
Remarks:

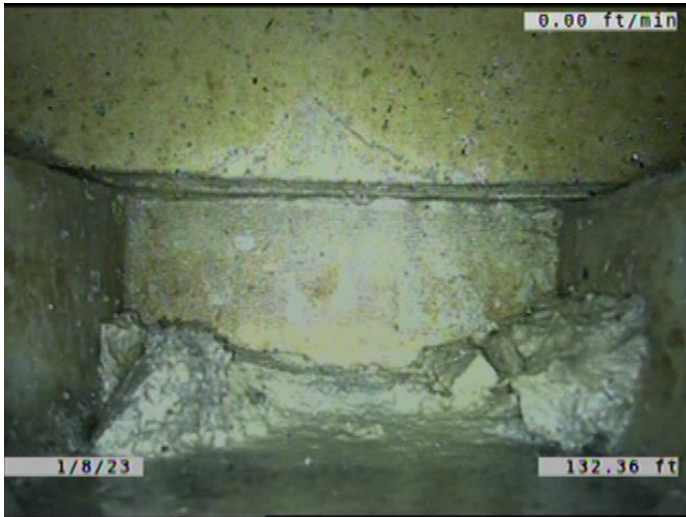
Code: **DSF**  
 Description: **Deposits Settled Fine**

Distance (ft): **132.4**  
 Structural Grade: **0**  
 O&M Grade: **2**  
 Clock Start/From: **5**  
 Clock To: **7**  
 1st Value:  
 2nd Value:  
 Value Percent: **5.000**  
 Continuous Index: **F02**  
 Within 8" of Joint: **YES**  
 Remarks:

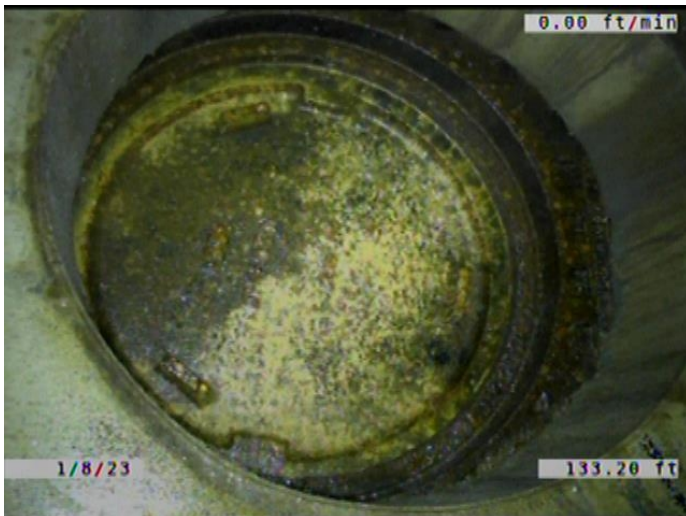
Code: **AMH**  
 Description: **Manhole**

Distance (ft): **133.2**  
 Structural Grade: **0**  
 O&M Grade: **0**  
 Clock Start/From:  
 Clock To:  
 1st Value:  
 2nd Value:  
 Value Percent:  
 Continuous Index:  
 Within 8" of Joint: **NO**  
 Remarks: **M-1004-078**
