## Profile/Photo Observation Report

| Street: | <b>TULIP LN</b> | Flow Control: | <b>Not Controlled</b> |
| City: | <b>Hobart, IN</b> | Year Renewed: | |

| US MH: | <b>M-1004-079</b> | DS MH: | <b>M-1004-080</b> |

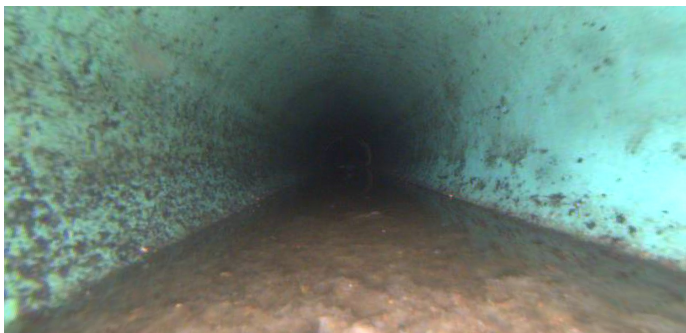
Code: **AMH**  
Description: **Manhole**

Distance (ft): **.0**  
Structural Grade: **0**  
O&M Grade: **0**  
Clock Start/From:  
Clock To:  
1st Value:  
2nd Value:  
Value Percent:  
Continuous Index:  
Within 8" of Joint: **NO**  
Remarks: **M-1004-080**

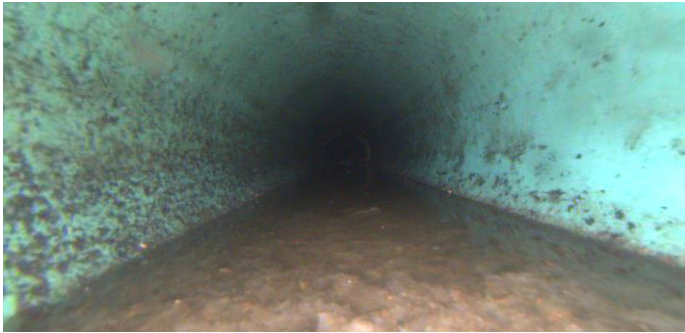
| Code: | <b>MWL</b> |
| Description: | <b>Water Level</b> |

| Distance (ft): | <b>.0</b> |
| Value Percent: | <b>20.000</b> |

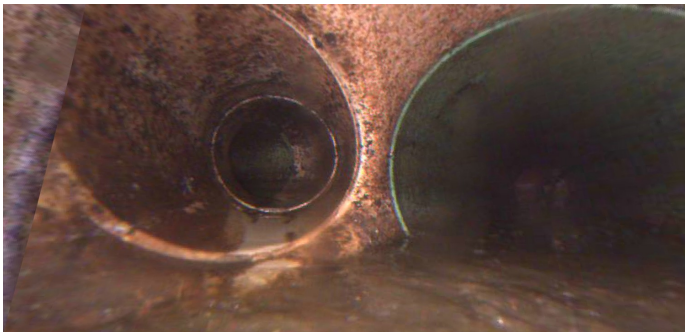
| Code: | <b>TF</b> |
| Description: | <b>Tap Factory</b> |

| Distance (ft): | <b>6.4</b> |
| Clock Start/From: | <b>3</b> |
| 1st Value: | <b>4.000</b> |
