## Profile/Photo Observation Report

Date:	<b>04/13/2018</b>	Weather:		Coding:	<b>PACP 6.0</b>
Pipe Length (ft):	<b>106.7</b>	Owner:	<b>NA</b>	Pre Clean:	<b>Not Known</b>
P.O.#:		Surveyor:	<b>Jen Costello</b>	PSR:	<b>P-1004-080-079</b>
Customer:		Clean Date:	<b>01/01/1900</b>	Shape:	<b>C</b>

Street:	<b>Tulip Ln.</b>	Flow Control:	<b>Not Controlled</b>
City:	<b>Hobart, IN</b>	Year Renewed:	
Location:	<b>Other</b>	Tape/Media #:	
Purpose:	<b>Not Known</b>	Dia/Height:	<b>8"</b>
Use:	<b>Sanitary</b>	Material:	<b>PVC</b>
Drain Area:	<b>NA</b>	Lining:	
Category:	<b>NA</b>		
Comment:

Location Details:		Direction of Survey:	<b>Upstream</b>
US MH:	<b>M-1004-079</b>	DS MH:	<b>M-1004-080</b>
		Total Length Surveyed (ft):	<b>60.3</b>

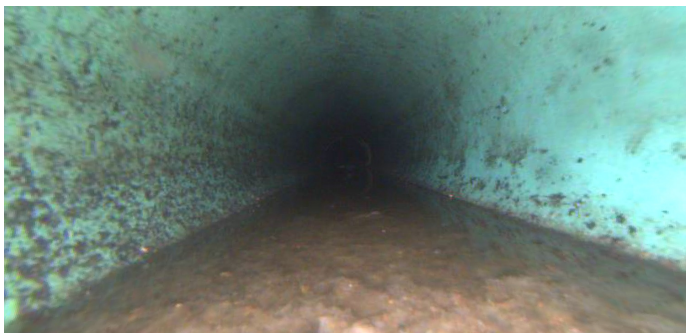
Code: **AMH**  
Description: **Manhole**

Distance (ft): **.0**  
Structural Grade: **0**  
O&M Grade: **0**  
Clock Start/From:  
Clock To:  
1st Value:  
2nd Value:  
Value Percent:  
Continuous Index:  
Within 8" of Joint: **NO**  
Remarks: **M-1004-080**

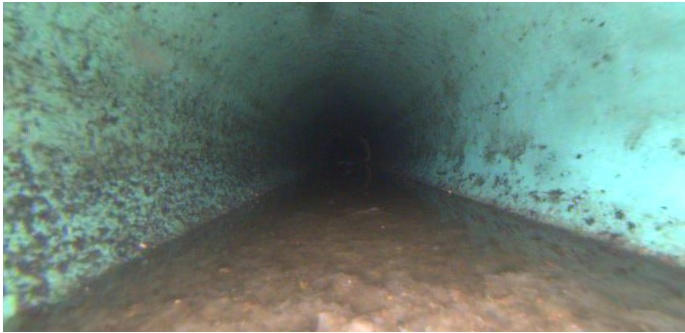
Code:	<b>MWL</b>
Description:	<b>Water Level</b>

Distance (ft):	<b>.0</b>
Structural Grade:	<b>0</b>
O&M Grade:	<b>0</b>
Clock Start/From:	
Clock To:	
1st Value:	
2nd Value:	
Value Percent:	<b>20.000</b>
Continuous Index:	
Within 8" of Joint:	<b>NO</b>
Remarks:

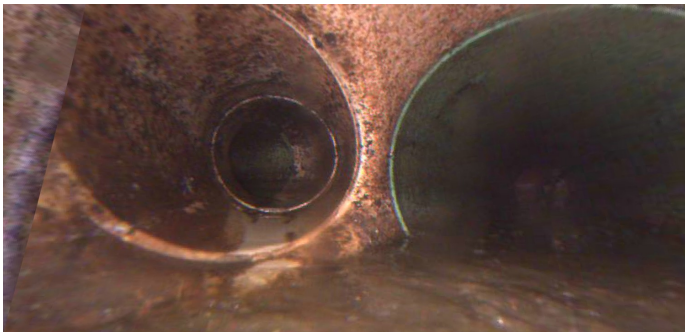
Code:	<b>TF</b>
Description:	<b>Tap Factory</b>

Distance (ft):	<b>6.4</b>
Structural Grade:	<b>0</b>
O&M Grade:	<b>0</b>
Clock Start/From:	<b>3</b>
Clock To:	
1st Value:	<b>4.000</b>
2nd Value:	
Value Percent:	
Continuous Index:	
Within 8" of Joint:	
Remarks:
