## Profile/Photo Observation Report

Street:	<b>TULIP LN</b>	Flow Control:	<b>Not Controlled</b>
City:	<b>Hobart, IN</b>	Year Renewed:	
Location:	<b>Other</b>	Tape/Media #:	
Purpose:	<b>Not Known</b>	Dia/Height:	<b>8"</b>
Use:	<b>Sanitary</b>	Material:	<b>PVC</b>
Drain Area:	<b>NA</b>	Lining:	
Category:	<b>NA</b>		
Comment:

Location Details:		Direction of Survey:	<b>Downstream</b>
US MH:	<b>M-1004-082</b>	DS MH:	<b>M-1004-047</b>
		Total Length Surveyed (ft):	<b>168.2</b>

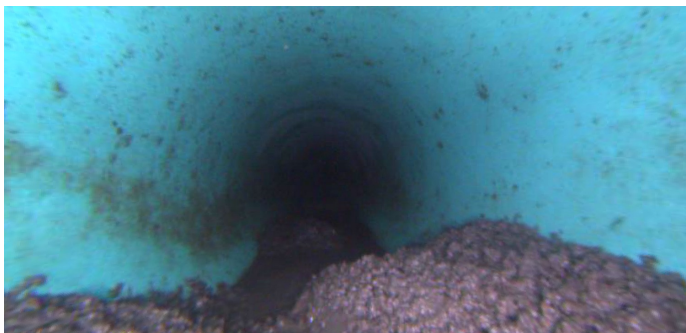
Code: **AMH**  
Description: **Manhole**

Distance (ft): **.0**  
Structural Grade: **0**  
O&M Grade: **0**  
Clock Start/From:  
Clock To:  
1st Value:  
2nd Value:  
Value Percent:  
Continuous Index:  
Within 8" of Joint: **NO**  
Remarks: **M-1004-082**

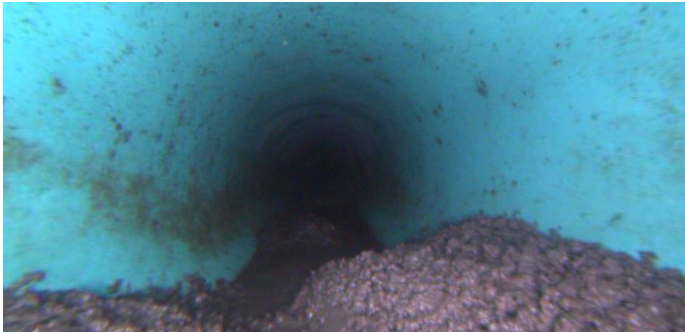
Code:	<b>MWL</b>
Description:	<b>Water Level</b>

Distance (ft):	<b>.0</b>
Structural Grade:	<b>0</b>
O&M Grade:	<b>0</b>
Clock Start/From:	
Clock To:	
1st Value:	
2nd Value:	
Value Percent:	<b>5.000</b>
Continuous Index:	
Within 8" of Joint:	<b>NO</b>
Remarks:

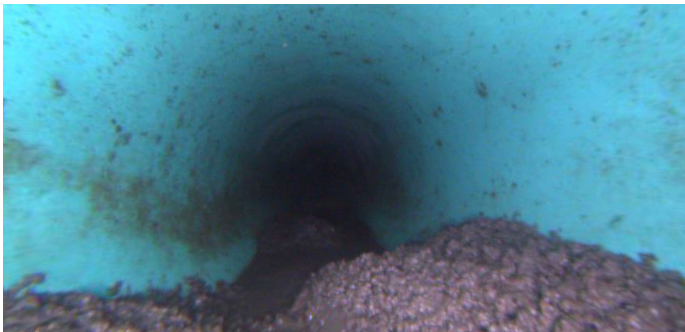
Code:	<b>DSF</b>
Description:	<b>Deposits Settled Fine</b>

Distance (ft):	<b>.0</b>
Structural Grade:	<b>0</b>
O&M Grade:	<b>3</b>
Clock Start/From:	<b>4</b>
Clock To:	<b>8</b>
1st Value:	
2nd Value:	
Value Percent:	<b>20.000</b>
Continuous Index:	
Within 8" of Joint:	<b>NO</b>
Remarks:

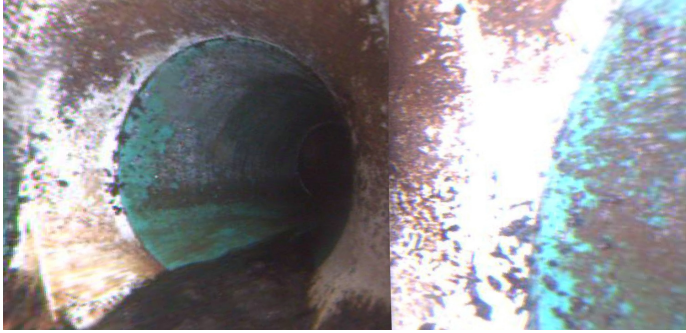
Code: **TFA**  
Description: **Tap Factory Active**

Distance (ft): **10.3**  
Structural Grade: **0**  
O&M Grade: **0**  
Clock Start/From: **9**  
Clock To:  
1st Value: **4.000**  
2nd Value:  
Value Percent:  
Continuous Index:  
Within 8" of Joint:  
Remarks:

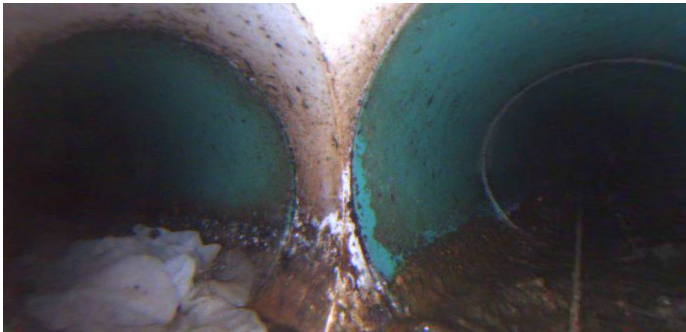
Code: **TF**  
Description: **Tap Factory**

Distance (ft): **17.6**  
Structural Grade: **0**  
O&M Grade: **0**  
Clock Start/From: **3**  
Clock To:  
1st Value: **4.000**  
2nd Value:  
Value Percent:  
Continuous Index:  
Within 8" of Joint:  
Remarks:

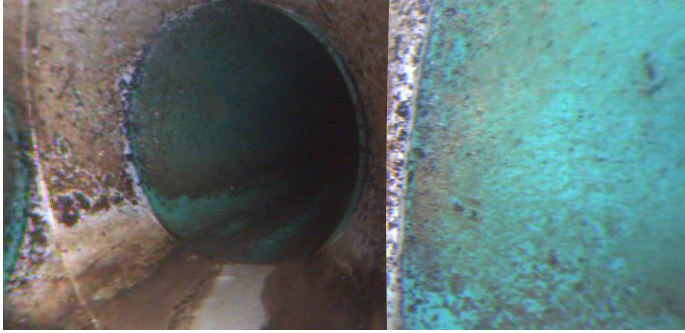
Code: **TF**  
Description: **Tap Factory**

Distance (ft): **25.3**  
Structural Grade: **0**  
O&M Grade: **0**  
Clock Start/From: **9**  
Clock To:  
1st Value: **4.000**  
2nd Value:  
Value Percent:  
Continuous Index:  
Within 8" of Joint:  
Remarks:

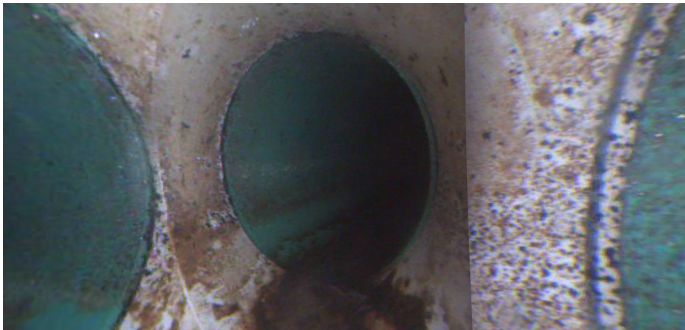
Code: **TF**  
Description: **Tap Factory**

Distance (ft): **86.8**  
Structural Grade: **0**  
O&M Grade: **0**  
Clock Start/From: **9**  
Clock To:  
1st Value: **4.000**  
2nd Value:  
Value Percent:  
Continuous Index:  
Within 8" of Joint:  
Remarks:

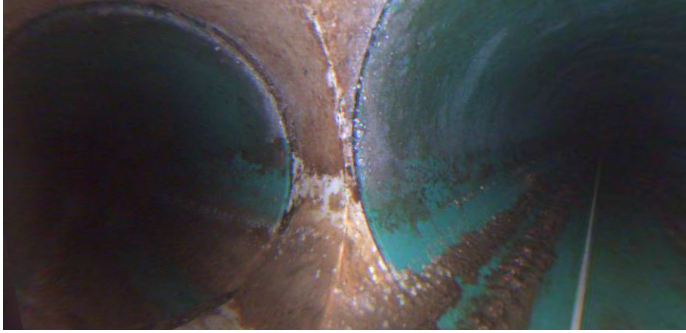
Code: **TFA**  
Description: **Tap Factory Active**

Distance (ft): **106.0**  
Structural Grade: **0**  
O&M Grade: **0**  
Clock Start/From: **3**  
Clock To:  
1st Value: **4.000**  
2nd Value:  
Value Percent:  
Continuous Index:  
Within 8" of Joint:  
Remarks:

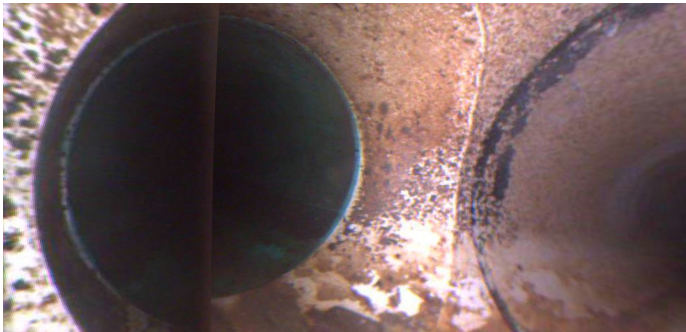
Code: **TF**  
Description: **Tap Factory**

Distance (ft): **160.4**  
Structural Grade: **0**  
O&M Grade: **0**  
Clock Start/From: **9**  
Clock To:  
1st Value: **4.000**  
2nd Value:  
Value Percent:  
Continuous Index:  
Within 8" of Joint:  
Remarks:

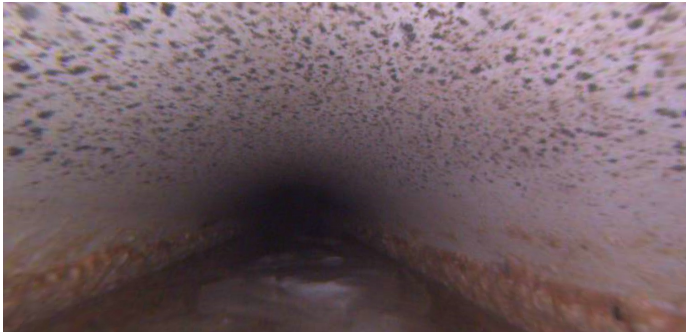
Code: **MWL**  
Description: **Water Level**

Distance (ft): **168.2**  
Structural Grade: **0**  
O&M Grade: **0**  
Clock Start/From:  
Clock To:  
1st Value:  
2nd Value:  
Value Percent: **30.000**  
Continuous Index:  
Within 8" of Joint: **NO**  
Remarks:

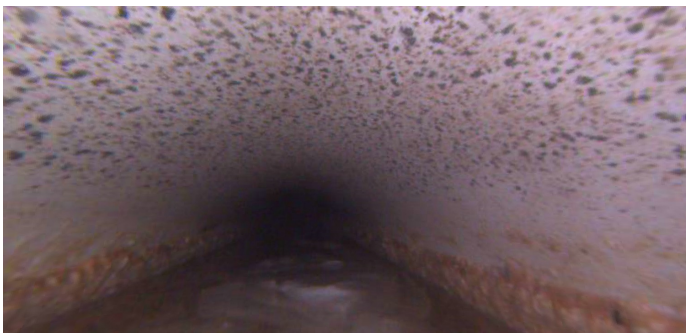
Code: **MSA**  
Description: **Abandoned Survey**

Distance (ft): **168.2**  
Structural Grade: **0**  
O&M Grade: **0**  
Clock Start/From:  
Clock To:  
1st Value:  
2nd Value:  
Value Percent:  
Continuous Index:  
Within 8" of Joint: **NO**  
Remarks: **debris under water**
