## Profile/Photo Observation Report

Street:	<b>Tulip Ln.</b>	Flow Control:	<b>Not Controlled</b>
City:	<b>Hobart, IN</b>	Year Renewed:	
Location:	<b>Other</b>	Tape/Media #:	
Purpose:	<b>Not Known</b>	Dia/Height:	<b>8"</b>
Use:	<b>Sanitary</b>	Material:	<b>PVC</b>
Drain Area:	<b>NA</b>	Lining:	
Category:	<b>NA</b>		
Comment:

Location Details:		Direction of Survey:	<b>Downstream</b>
US MH:	<b>M-1004-082</b>	DS MH:	<b>M-1004-047</b>
		Total Length Surveyed (ft):	<b>168.2</b>

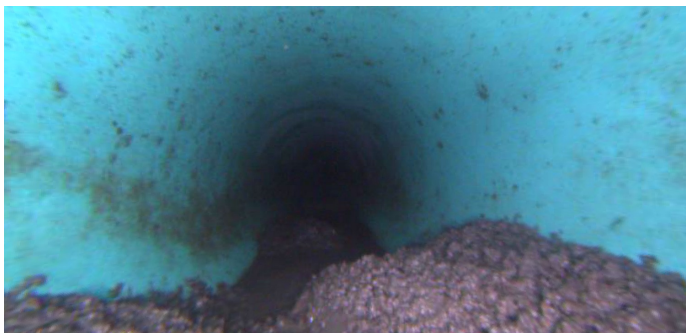
Code: **AMH**  
Description: **Manhole**

Distance (ft): **.0**  
Structural Grade: **0**  
O&M Grade: **0**  
Clock Start/From:  
Clock To:  
1st Value:  
2nd Value:  
Value Percent:  
Continuous Index:  
Within 8" of Joint: **NO**  
Remarks: **M-1004-082**

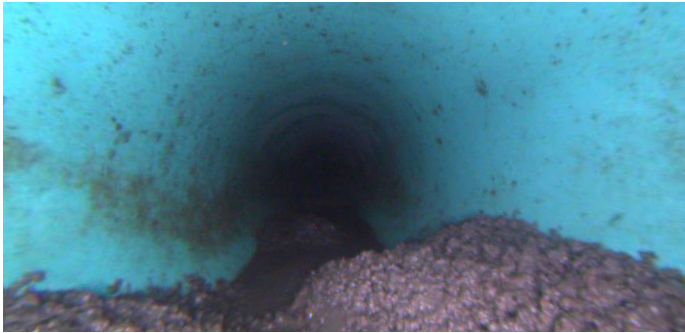
Code:	<b>MWL</b>
Description:	<b>Water Level</b>

Distance (ft):	<b>.0</b>
Structural Grade:	<b>0</b>
O&M Grade:	<b>0</b>
Clock Start/From:	
Clock To:	
1st Value:	
2nd Value:	
Value Percent:	<b>5.000</b>
Continuous Index:	
Within 8" of Joint:	<b>NO</b>
Remarks:

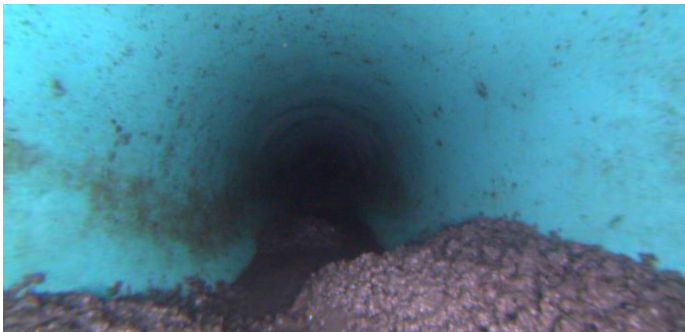
Code:	<b>DSF</b>
Description:	<b>Deposits Settled Fine</b>

Distance (ft):	<b>.0</b>
Structural Grade:	<b>0</b>
O&M Grade:	<b>3</b>
Clock Start/From:	<b>4</b>
Clock To:	<b>8</b>
1st Value:	
2nd Value:	
Value Percent:	<b>20.000</b>
Continuous Index:	
Within 8" of Joint:	<b>NO</b>
Remarks:

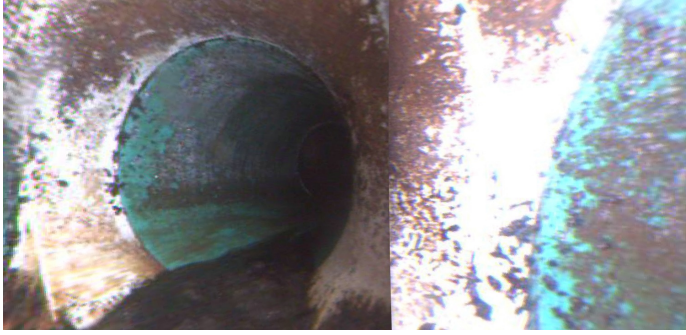
Code: **TFA**  
Description: **Tap Factory Active**

Distance (ft): **10.3**  
Structural Grade: **0**  
O&M Grade: **0**  
Clock Start/From: **9**  
Clock To:  
1st Value: **4.000**  
2nd Value:  
Value Percent:  
Continuous Index:  
Within 8" of Joint:  
Remarks:

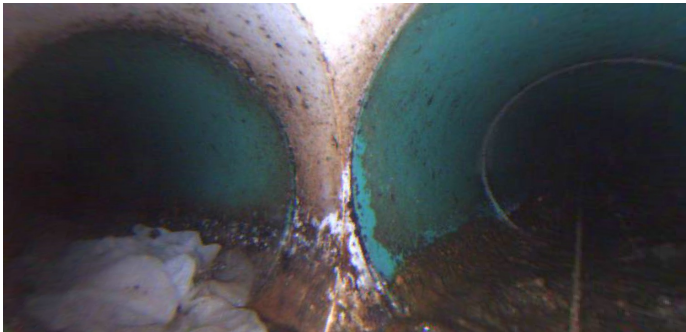
Code: **TF**  
Description: **Tap Factory**

Distance (ft): **17.6**  
Structural Grade: **0**  
O&M Grade: **0**  
Clock Start/From: **3**  
Clock To:  
1st Value: **4.000**  
2nd Value:  
Value Percent:  
Continuous Index:  
Within 8" of Joint:  
Remarks:

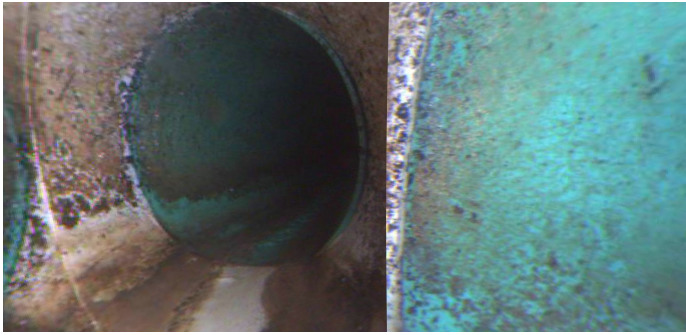
Code: **TF**  
Description: **Tap Factory**

Distance (ft): **25.3**  
Structural Grade: **0**  
O&M Grade: **0**  
Clock Start/From: **9**  
Clock To:  
1st Value: **4.000**  
2nd Value:  
Value Percent:  
Continuous Index:  
Within 8" of Joint:  
Remarks:

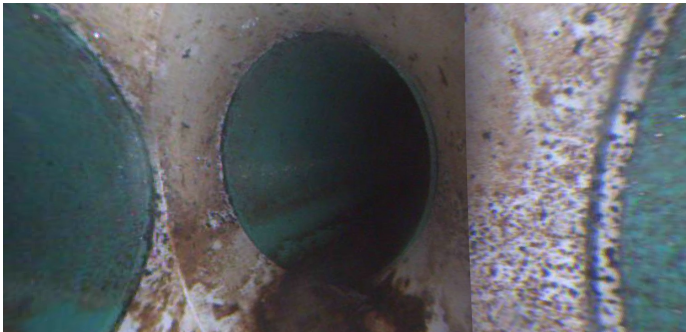
Code: **TF**  
Description: **Tap Factory**

Distance (ft): **86.8**  
Structural Grade: **0**  
O&M Grade: **0**  
Clock Start/From: **9**  
Clock To:  
1st Value: **4.000**  
2nd Value:  
Value Percent:  
Continuous Index:  
Within 8" of Joint:  
Remarks:

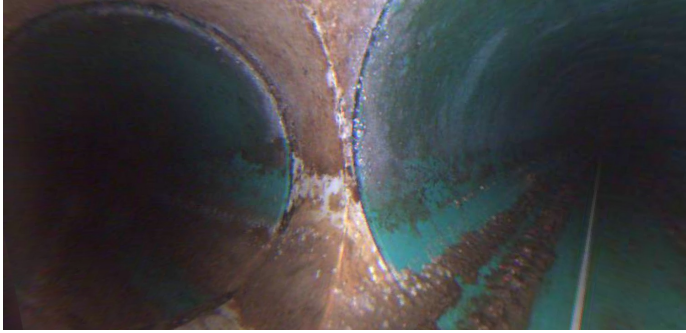
Code: **TFA**  
Description: **Tap Factory Active**

Distance (ft): **106.0**  
Structural Grade: **0**  
O&M Grade: **0**  
Clock Start/From: **3**  
Clock To:  
1st Value: **4.000**  
2nd Value:  
Value Percent:  
Continuous Index:  
Within 8" of Joint:  
Remarks:

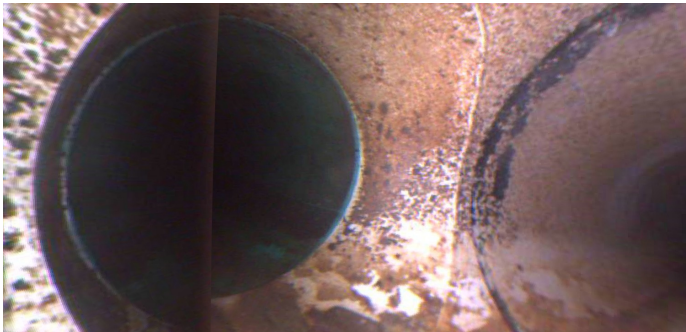
Code: **TF**  
Description: **Tap Factory**

Distance (ft): **160.4**  
Structural Grade: **0**  
O&M Grade: **0**  
Clock Start/From: **9**  
Clock To:  
1st Value: **4.000**  
2nd Value:  
Value Percent:  
Continuous Index:  
Within 8" of Joint:  
Remarks:

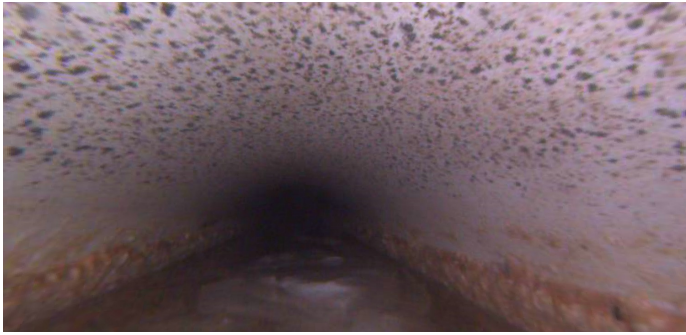
Code: **MWL**  
Description: **Water Level**

Distance (ft): **168.2**  
Structural Grade: **0**  
O&M Grade: **0**  
Clock Start/From:  
Clock To:  
1st Value:  
2nd Value:  
Value Percent: **30.000**  
Continuous Index:  
Within 8" of Joint: **NO**  
Remarks:

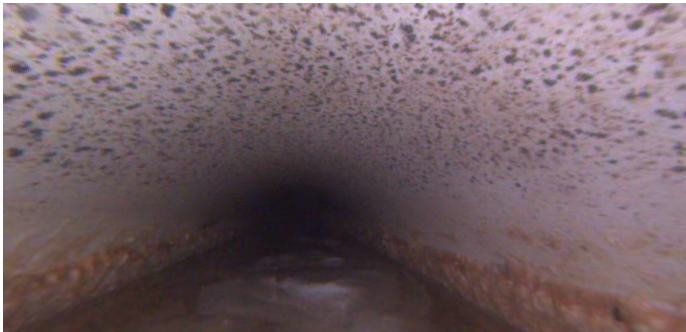
Code: **MSA**  
Description: **Abandoned Survey**

Distance (ft): **168.2**  
Structural Grade: **0**  
O&M Grade: **0**  
Clock Start/From:  
Clock To:  
1st Value:  
2nd Value:  
Value Percent:  
Continuous Index:  
Within 8" of Joint: **NO**  
Remarks: **debris under water**
