## Profile/Photo Observation Report

Date:	<b>04/12/2018</b>	Weather:		Coding:	<b>PACP 4.2</b>
Pipe Length (ft):	<b>140.1</b>	Owner:	<b>City of Hobart</b>	Pre Clean:	<b>No Pre-Cleaning</b>
P.O.#:	<b>2004</b>	Surveyor:	<b>SAN</b>	PSR:	<b>P-902-032-032A</b>
Customer:	<b>Red Zone</b>	Clean Date:		Shape:	<b>C</b>

Street:	<b>3418 Shelby St</b>	Flow Control:	<b>Not Controlled</b>
City:	<b>Hobart In</b>	Year Renewed:	
Location:	<b>Easement/Right of Way</b>	Tape/Media #:	<b>Deliverable 1</b>
Purpose:	<b>Routine Assessment</b>	Dia/Height:	<b>15"</b>
Use:	<b>Sanitary</b>	Material:	<b>RCP</b>
Drain Area:	<b>Northeast</b>	Lining:	
Category:	<b>NA</b>		
Comment:	<b>406-1/DSMH was not shown on mapping. MH is located in the street at 3770 34th Ave/Incomplete due to ro</b>		
Location Details:	<b>Backyards</b>	Direction of Survey:	<b>Upstream</b>
US MH:	<b>M-902-032</b>	DS MH:	<b>M-902-032A</b>
		Total Length Surveyed (ft):	<b>11.9</b>

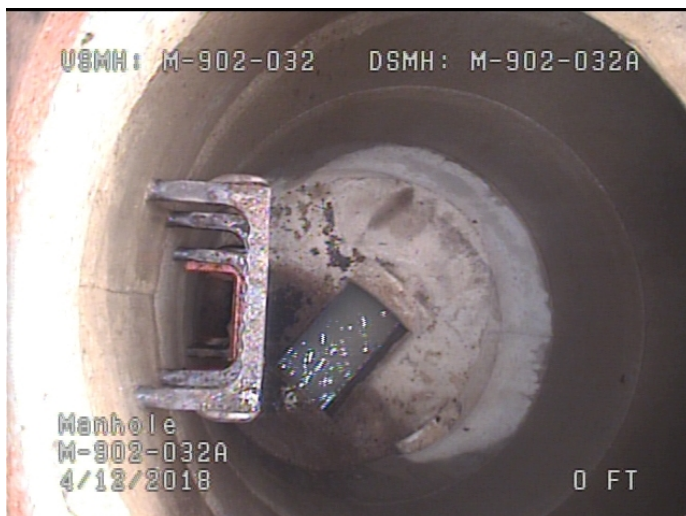
Code: **AMH**  
 Description: **Manhole**

Distance (ft): **.0**  
 Structural Grade: **0**  
 O&M Grade: **0**  
 Clock Start/From:  
 Clock To:  
 1st Value:  
 2nd Value:  
 Value Percent:  
 Continuous Index:  
 Within 8" of Joint: **NO**  
 Remarks: **M-902-032A**

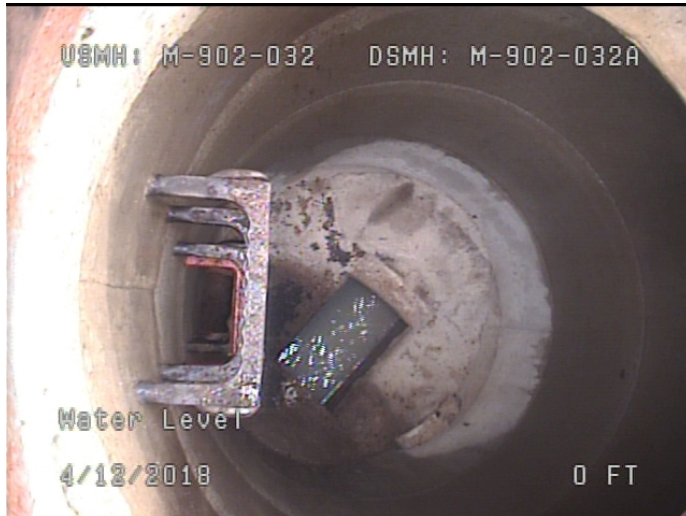
Code: **MWL**  
Description: **Water Level**

Distance (ft): **.0**  
Structural Grade: **0**  
O&M Grade: **0**  
Clock Start/From:  
Clock To:  
1st Value:  
2nd Value:  
Value Percent: **20.000**  
Continuous Index:  
Within 8" of Joint: **NO**  
Remarks:

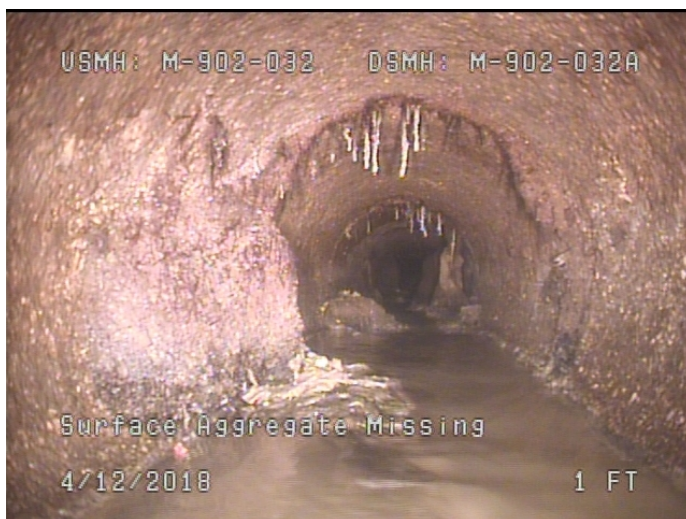
Code: **SAM**  
Description: **Surface Aggregate Missing**

Distance (ft): **1.0**  
Structural Grade: **4**  
O&M Grade: **0**  
Clock Start/From: **7**  
Clock To: **5**  
1st Value:  
2nd Value:  
Value Percent:  
Continuous Index: **S01**  
Within 8" of Joint: **NO**  
Remarks:

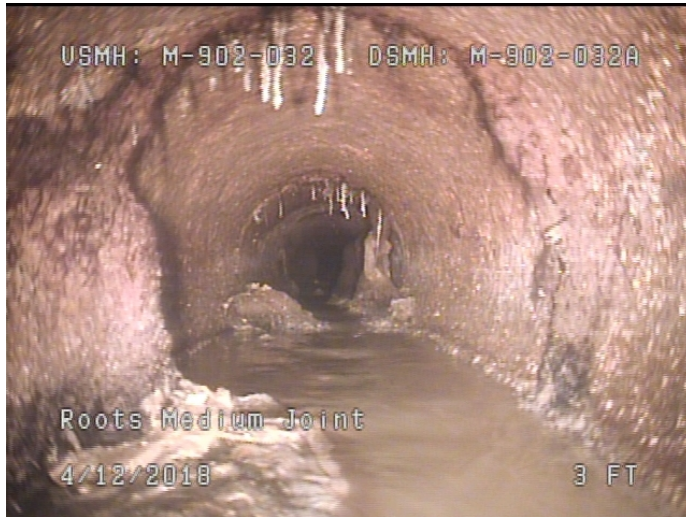
Code: **RMJ**  
 Description: **Roots Medium Joint**

Distance (ft): **3.0**  
 Structural Grade: **0**  
 O&M Grade: **3**  
 Clock Start/From: **7**  
 Clock To: **11**  
 1st Value:  
 2nd Value:  
 Value Percent: **25.000**  
 Continuous Index: **S02**  
 Within 8" of Joint: **YES**  
 Remarks:

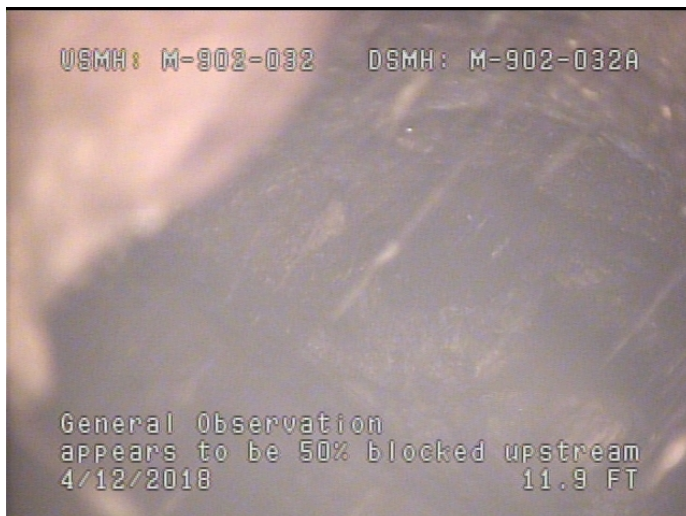
Code: **MGO**  
 Description: **General Observation**

Distance (ft): **11.9**  
 Structural Grade: **0**  
 O&M Grade: **0**  
 Clock Start/From:  
 Clock To:  
 1st Value:  
 2nd Value:  
 Value Percent:  
 Continuous Index:  
 Within 8" of Joint: **NO**  
 Remarks: **appears to be 50% blocked upstream**

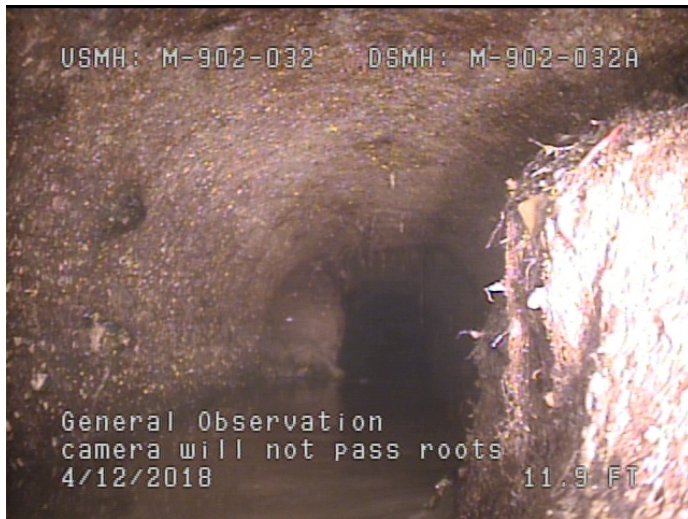
Code:	<b>MGO</b>
Description:	<b>General Observation</b>
Distance (ft):	<b>11.9</b>
Structural Grade:	<b>0</b>
O&M Grade:	<b>0</b>
Clock Start/From:	
Clock To:	
1st Value:	
2nd Value:	
Value Percent:	
Continuous Index:	
Within 8" of Joint:	<b>NO</b>
Remarks:	<b>camera will not pass roots</b>

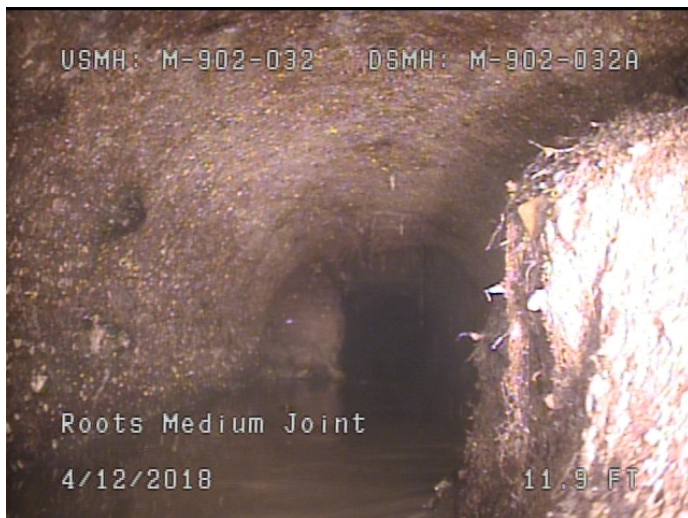
Code:	<b>RMJ</b>
Description:	<b>Roots Medium Joint</b>
Distance (ft):	<b>11.9</b>
Structural Grade:	<b>0</b>
O&M Grade:	<b>3</b>
Clock Start/From:	<b>7</b>
Clock To:	<b>11</b>
1st Value:	
2nd Value:	
Value Percent:	<b>25.000</b>
Continuous Index:	<b>F02</b>
Within 8" of Joint:	<b>YES</b>
Remarks:

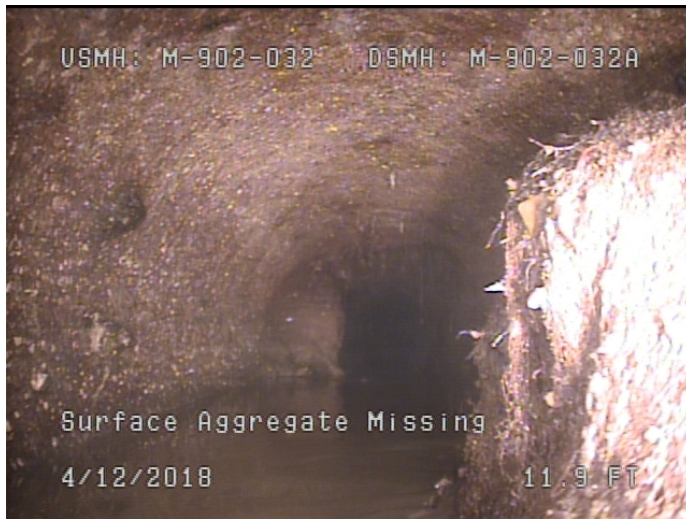
Code:	<b>SAM</b>
Description:	<b>Surface Aggregate Missing</b>
Distance (ft):	<b>11.9</b>
Structural Grade:	<b>4</b>
O&M Grade:	<b>0</b>
Clock Start/From:	<b>7</b>
Clock To:	<b>5</b>
1st Value:	
2nd Value:	
Value Percent:	
Continuous Index:	<b>F01</b>
Within 8" of Joint:	<b>NO</b>
Remarks:

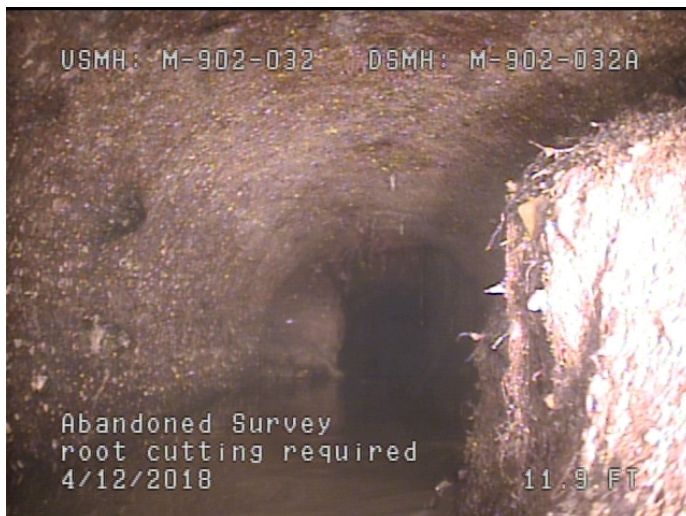
Code:	<b>MSA</b>
Description:	<b>Abandoned Survey</b>
Distance (ft):	<b>11.9</b>
Structural Grade:	<b>0</b>
O&M Grade:	<b>0</b>
Clock Start/From:	
Clock To:	
1st Value:	
2nd Value:	
Value Percent:	
Continuous Index:	
Within 8" of Joint:	<b>NO</b>
Remarks:	<b>root cutting required</b>
