## Profile/Photo Observation Report

| Street: | <b>3770 34th Ave</b> | Flow Control: | <b>Not Controlled</b> |
| US MH: | <b>M-902-032A</b> | DS MH: | <b>M-902-027</b> |

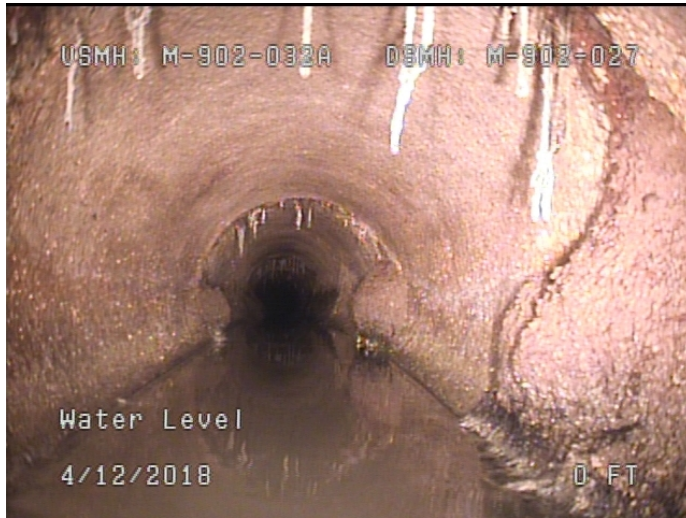
Code: **MWL**  
 Description: **Water Level**

Distance (ft): **.0**  
 Structural Grade: **0**  
 O&M Grade: **0**  
 Clock Start/From:  
 Clock To:  
 1st Value:  
 2nd Value:  
 Value Percent: **15.000**  
 Continuous Index:  
 Within 8" of Joint: **NO**  
 Remarks:

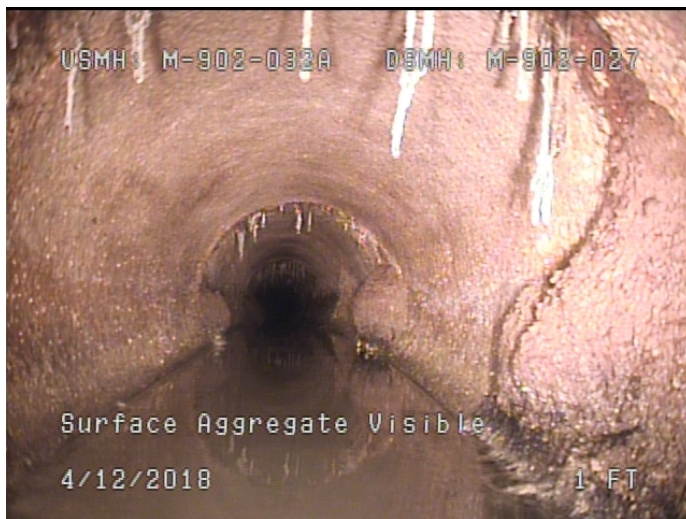
Code: **SAV**  
 Description: **Surface Aggregate Visible**

Distance (ft): **1.0**  
 Structural Grade: **3**  
 O&M Grade: **0**  
 Clock Start/From: **7**  
 Clock To: **5**  
 1st Value:  
 2nd Value:  
 Value Percent:  
 Continuous Index: **S01**  
 Within 8" of Joint: **NO**  
 Remarks:

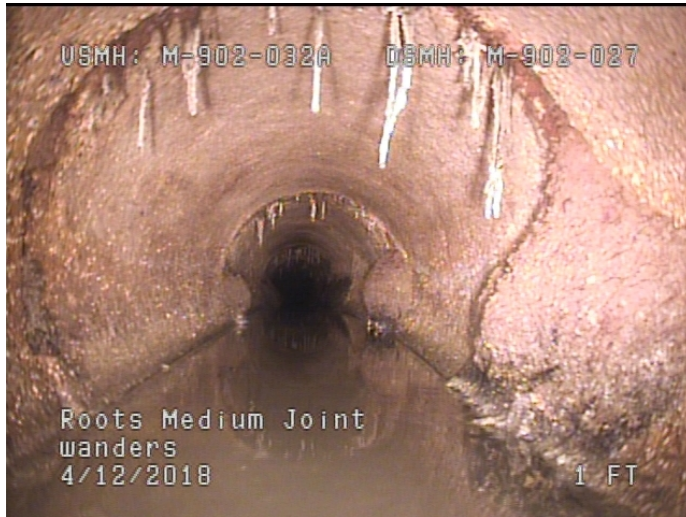
| Code: | <b>RMJ</b> |
| Description: | <b>Roots Medium Joint</b> |
| Distance (ft): | <b>1.0</b> |
| O&M Grade: | <b>3</b> |
| Value Percent: | <b>20.000</b> |
| Remarks: | <b>wanders</b> |

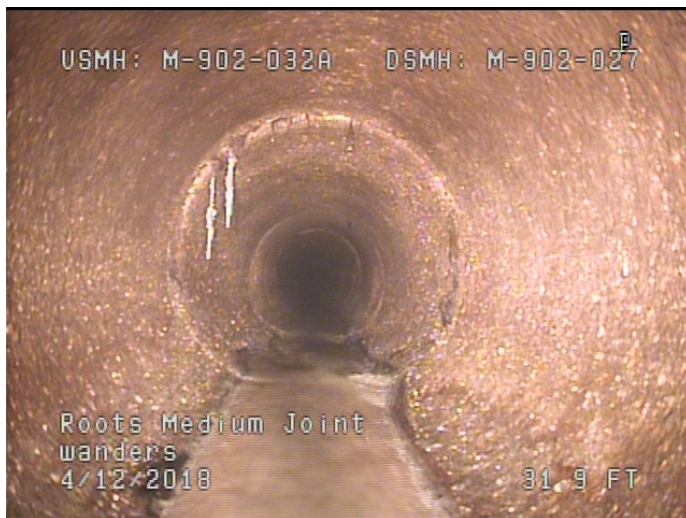
| Code: | <b>RMJ</b> |
| Description: | <b>Roots Medium Joint</b> |
| Distance (ft): | <b>31.9</b> |
| O&M Grade: | <b>3</b> |
| Value Percent: | <b>20.000</b> |
| Remarks: | <b>wanders</b> |

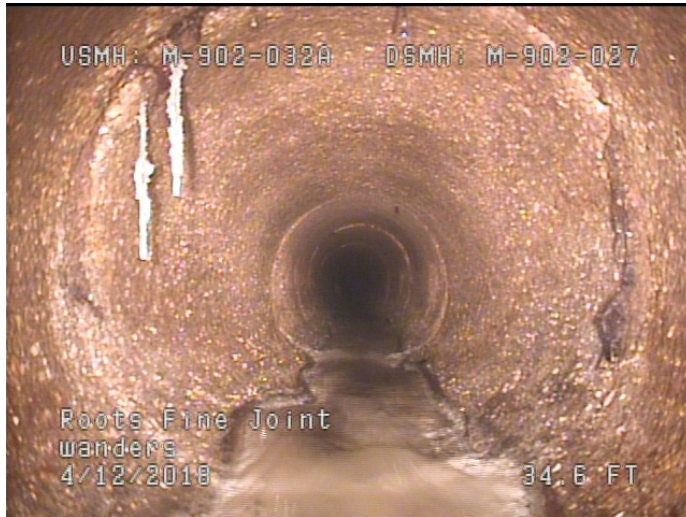
| Code: | <b>RFJ</b> |
| Description: | <b>Roots Fine Joint</b> |
| Distance (ft): | <b>34.6</b> |
| O&M Grade: | <b>1</b> |
| Remarks: | <b>wanders</b> |

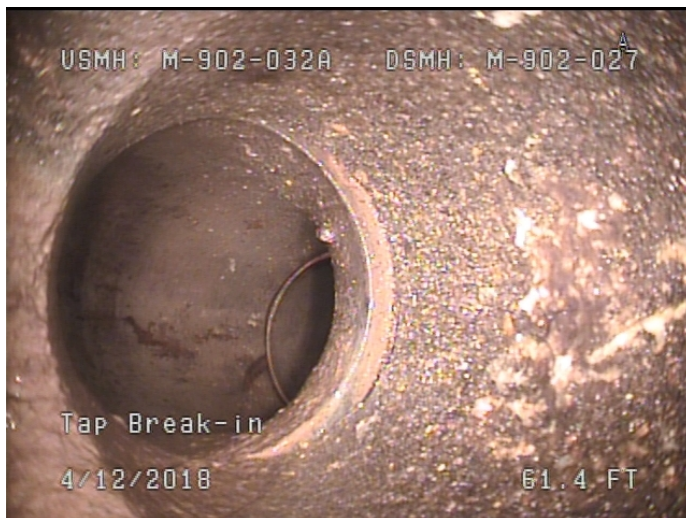
| Code: | <b>TB</b> |
| Description: | <b>Tap Break-in</b> |
| Distance (ft): | <b>61.4</b> |
| 1st Value: | <b>6.000</b> |

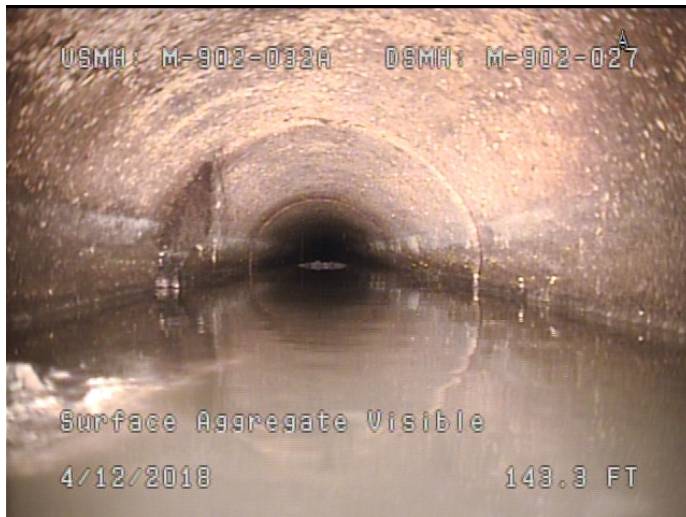
Code: **SAV**  
 Description: **Surface Aggregate Visible**

Distance (ft): **143.3**  
 Structural Grade: **3**  
 O&M Grade: **0**  
 Clock Start/From: **7**  
 Clock To: **5**  
 1st Value:  
 2nd Value:  
 Value Percent:  
 Continuous Index: **F01**  
 Within 8" of Joint: **NO**  
 Remarks:

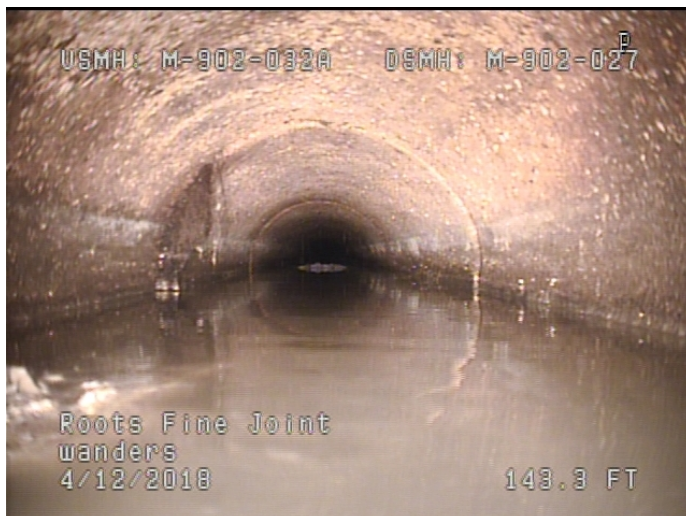
Code: **RFJ**  
 Description: **Roots Fine Joint**

Distance (ft): **143.3**  
 Structural Grade: **0**  
 O&M Grade: **1**  
 Clock Start/From: **9**  
 Clock To: **4**  
 1st Value:  
 2nd Value:  
 Value Percent:  
 Continuous Index: **F03**  
 Within 8" of Joint: **YES**  
 Remarks: **wanders**
