Profile/Photo Observation Report

Date:	04/23/2018	Weather:		Coding:	PACP 4.2
Pipe Length (ft):	343.0	Owner:	City of Hobart	Pre Clean:	No Pre-Cleaning
P.O.#:	2004	Surveyor:	SAN	PSR:	P-904-041-041A
Customer:	Red Zone	Clean Date:		Shape:	C

Street:	149 Bush St	Flow Control:	Not Controlled
City:	Hobart In	Year Renewed:	
Location:	Yard	Tape/Media #:	Deliverable 1
Purpose:	Routine Assessment	Dia/Height:	18"
Use:	Sanitary	Material:	VCP
Drain Area:	Northeast	Lining:	
Category:	NA		
Comment:	426-1/DSMH was not shown on mapping and is covered. Configuration differs from provided mapping.		
Location Details:	Grass between homes	Direction of Survey:	Upstream
US MH:	M-904-041	DS MH:	M-904-041A
		Total Length Surveyed (ft):	343.0

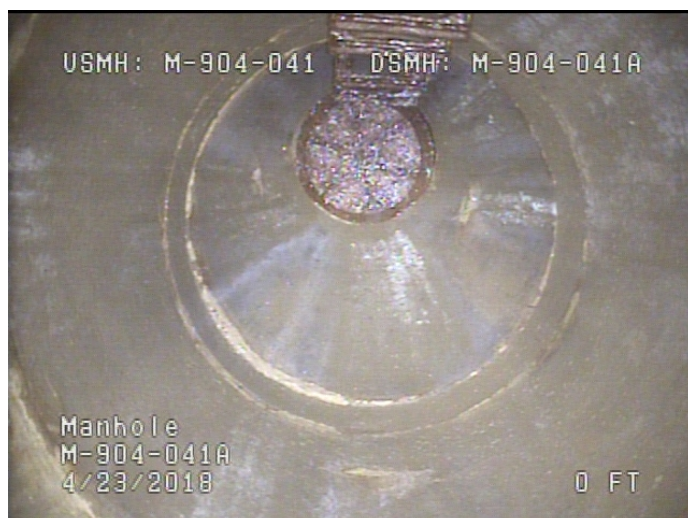
Code: **AMH**
Description: **Manhole**

Distance (ft): **.0**
Structural Grade: **0**
O&M Grade: **0**
Clock Start/From:
Clock To:
1st Value:
2nd Value:
Value Percent:
Continuous Index:
Within 8" of Joint: **NO**
Remarks: **M-904-041A**

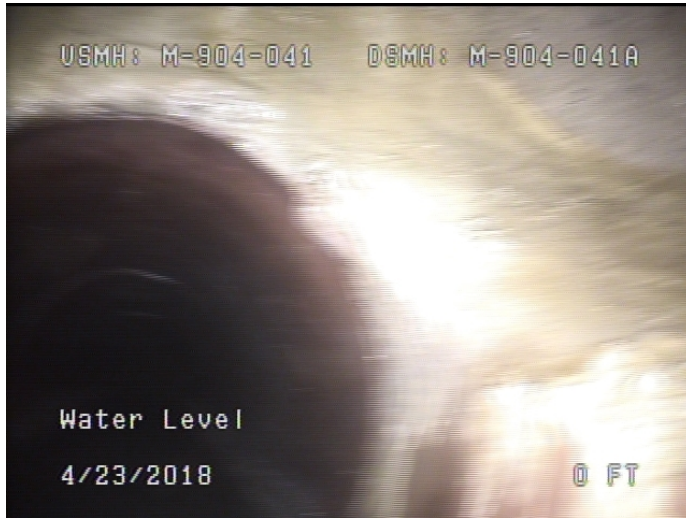
Code:	MWL
Description:	Water Level
Distance (ft):	.0
Structural Grade:	0
O&M Grade:	0
Clock Start/From:	
Clock To:	
1st Value:	
2nd Value:	
Value Percent:	10.000
Continuous Index:	
Within 8" of Joint:	NO
Remarks:

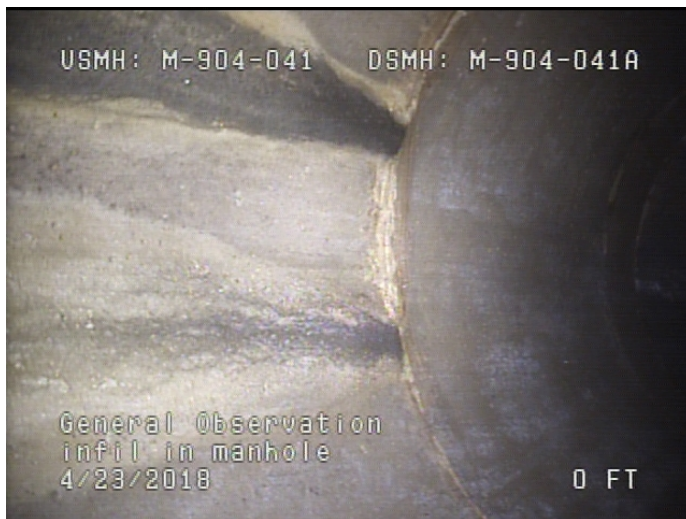
Code:	MGO
Description:	General Observation
Distance (ft):	.0
Structural Grade:	0
O&M Grade:	0
Clock Start/From:	
Clock To:	
1st Value:	
2nd Value:	
Value Percent:	
Continuous Index:	
Within 8" of Joint:	NO
Remarks:	infil in manhole

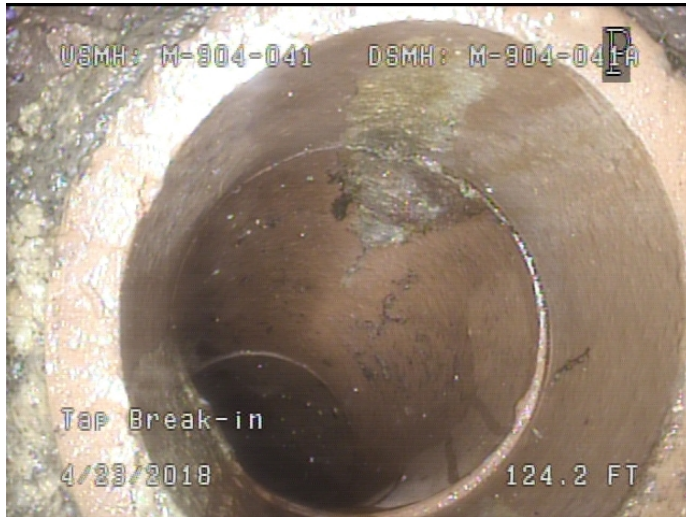
Code:	TB
Description:	Tap Break-in
Distance (ft):	124.2
Structural Grade:	0
O&M Grade:	0
Clock Start/From:	11
Clock To:	
1st Value:	4.000
2nd Value:	
Value Percent:	
Continuous Index:	
Within 8" of Joint:	NO
Remarks:

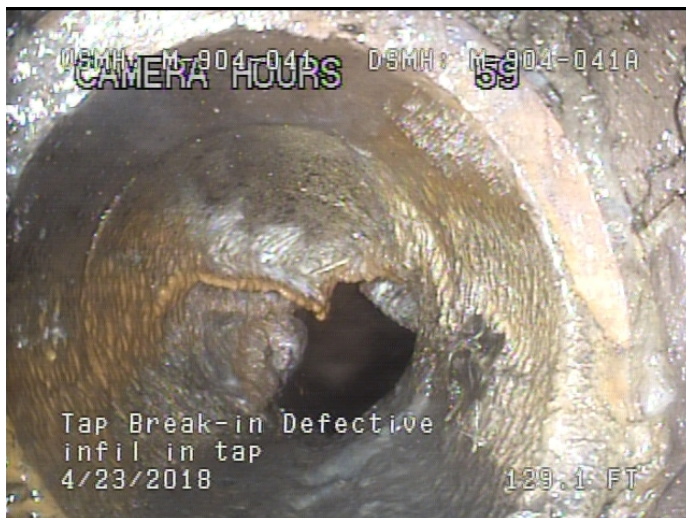
Code:	TBD
Description:	Tap Break-in Defective
Distance (ft):	129.1
Structural Grade:	0
O&M Grade:	3
Clock Start/From:	11
Clock To:	
1st Value:	4.000
2nd Value:	
Value Percent:	
Continuous Index:	
Within 8" of Joint:	NO
Remarks:	infil in tap

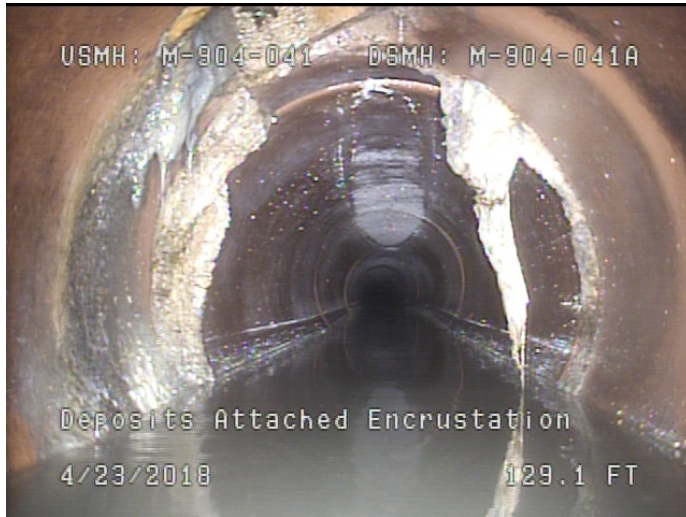
Code:	DAE
Description:	Deposits Attached Encrustation
Distance (ft):	129.1
Structural Grade:	0
O&M Grade:	3
Clock Start/From:	7
Clock To:	5
1st Value:	
2nd Value:	
Value Percent:	15.000
Continuous Index:	
Within 8" of Joint:	YES
Remarks:

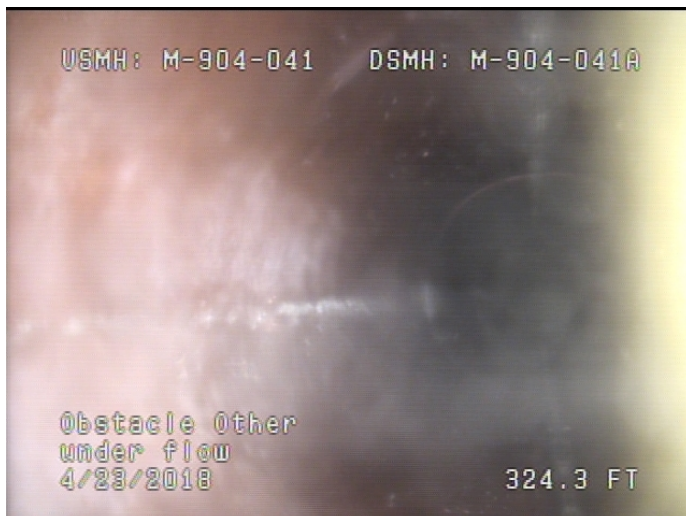
Code:	OBZ
Description:	Obstacle Other
Distance (ft):	324.3
Structural Grade:	0
O&M Grade:	3
Clock Start/From:	5
Clock To:	7
1st Value:	
2nd Value:	
Value Percent:	15.000
Continuous Index:	
Within 8" of Joint:	NO
Remarks:	under flow

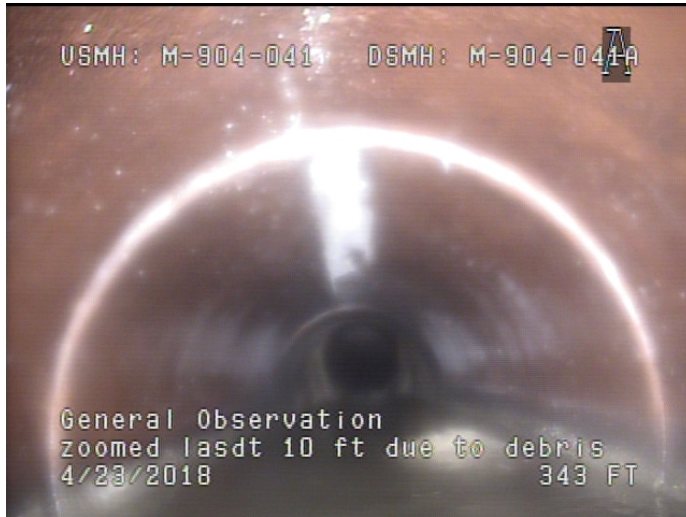
Code:	MGO
Description:	General Observation
Distance (ft):	343.0
Structural Grade:	0
O&M Grade:	0
Clock Start/From:	
Clock To:	
1st Value:	
2nd Value:	
Value Percent:	
Continuous Index:	
Within 8" of Joint:	NO
Remarks:	zoomed lasdt 10 ft due to debris
