Profile/Photo Observation Report

Date:	07/28/2022	Weather:		Coding:	PACP 7.0
Pipe Length (ft):	305.0	Owner:	City of Hobart	Pre Clean:	No Pre-Cleaning
P.O.#:	YES502259	Surveyor:	S. Bucklin	PSR:	M-405-069-M-505-095
Customer:	City of Hobart	Clean Date:		Shape:	C

Street:	West 3rd Street	Flow Control:	Not Controlled
City:	Hobart, IN	Year Renewed:	
Location:	Easement/Right of Way	Tape/Media #:	
Purpose:	Routine Assessment	Dia/Height:	18"
Use:	Sanitary Sewage Pipe	Material:	RCP
Drain Area:		Lining:	None
Category:	NA

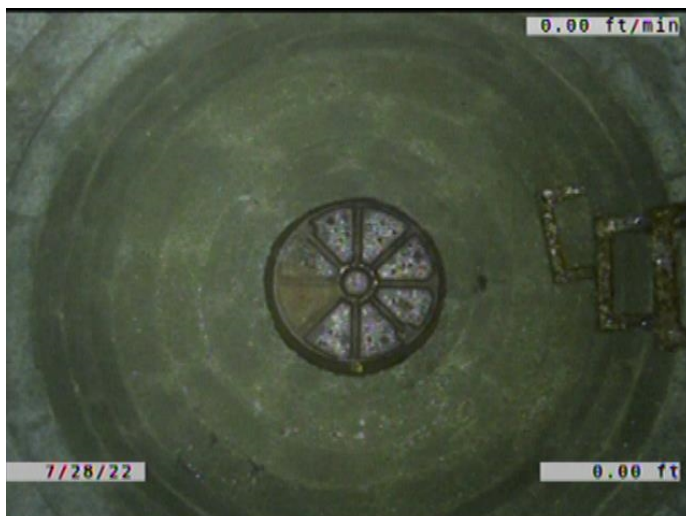
Code: **AMH**
Description: **Manhole**

Distance (ft): **.0**
Structural Grade: **0**
O&M Grade: **0**
Clock Start/From:
Clock To:
1st Value:
2nd Value:
Value Percent:
Continuous Index:
Within 8" of Joint: **NO**
Remarks: **M-405-069**

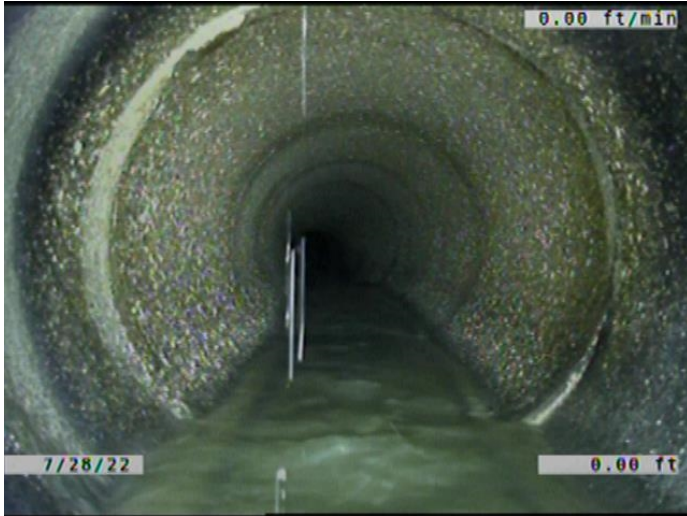
Code: **MWL**
Description: **Miscellaneous Water Level**

Distance (ft): **.0**
Structural Grade: **0**
O&M Grade: **0**
Clock Start/From:
Clock To:
1st Value:
2nd Value:
Value Percent: **10.000**
Continuous Index:
Within 8" of Joint: **NO**
Remarks:

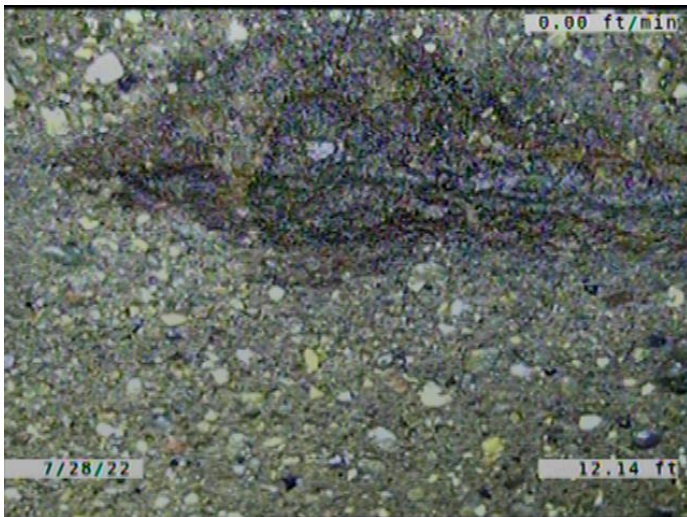
Code: **DAE**
Description: **Deposits Attached Encrustation**

Distance (ft): **12.1**
Structural Grade: **0**
O&M Grade: **2**
Clock Start/From: **8**
Clock To: **4**
1st Value:
2nd Value:
Value Percent: **5.000**
Continuous Index:
Within 8" of Joint: **YES**
Remarks:

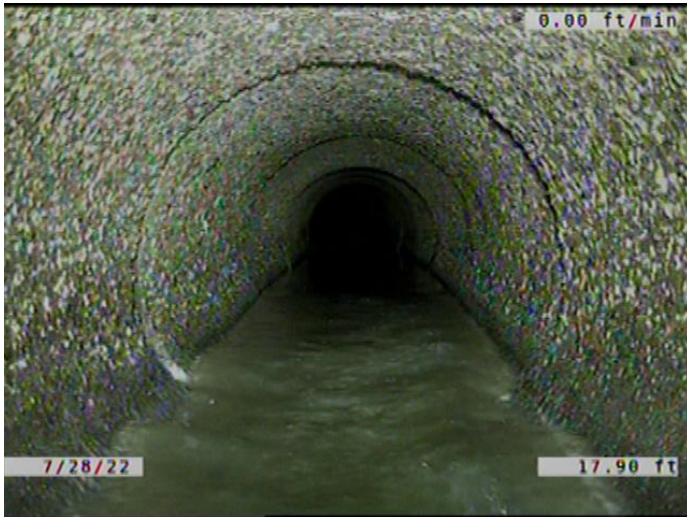
Code: **MWL**
 Description: **Miscellaneous Water Level**

Distance (ft): **17.9**
 Structural Grade: **0**
 O&M Grade: **0**
 Clock Start/From:
 Clock To:
 1st Value:
 2nd Value:
 Value Percent: **20.000**
 Continuous Index:
 Within 8" of Joint: **NO**
 Remarks:

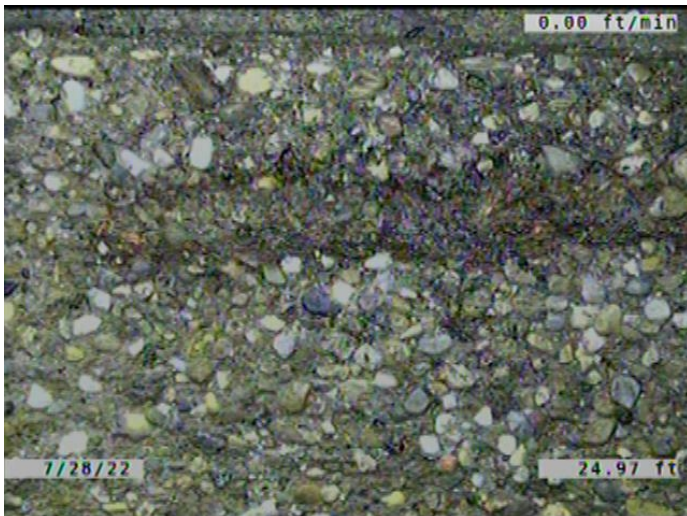
Code: **DAE**
 Description: **Deposits Attached Encrustation**

Distance (ft): **25.0**
 Structural Grade: **0**
 O&M Grade: **2**
 Clock Start/From: **1**
 Clock To: **4**
 1st Value:
 2nd Value:
 Value Percent: **5.000**
 Continuous Index:
 Within 8" of Joint: **YES**
 Remarks:

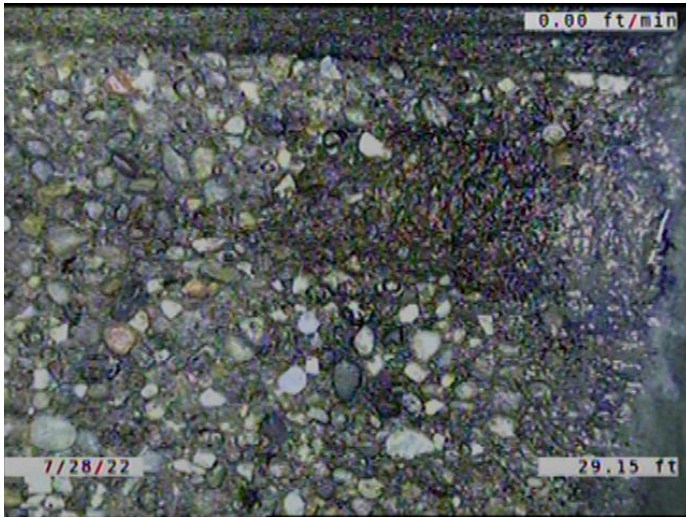
Code: **DAE**
 Description: **Deposits Attached Encrustation**

Distance (ft): **29.1**
 Structural Grade: **0**
 O&M Grade: **2**
 Clock Start/From: **3**
 Clock To: **4**
 1st Value:
 2nd Value:
 Value Percent: **5.000**
 Continuous Index:
 Within 8" of Joint: **YES**
 Remarks:

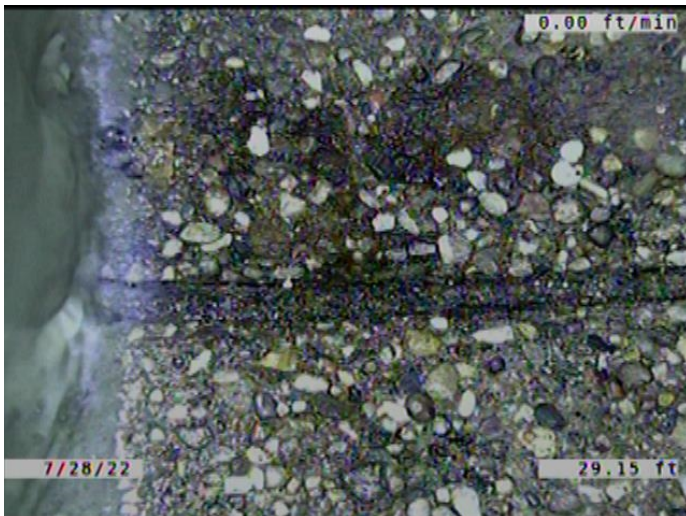
Code: **DAE**
 Description: **Deposits Attached Encrustation**

Distance (ft): **29.1**
 Structural Grade: **0**
 O&M Grade: **2**
 Clock Start/From: **8**
 Clock To: **9**
 1st Value:
 2nd Value:
 Value Percent: **5.000**
 Continuous Index:
 Within 8" of Joint: **YES**
 Remarks:

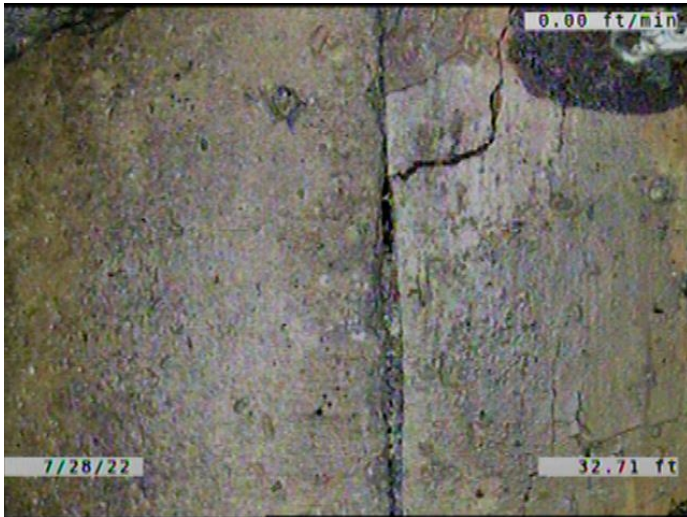
Code: **TBD**
 Description: **Tap Break-in/Hammer Defective**

Distance (ft): **32.7**
 Structural Grade: **0**
 O&M Grade: **3**
 Clock Start/From: **9**
 Clock To:
 1st Value: **6.000**
 2nd Value:
 Value Percent:
 Continuous Index:
 Within 8" of Joint: **YES**
 Remarks: **CAP CRACKED. SOIL VISIBLE. THROUGH THE BRICKS.**

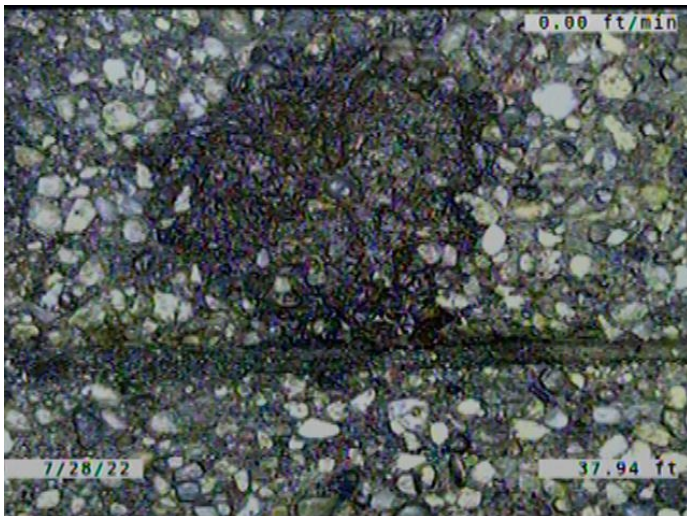
Code: **DAE**
 Description: **Deposits Attached Encrustation**

Distance (ft): **37.9**
 Structural Grade: **0**
 O&M Grade: **2**
 Clock Start/From: **9**
 Clock To:
 1st Value:
 2nd Value:
 Value Percent: **5.000**
 Continuous Index:
 Within 8" of Joint: **YES**
 Remarks:

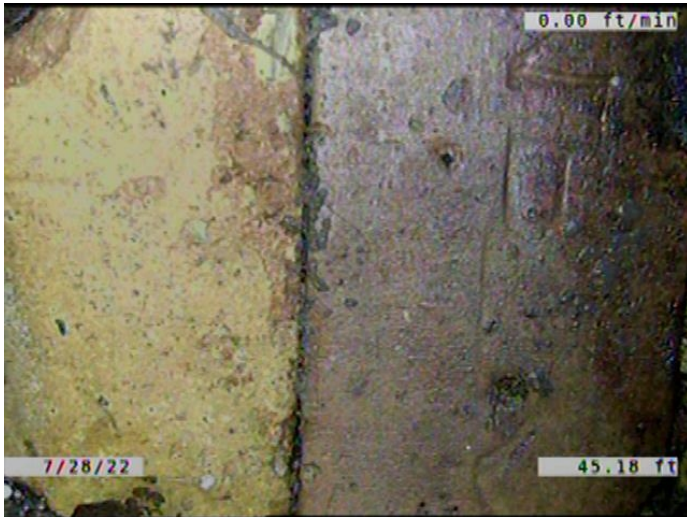
Code: **TBC**
 Description: **Tap Break-in Capped**

Distance (ft): **45.2**
 Structural Grade: **0**
 O&M Grade: **0**
 Clock Start/From: **3**
 Clock To:
 1st Value: **6.000**
 2nd Value:
 Value Percent:
 Continuous Index:
 Within 8" of Joint: **YES**
 Remarks:

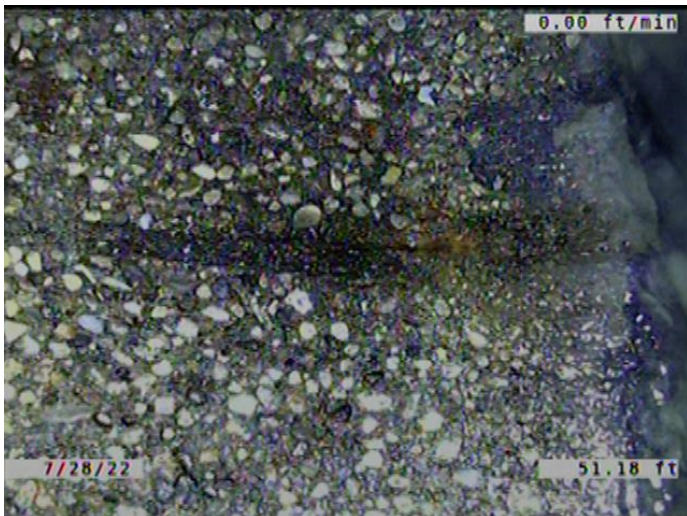
Code: **DAE**
 Description: **Deposits Attached Encrustation**

Distance (ft): **51.2**
 Structural Grade: **0**
 O&M Grade: **2**
 Clock Start/From: **8**
 Clock To: **4**
 1st Value:
 2nd Value:
 Value Percent: **5.000**
 Continuous Index: **S01**
 Within 8" of Joint: **YES**
 Remarks:

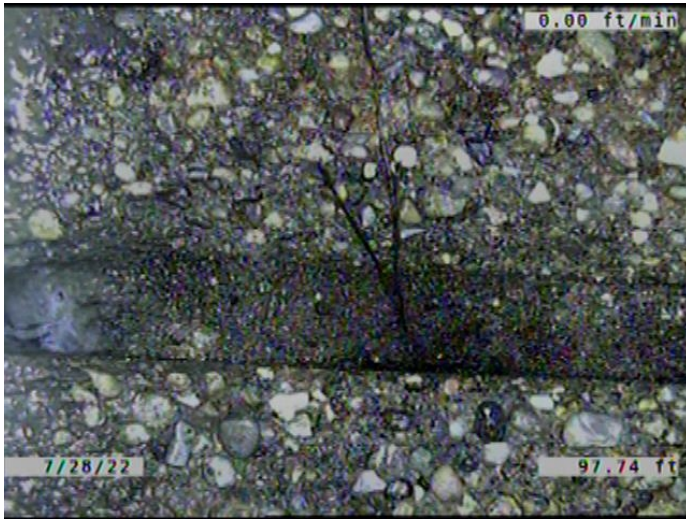
Code: **RFJ**
Description: **Roots Fine Joint**

Distance (ft): **97.7**
Structural Grade: **0**
O&M Grade: **1**
Clock Start/From: **2**
Clock To: **3**
1st Value:
2nd Value:
Value Percent:
Continuous Index:
Within 8" of Joint: **YES**
Remarks:

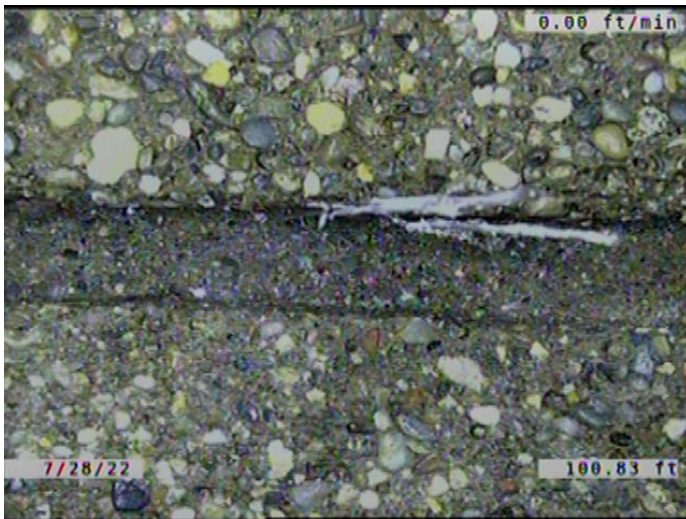
Code: **RFJ**
Description: **Roots Fine Joint**

Distance (ft): **100.8**
Structural Grade: **0**
O&M Grade: **1**
Clock Start/From: **1**
Clock To:
1st Value:
2nd Value:
Value Percent:
Continuous Index:
Within 8" of Joint: **YES**
Remarks:

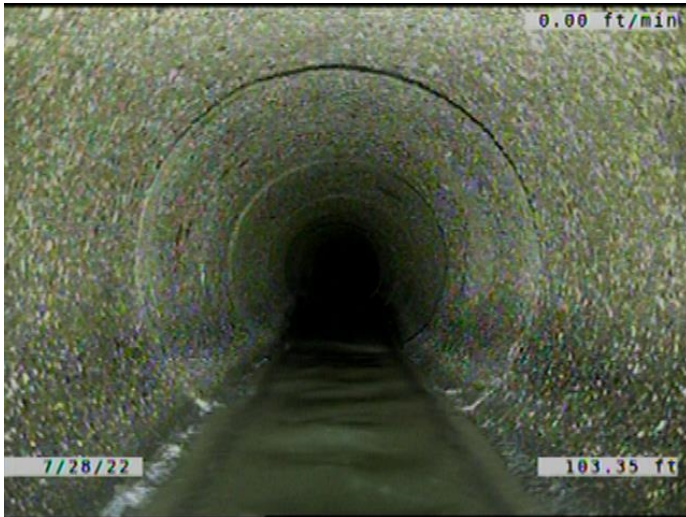
Code: **MWL**
 Description: **Miscellaneous Water Level**

Distance (ft): **103.3**
 Structural Grade: **0**
 O&M Grade: **0**
 Clock Start/From:
 Clock To:
 1st Value:
 2nd Value:
 Value Percent: **10.000**
 Continuous Index:
 Within 8" of Joint: **NO**
 Remarks:

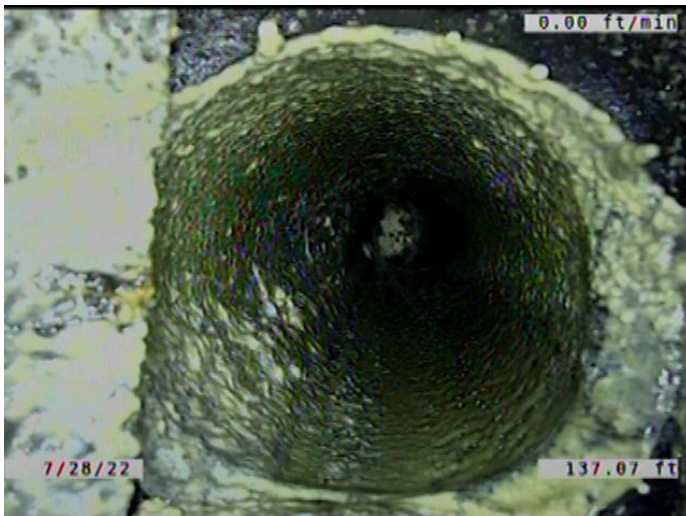
Code: **TS**
 Description: **Tap Saddle**

Distance (ft): **137.1**
 Structural Grade: **0**
 O&M Grade: **0**
 Clock Start/From: **12**
 Clock To:
 1st Value: **6.000**
 2nd Value:
 Value Percent:
 Continuous Index:
 Within 8" of Joint: **NO**
 Remarks: **CONSTANTLY DRIPPING WATER.**

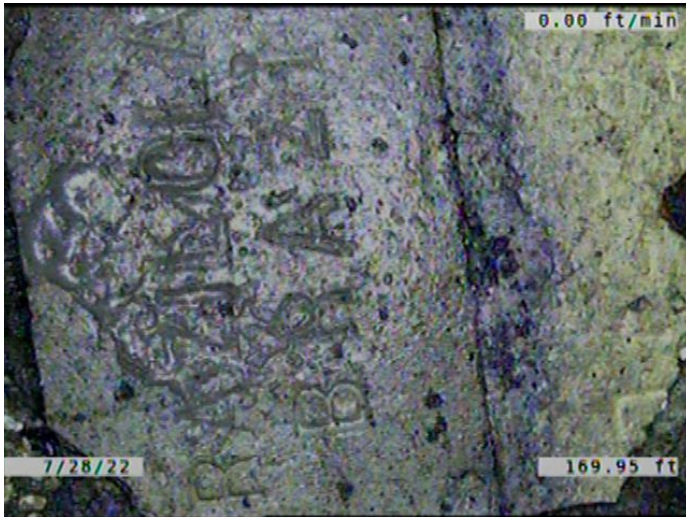
Code: **TBC**
Description: **Tap Break-in Capped**

Distance (ft): **169.9**
Structural Grade: **0**
O&M Grade: **0**
Clock Start/From: **9**
Clock To:
1st Value: **6.000**
2nd Value:
Value Percent:
Continuous Index:
Within 8" of Joint: **YES**
Remarks:

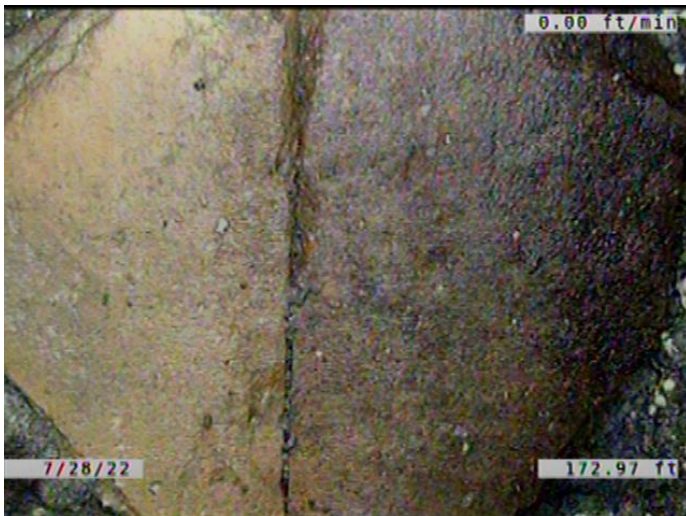
Code: **TBC**
Description: **Tap Break-in Capped**

Distance (ft): **173.0**
Structural Grade: **0**
O&M Grade: **0**
Clock Start/From: **3**
Clock To:
1st Value: **6.000**
2nd Value:
Value Percent:
Continuous Index:
Within 8" of Joint: **YES**
Remarks:

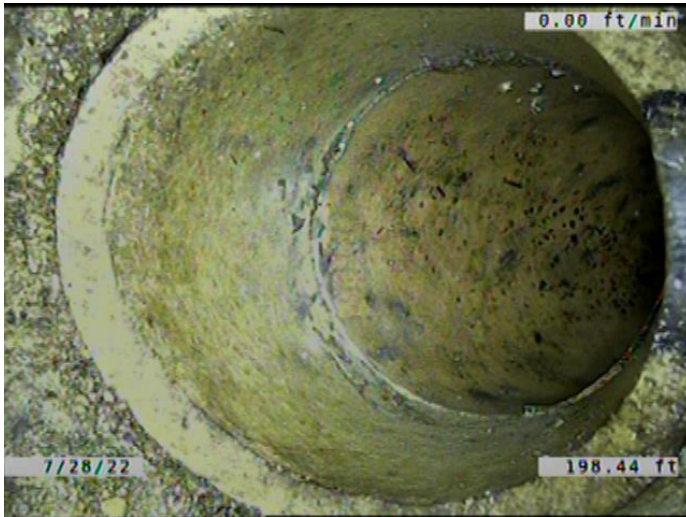
Code: **TBD**
Description: **Tap Break-in/Hammer Defective**

Distance (ft): **198.4**
Structural Grade: **0**
O&M Grade: **3**
Clock Start/From: **1**
Clock To:
1st Value: **6.000**
2nd Value:
Value Percent:
Continuous Index:
Within 8" of Joint: **YES**
Remarks: **CONSTANTLY RUNNING WATER.**

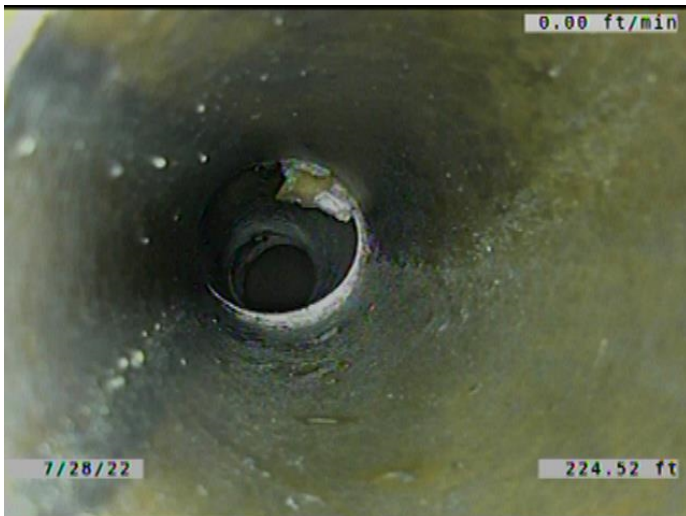
Code: **TBI**
Description: **Tap Break-in Intruding**

Distance (ft): **224.5**
Structural Grade: **0**
O&M Grade: **2**
Clock Start/From: **11**
Clock To:
1st Value: **6.000**
2nd Value: **3.000**
Value Percent:
Continuous Index:
Within 8" of Joint: **YES**
Remarks:

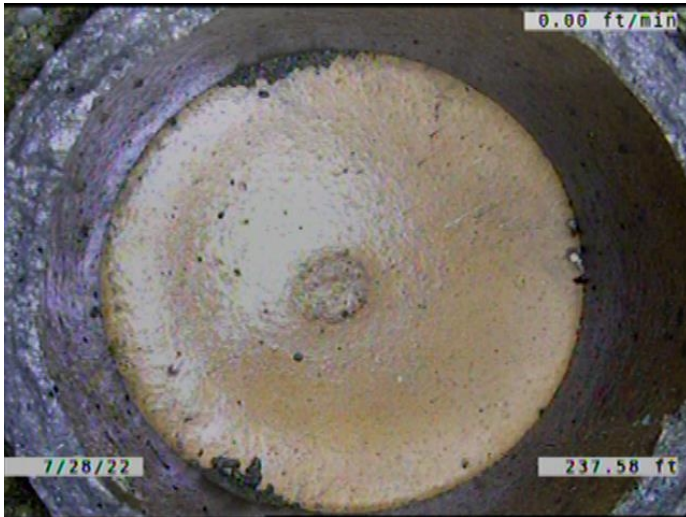
Code: **TBD**
Description: **Tap Break-in/Hammer Defective**

Distance (ft): **237.6**
Structural Grade: **0**
O&M Grade: **3**
Clock Start/From: **10**
Clock To:
1st Value: **6.000**
2nd Value:
Value Percent:
Continuous Index:
Within 8" of Joint: **YES**
Remarks: **TAP CRACKED. CAPPED.**

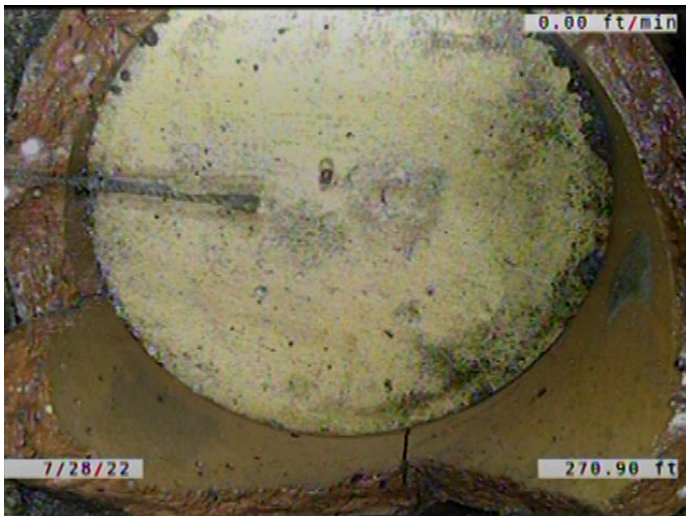
Code: **TBD**
Description: **Tap Break-in/Hammer Defective**

Distance (ft): **270.9**
Structural Grade: **0**
O&M Grade: **3**
Clock Start/From: **2**
Clock To:
1st Value: **6.000**
2nd Value:
Value Percent:
Continuous Index:
Within 8" of Joint: **YES**
Remarks: **TAP CRACKED. CAPPED.**

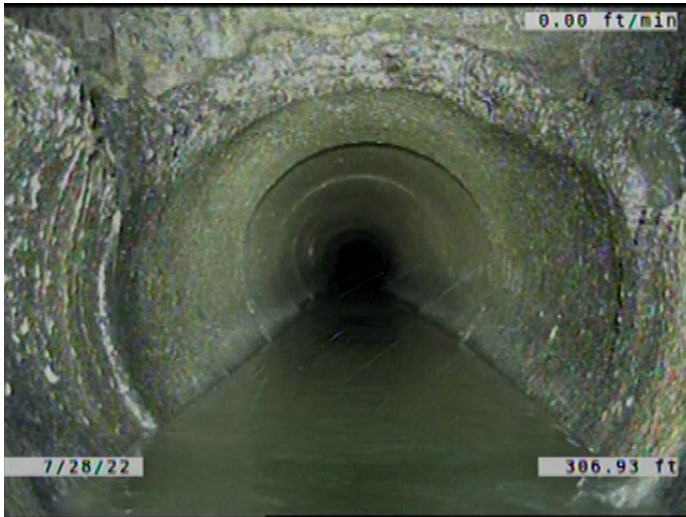
Code: **DAE**
 Description: **Deposits Attached Encrustation**

Distance (ft): **306.9**
 Structural Grade: **0**
 O&M Grade: **2**
 Clock Start/From: **8**
 Clock To: **4**
 1st Value:
 2nd Value:
 Value Percent: **5.000**
 Continuous Index: **F01**
 Within 8" of Joint: **YES**
 Remarks:

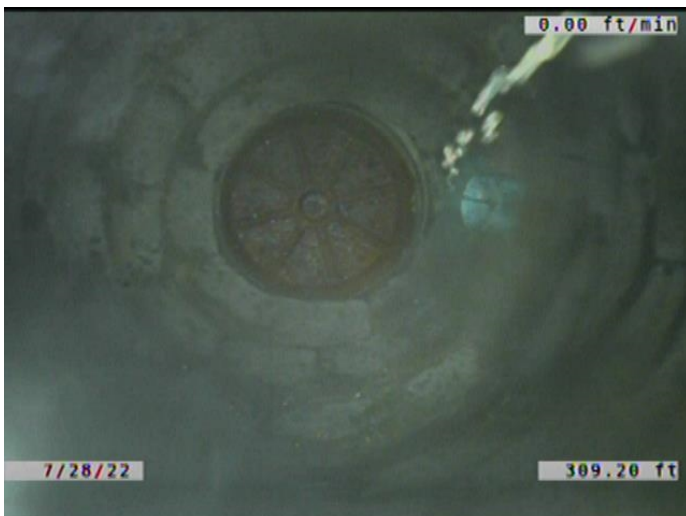
Code: **AMH**
 Description: **Manhole**

Distance (ft): **309.2**
 Structural Grade: **0**
 O&M Grade: **0**
 Clock Start/From:
 Clock To:
 1st Value:
 2nd Value:
 Value Percent:
 Continuous Index:
 Within 8" of Joint: **NO**
 Remarks: **M-505-095**
