## Profile/Photo Observation Report

Date:	<b>09/10/2021</b>	Weather:		Coding:	<b>PACP 7.0</b>
Pipe Length (ft):	<b>58.1</b>	Owner:	<b>City of Hobart</b>	Pre Clean:	<b>Light Cleaning</b>
P.O.#:	<b>YES502259</b>	Surveyor:	<b>S. Bucklin</b>	PSR:	<b>M-503-032.1_M-503-032</b>
Customer:	<b>City of Hobart</b>	Clean Date:	<b>09/10/2021</b>	Shape:	<b>C</b>

Street:	<b>West 41st Avenue</b>	Flow Control:	<b>Not Controlled</b>
City:	<b>Hobart, IN</b>	Year Renewed:	
Location:	<b>Local rural streets with light traffic, t</b>	Tape/Media #:	
Purpose:	<b>Routine Assessment</b>	Dia/Height:	<b>8"</b>
Use:	<b>Sanitary Sewage Pipe</b>	Material:	<b>CP</b>
Drain Area:		Lining:	<b>None</b>
Category:	<b>NA</b>		
Comment:			
Location Details:		Direction of Survey:	<b>Upstream</b>
US MH:	<b>M-503-032.1</b>	DS MH:	<b>M-503-032</b>
		Total Length Surveyed (ft):	<b>58.1</b>

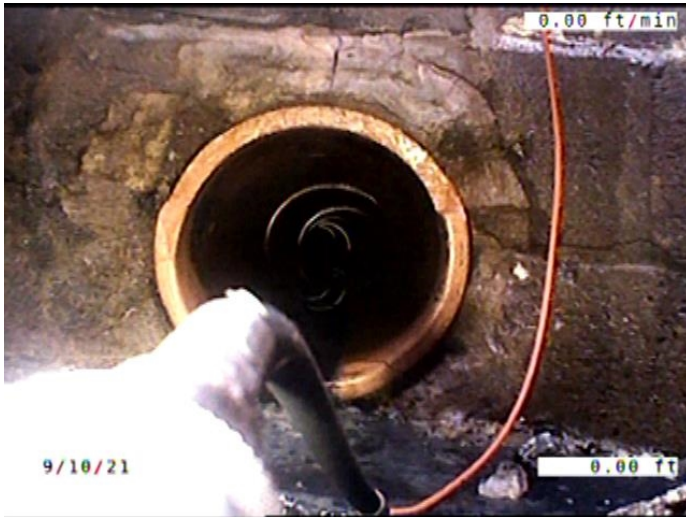
Code: **AMH**  
 Description: **Manhole**

Distance (ft): **.0**  
 Structural Grade: **0**  
 O&M Grade: **0**  
 Clock Start/From:  
 Clock To:  
 1st Value:  
 2nd Value:  
 Value Percent:  
 Continuous Index:  
 Within 8" of Joint: **NO**  
 Remarks: **M-503-032**

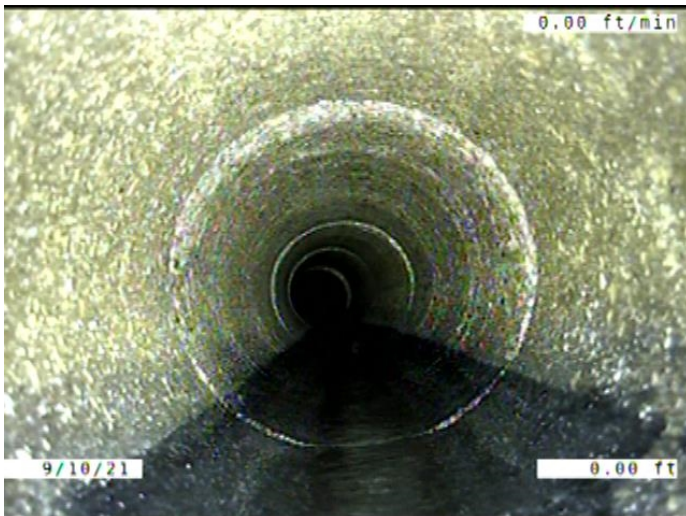
Code: **MWL**  
 Description: **Miscellaneous Water Level**

Distance (ft): **.0**  
 Structural Grade: **0**  
 O&M Grade: **0**  
 Clock Start/From:  
 Clock To:  
 1st Value:  
 2nd Value:  
 Value Percent: **5.000**  
 Continuous Index:  
 Within 8" of Joint: **NO**  
 Remarks:

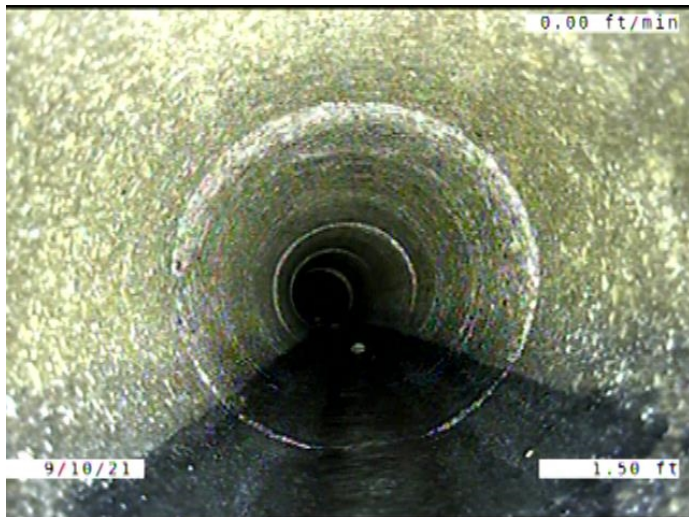
Code: **MGO**  
 Description: **Miscellaneous General Observation**

Distance (ft): **1.5**  
 Structural Grade: **0**  
 O&M Grade: **0**  
 Clock Start/From:  
 Clock To:  
 1st Value:  
 2nd Value:  
 Value Percent:  
 Continuous Index:  
 Within 8" of Joint: **NO**  
 Remarks: **DROP INTO THE MANHOLE. HAD TO START IN THE PIPE.**

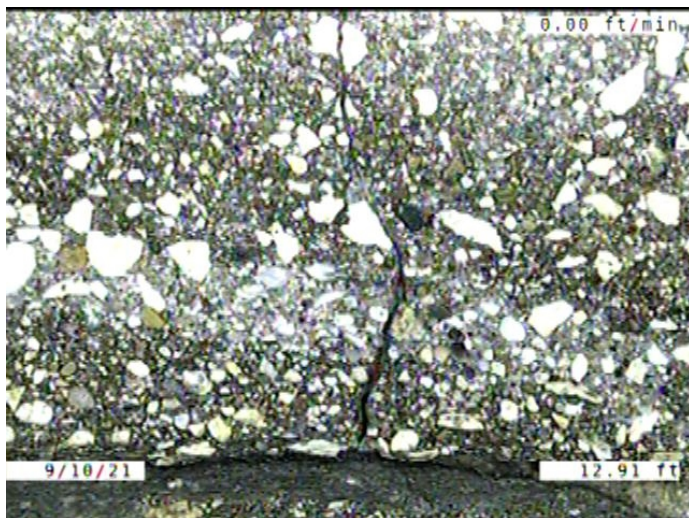
Code: **FS**  
 Description: **Fracture Spiral**

Distance (ft): **12.9**  
 Structural Grade: **3**  
 O&M Grade: **0**  
 Clock Start/From: **12**  
 Clock To: **1**  
 1st Value:  
 2nd Value:  
 Value Percent:  
 Continuous Index:  
 Within 8" of Joint: **YES**  
 Remarks:

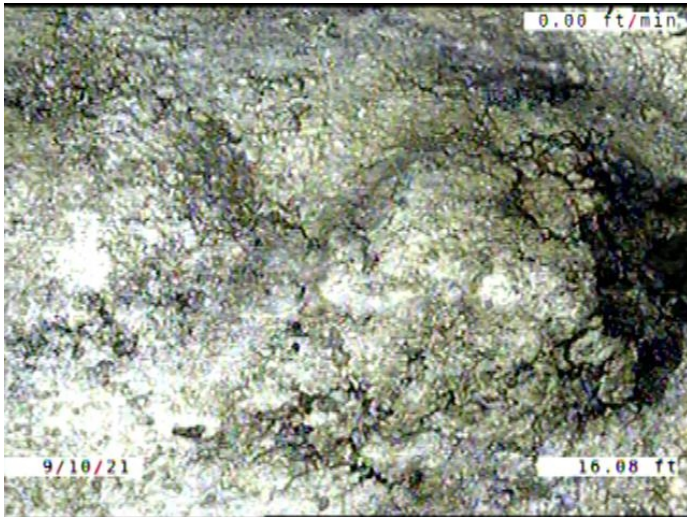
Code: **DAE**  
 Description: **Deposits Attached Encrustation**

Distance (ft): **16.1**  
 Structural Grade: **0**  
 O&M Grade: **2**  
 Clock Start/From: **3**  
 Clock To: **5**  
 1st Value:  
 2nd Value:  
 Value Percent: **5.000**  
 Continuous Index:  
 Within 8" of Joint: **YES**  
 Remarks:

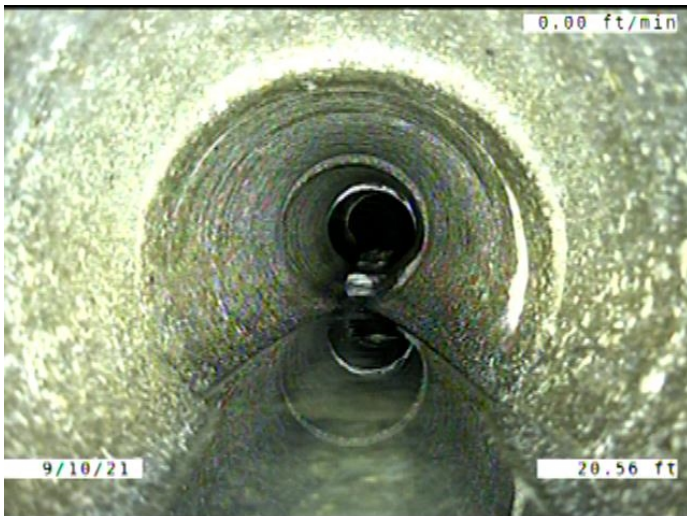
Code: **MWLS**  
 Description: **Miscellaneous Water Level Sag**

Distance (ft): **20.6**  
 Structural Grade: **2**  
 O&M Grade: **0**  
 Clock Start/From:  
 Clock To:  
 1st Value:  
 2nd Value:  
 Value Percent: **5.000**  
 Continuous Index:  
 Within 8" of Joint: **NO**  
 Remarks:

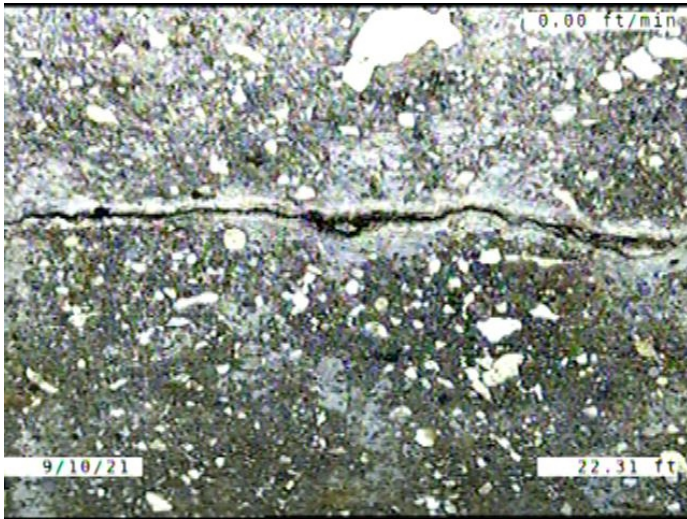
Code: **FS**  
 Description: **Fracture Spiral**

Distance (ft): **22.3**  
 Structural Grade: **3**  
 O&M Grade: **0**  
 Clock Start/From: **8**  
 Clock To: **3**  
 1st Value:  
 2nd Value:  
 Value Percent:  
 Continuous Index:  
 Within 8" of Joint: **YES**  
 Remarks:

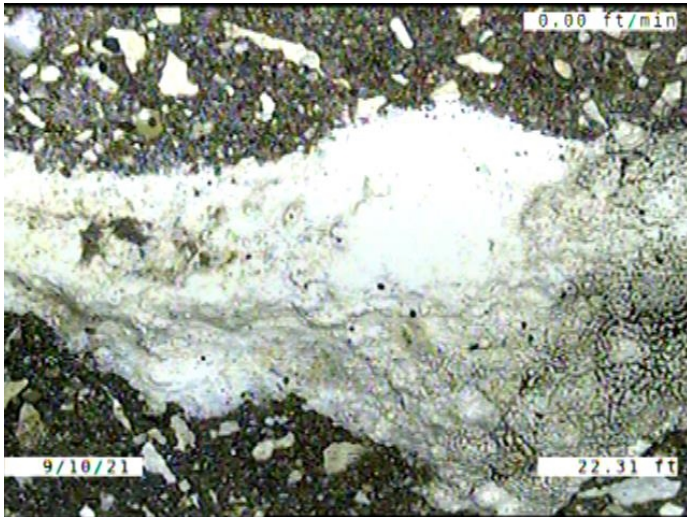
Code: **DAE**  
 Description: **Deposits Attached Encrustation**

Distance (ft): **22.3**  
 Structural Grade: **0**  
 O&M Grade: **2**  
 Clock Start/From: **1**  
 Clock To: **4**  
 1st Value:  
 2nd Value:  
 Value Percent: **5.000**  
 Continuous Index:  
 Within 8" of Joint: **YES**  
 Remarks:

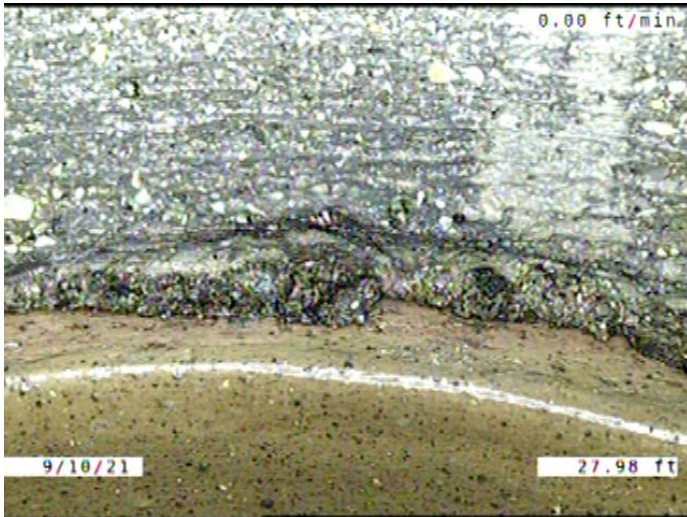
Code: **MMC**  
 Description: **Miscellaneous Material Change**

Distance (ft): **28.0**  
 Structural Grade: **0**  
 O&M Grade: **0**  
 Clock Start/From:  
 Clock To:  
 1st Value:  
 2nd Value:  
 Value Percent:  
 Continuous Index:  
 Within 8" of Joint: **NO**  
 Remarks: **CONCRETE TO VCP**

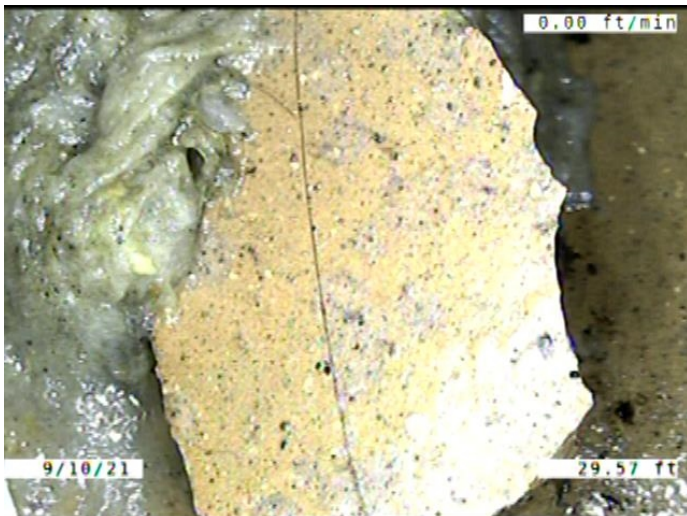
Code: **OBM**  
 Description: **Obstruction Pipe Material in Invert**

Distance (ft): **29.6**  
 Structural Grade: **0**  
 O&M Grade: **2**  
 Clock Start/From: **5**  
 Clock To: **6**  
 1st Value:  
 2nd Value:  
 Value Percent: **5.000**  
 Continuous Index:  
 Within 8" of Joint: **YES**  
 Remarks:

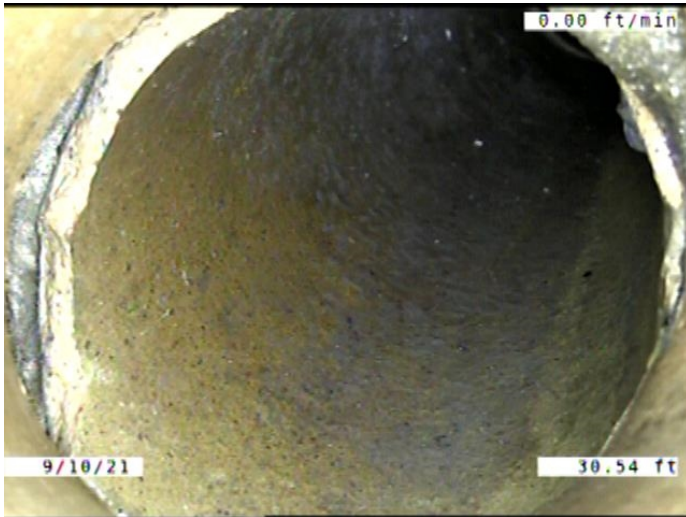
Code: **TF**  
 Description: **Tap Factory**

Distance (ft): **30.5**  
 Structural Grade: **0**  
 O&M Grade: **0**  
 Clock Start/From: **2**  
 Clock To:  
 1st Value: **4.000**  
 2nd Value:  
 Value Percent:  
 Continuous Index:  
 Within 8" of Joint: **YES**  
 Remarks:

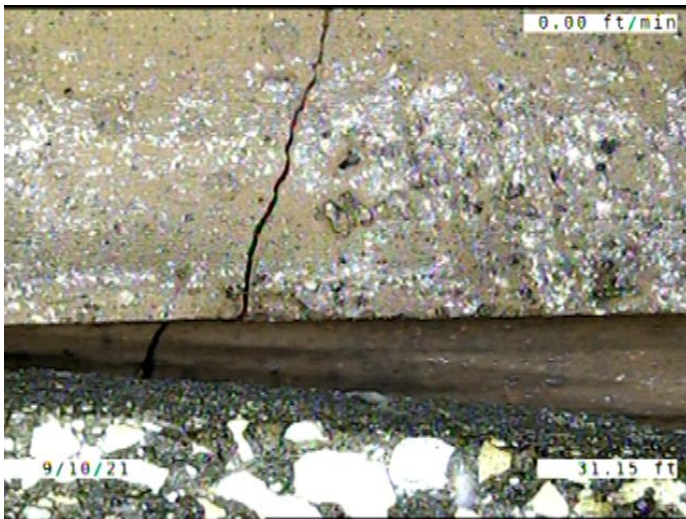
Code: **CS**  
 Description: **Crack Spiral**

Distance (ft): **31.2**  
 Structural Grade: **2**  
 O&M Grade: **0**  
 Clock Start/From: **11**  
 Clock To: **1**  
 1st Value:  
 2nd Value:  
 Value Percent:  
 Continuous Index:  
 Within 8" of Joint: **YES**  
 Remarks:

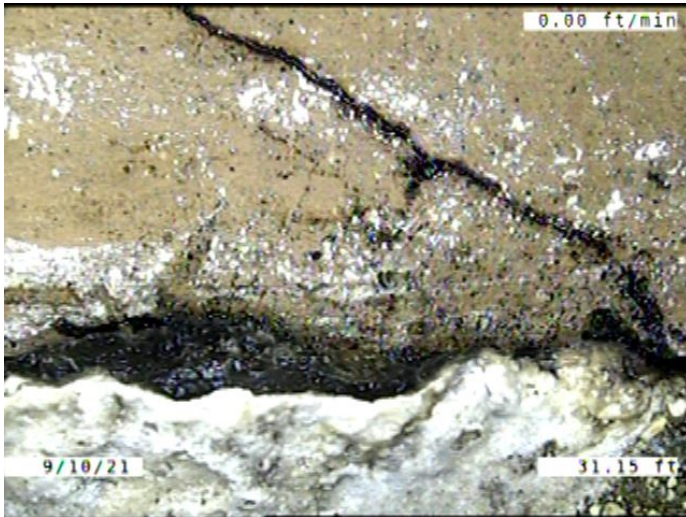
Code: **DAE**  
 Description: **Deposits Attached Encrustation**

Distance (ft): **31.2**  
 Structural Grade: **0**  
 O&M Grade: **2**  
 Clock Start/From: **8**  
 Clock To: **9**  
 1st Value:  
 2nd Value:  
 Value Percent: **5.000**  
 Continuous Index:  
 Within 8" of Joint: **YES**  
 Remarks:

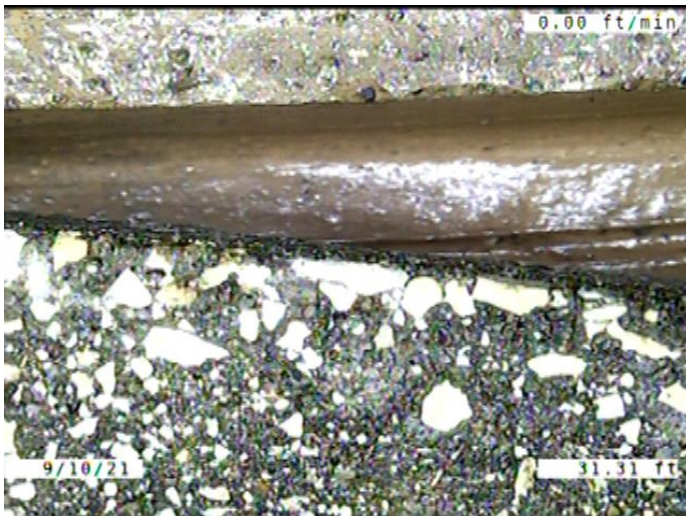
Code: **MMC**  
 Description: **Miscellaneous Material Change**

Distance (ft): **31.3**  
 Structural Grade: **0**  
 O&M Grade: **0**  
 Clock Start/From:  
 Clock To:  
 1st Value:  
 2nd Value:  
 Value Percent:  
 Continuous Index:  
 Within 8" of Joint: **NO**  
 Remarks: **VCP TO CONCRETE**

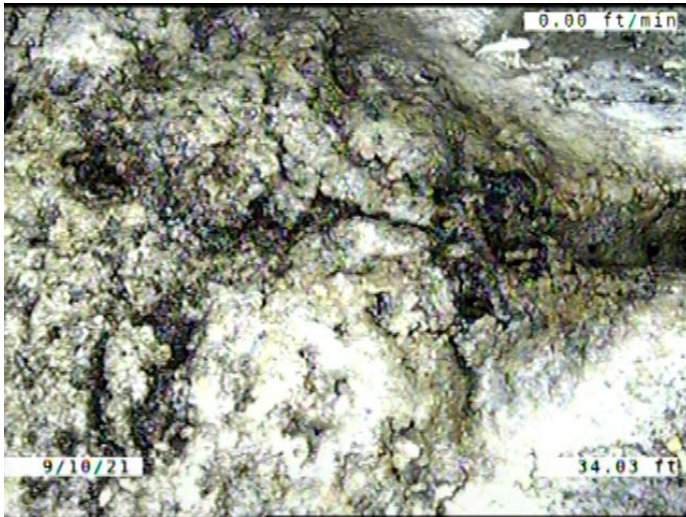
Code: **DAE**  
 Description: **Deposits Attached Encrustation**

Distance (ft): **34.0**  
 Structural Grade: **0**  
 O&M Grade: **2**  
 Clock Start/From: **2**  
 Clock To: **5**  
 1st Value:  
 2nd Value:  
 Value Percent: **5.000**  
 Continuous Index:  
 Within 8" of Joint: **YES**  
 Remarks:

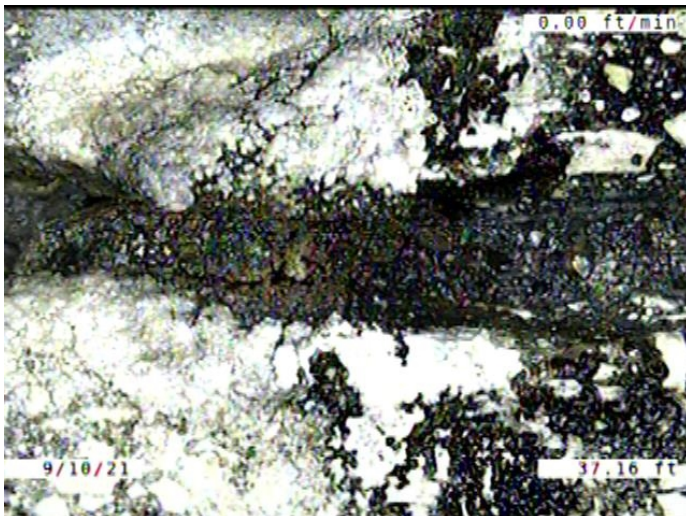
Code: **DAE**  
 Description: **Deposits Attached Encrustation**

Distance (ft): **37.2**  
 Structural Grade: **0**  
 O&M Grade: **2**  
 Clock Start/From: **7**  
 Clock To: **8**  
 1st Value:  
 2nd Value:  
 Value Percent: **5.000**  
 Continuous Index:  
 Within 8" of Joint: **YES**  
 Remarks:

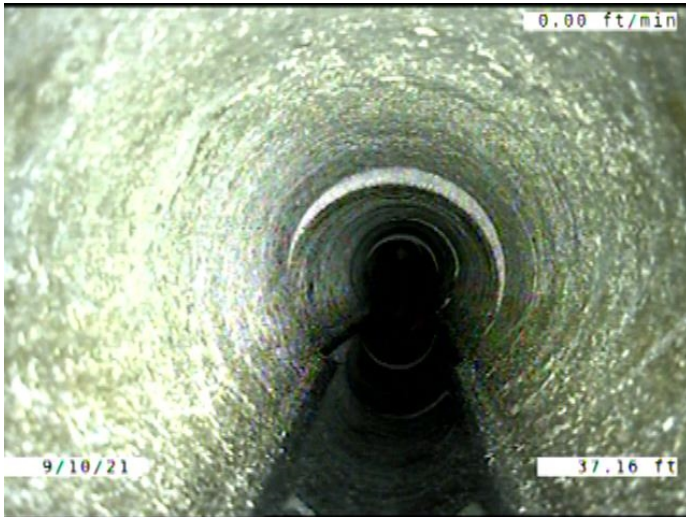
Code: **MWLS**  
Description: **Miscellaneous Water Level Sag**

Distance (ft): **37.2**  
Structural Grade: **2**  
O&M Grade: **0**  
Clock Start/From:  
Clock To:  
1st Value:  
2nd Value:  
Value Percent: **5.000**  
Continuous Index: **S01**  
Within 8" of Joint: **NO**  
Remarks:

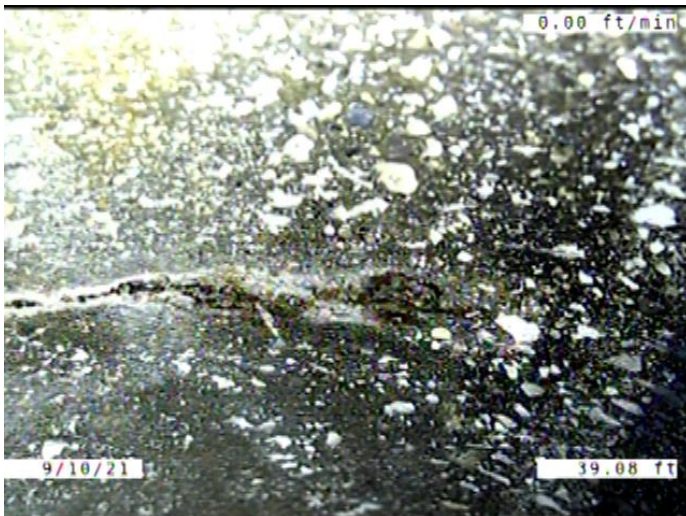
Code: **FS**  
Description: **Fracture Spiral**

Distance (ft): **39.1**  
Structural Grade: **3**  
O&M Grade: **0**  
Clock Start/From: **12**  
Clock To: **12**  
1st Value:  
2nd Value:  
Value Percent:  
Continuous Index:  
Within 8" of Joint: **NO**  
Remarks:

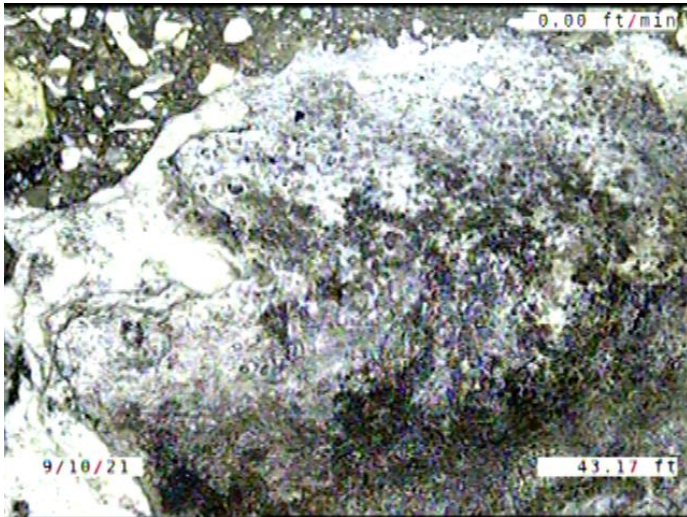
Code: **DAE**  
 Description: **Deposits Attached Encrustation**

Distance (ft): **43.2**  
 Structural Grade: **0**  
 O&M Grade: **2**  
 Clock Start/From: **2**  
 Clock To: **4**  
 1st Value:  
 2nd Value:  
 Value Percent: **5.000**  
 Continuous Index:  
 Within 8" of Joint: **YES**  
 Remarks:

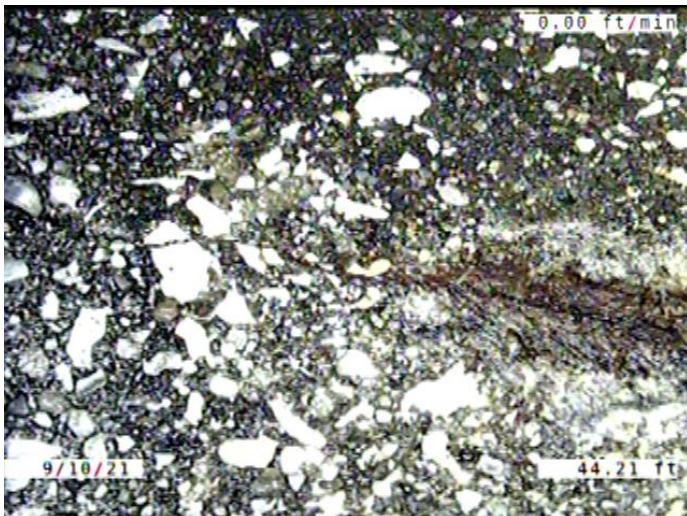
Code: **FS**  
 Description: **Fracture Spiral**

Distance (ft): **44.2**  
 Structural Grade: **3**  
 O&M Grade: **0**  
 Clock Start/From: **12**  
 Clock To: **12**  
 1st Value:  
 2nd Value:  
 Value Percent:  
 Continuous Index:  
 Within 8" of Joint: **NO**  
 Remarks:

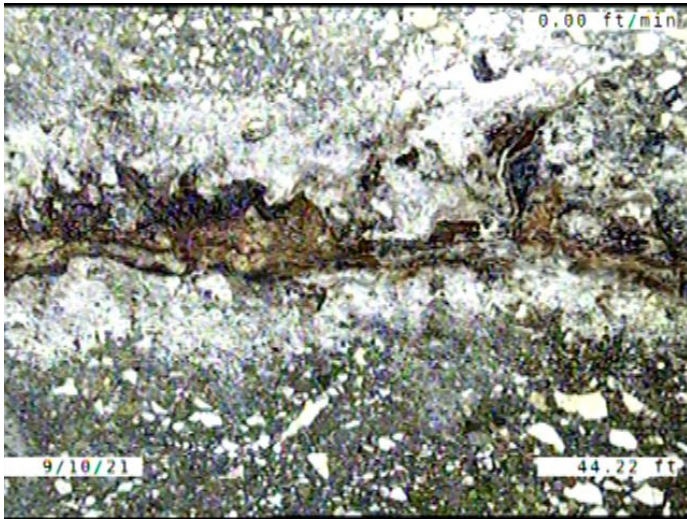
Code:	<b>DAE</b>
Description:	<b>Deposits Attached Encrustation</b>
Distance (ft):	<b>44.2</b>
Structural Grade:	<b>0</b>
O&M Grade:	<b>2</b>
Clock Start/From:	<b>10</b>
Clock To:	<b>4</b>
1st Value:	
2nd Value:	
Value Percent:	<b>5.000</b>
Continuous Index:	
Within 8" of Joint:	<b>YES</b>
Remarks:

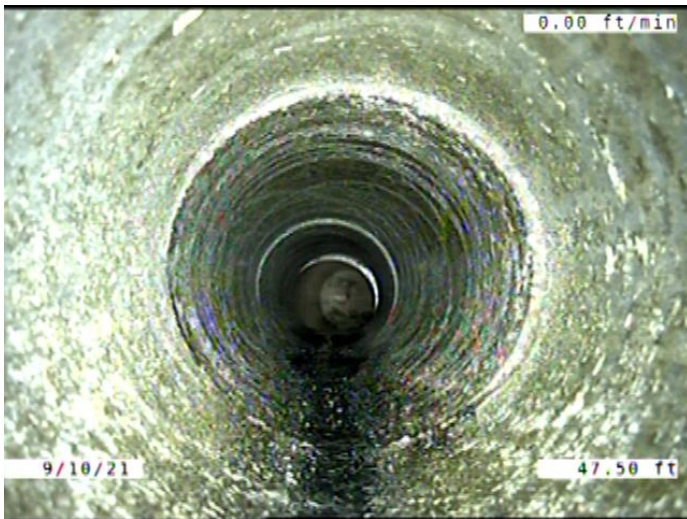
Code:	<b>MWLS</b>
Description:	<b>Miscellaneous Water Level Sag</b>
Distance (ft):	<b>47.5</b>
Structural Grade:	<b>2</b>
O&M Grade:	<b>0</b>
Clock Start/From:	
Clock To:	
1st Value:	
2nd Value:	
Value Percent:	<b>5.000</b>
Continuous Index:	<b>F01</b>
Within 8" of Joint:	<b>NO</b>
Remarks:

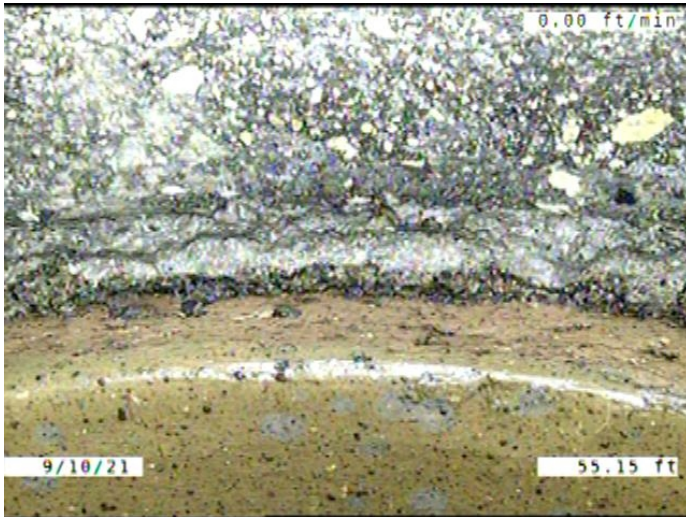
Code: **MMC**  
 Description: **Miscellaneous Material Change**

Distance (ft): **55.1**  
 Structural Grade: **0**  
 O&M Grade: **0**  
 Clock Start/From:  
 Clock To:  
 1st Value:  
 2nd Value:  
 Value Percent:  
 Continuous Index:  
 Within 8" of Joint: **NO**  
 Remarks: **CONCRETE TO VCP**

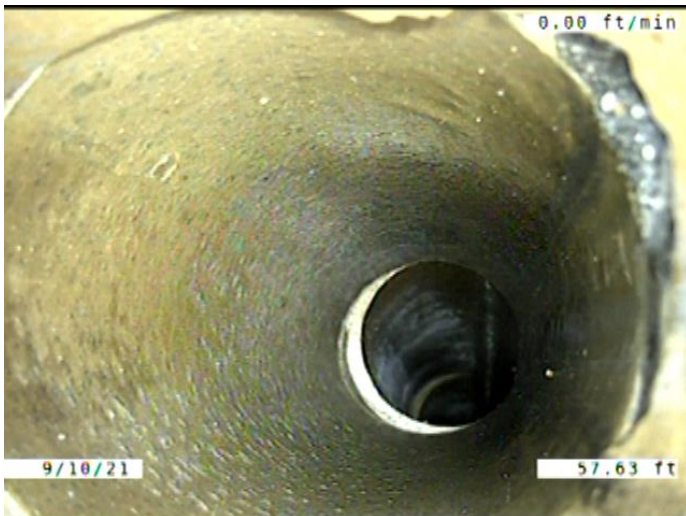
Code: **TFA**  
 Description: **Tap Factory Activity**

Distance (ft): **57.6**  
 Structural Grade: **0**  
 O&M Grade: **0**  
 Clock Start/From: **3**  
 Clock To:  
 1st Value: **4.000**  
 2nd Value:  
 Value Percent:  
 Continuous Index:  
 Within 8" of Joint: **YES**  
 Remarks:

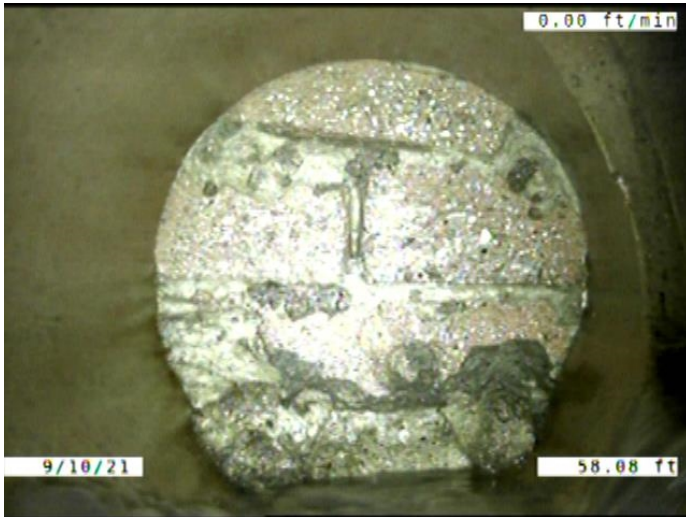
Code:	AEP
Description:	Access Point End of Pipe
Distance (ft):	58.1
Structural Grade:	0
O&M Grade:	0
Clock Start/From:	
Clock To:	
1st Value:	
2nd Value:	
Value Percent:	
Continuous Index:	
Within 8" of Joint:	NO
Remarks:	M-503-032.1
