## Profile/Photo Observation Report

| Street: | <b>EASTIN AV</b> | Flow Control: | <b>Not Controlled</b> |
| City: | <b>Hobart, IN</b> | Year Renewed: | |

| US MH: | <b>M-1004-097</b> | DS MH: | <b>M-1004-003</b> |

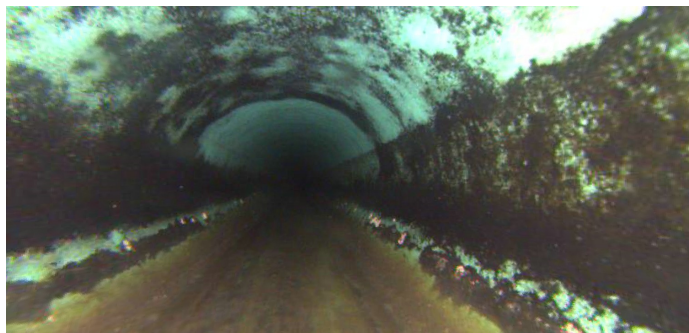
Code: **AMH**  
 Description: **Manhole**

Distance (ft): **.0**  
 Structural Grade: **0**  
 O&M Grade: **0**  
 Clock Start/From:  
 Clock To:  
 1st Value:  
 2nd Value:  
 Value Percent:  
 Continuous Index:  
 Within 8" of Joint: **NO**  
 Remarks: **M-1004-003**

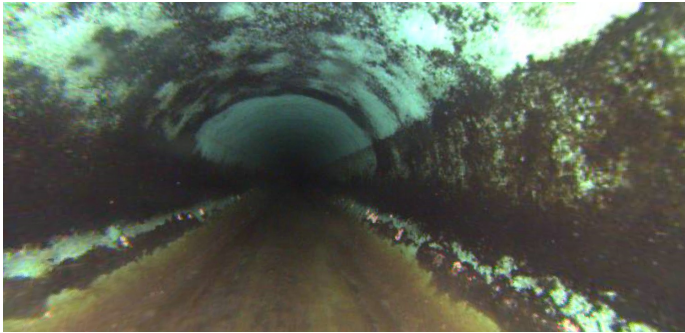
| Code: | <b>MWL</b> |
| Description: | <b>Water Level</b> |

| Distance (ft): | <b>.0</b> |
| Value Percent: | <b>10.000</b> |

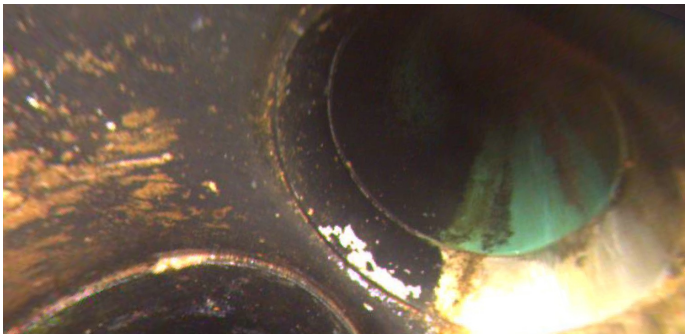
| Code: | <b>TFA</b> |
| Description: | <b>Tap Factory Active</b> |

| Distance (ft): | <b>95.9</b> |
| Clock Start/From: | <b>1</b> |
| 1st Value: | <b>4.000</b> |

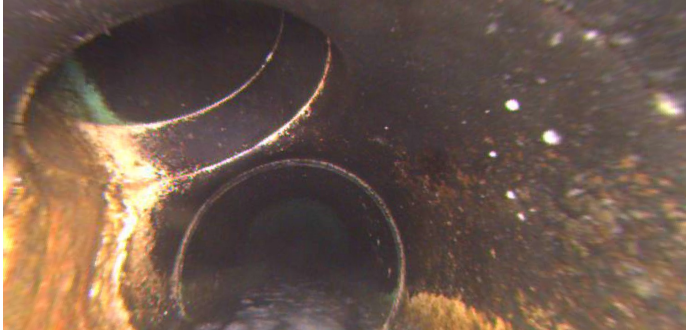
Code: **TFA**  
Description: **Tap Factory Active**

Distance (ft): **106.4**  
Structural Grade: **0**  
O&M Grade: **0**  
Clock Start/From: **11**  
Clock To:  
1st Value: **4.000**  
2nd Value:  
Value Percent:  
Continuous Index:  
Within 8" of Joint:  
Remarks:

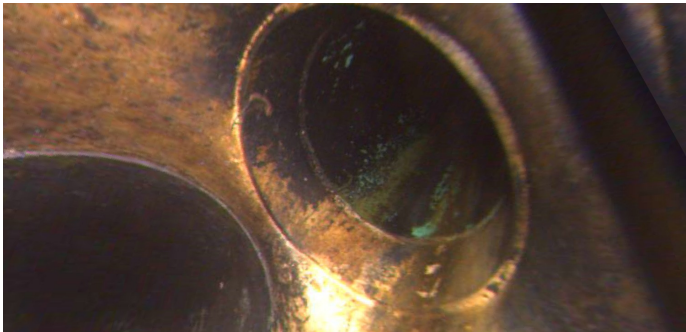
Code: **TF**  
Description: **Tap Factory**

Distance (ft): **239.5**  
Structural Grade: **0**  
O&M Grade: **0**  
Clock Start/From: **2**  
Clock To:  
1st Value: **4.000**  
2nd Value:  
Value Percent:  
Continuous Index:  
Within 8" of Joint:  
Remarks:

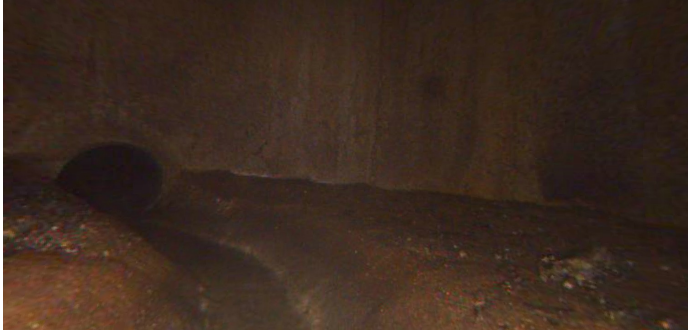
| Code: | AMH |
| Description: | Manhole |
| Distance (ft): | 257.2 |
| Remarks: | M-1004-097 |
