Profile/Photo Observation Report

Date:	05/03/2018	Weather:		Coding:	PACP 6.0
Pipe Length (ft):		Owner:	City of Hobart	Pre Clean:	No Pre-Cleaning
P.O.#:	185	Surveyor:	M. Pielacha	PSR:	P-1005-001-UNK
Customer:	City of Hobart	Clean Date:		Shape:	C

Street:	Off State Road 130	Flow Control:	Not Controlled
City:	Hobart, IN	Year Renewed:	
Location:	Parking Lot	Tape/Media #:	DEP 185
Purpose:	Routine Assessment	Dia/Height:	6"
Use:	Sanitary	Material:	CAS
Drain Area:		Lining:	
Category:	NA		
Comment:	5-21-2018

Location Details:		Direction of Survey:	Downstream
US MH:	M-1005-001	DS MH:	M-1005-001
		Total Length Surveyed (ft):	100.4

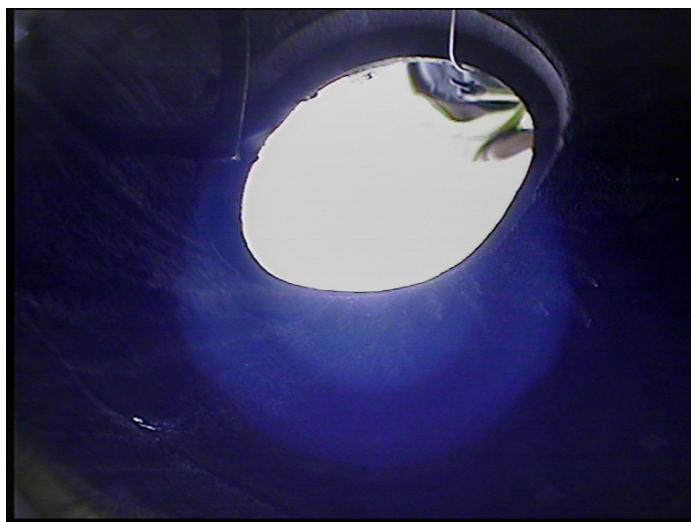
Code: **AMH**
Description: **Manhole**

Distance (ft): **.0**
Structural Grade: **0**
O&M Grade: **0**
Clock Start/From:
Clock To:
1st Value:
2nd Value:
Value Percent:
Continuous Index:
Within 8" of Joint: **NO**
Remarks: **M-1005-001**

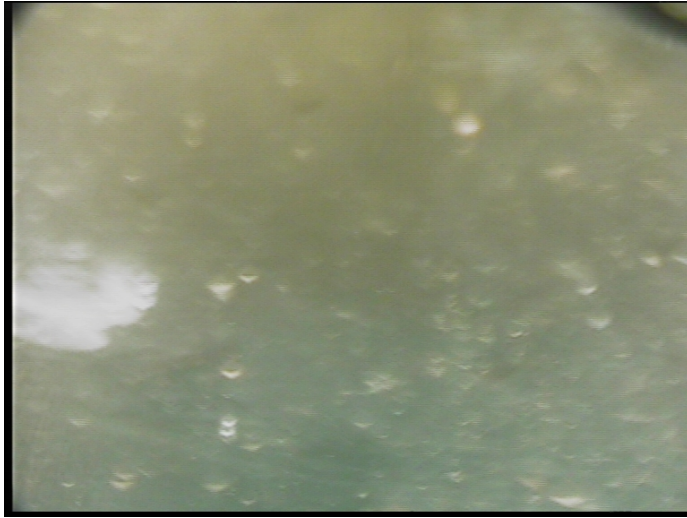
Code: **MWL**
Description: **Water Level**

Distance (ft): **.0**
Structural Grade: **0**
O&M Grade: **0**
Clock Start/From:
Clock To:
1st Value:
2nd Value:
Value Percent: **70.000**
Continuous Index:
Within 8" of Joint: **NO**
Remarks:

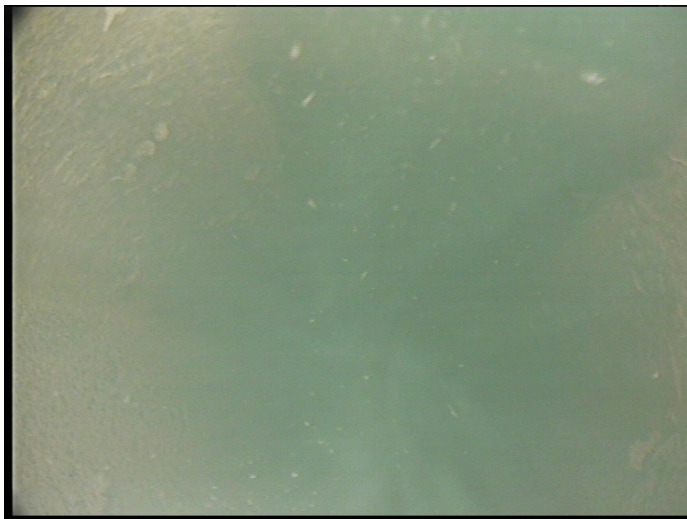
Code: **MCU**
Description: **Camera Underwater**

Distance (ft): **10.0**
Structural Grade: **0**
O&M Grade: **4**
Clock Start/From:
Clock To:
1st Value:
2nd Value:
Value Percent:
Continuous Index: **S01**
Within 8" of Joint: **NO**
Remarks:

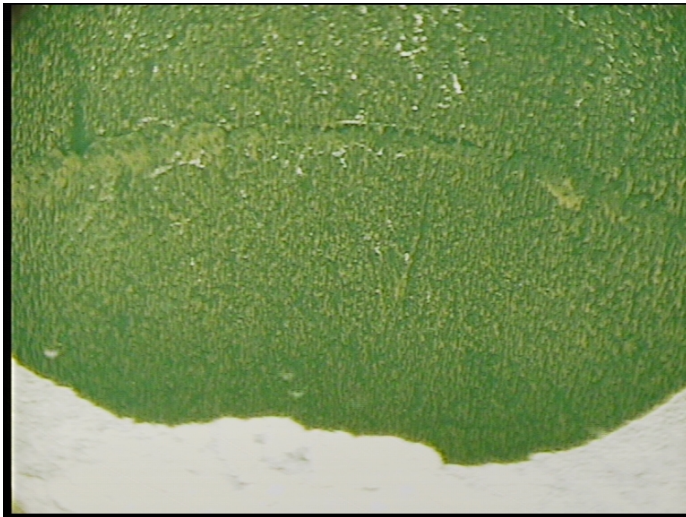
Code: **MCU**
Description: **Camera Underwater**

Distance (ft): **100.4**
Structural Grade: **0**
O&M Grade: **4**
Clock Start/From:
Clock To:
1st Value:
2nd Value:
Value Percent:
Continuous Index: **F01**
Within 8" of Joint: **NO**
Remarks:

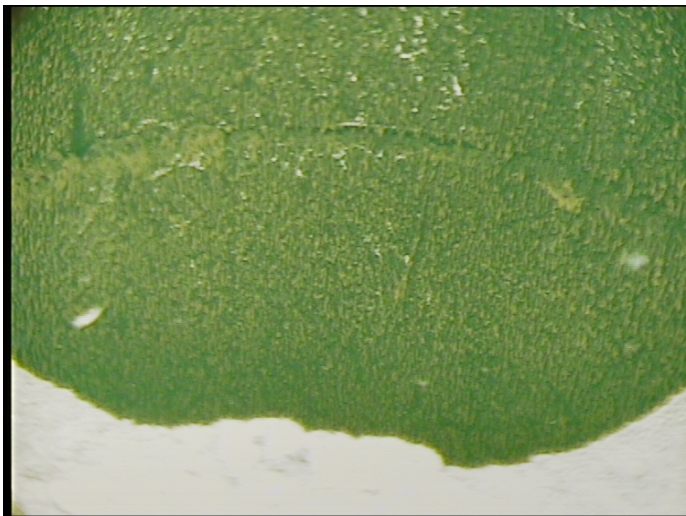
Code: **ADP**
Description: **Discharge Point**

Distance (ft): **100.4**
Structural Grade: **0**
O&M Grade: **0**
Clock Start/From:
Clock To:
1st Value:
2nd Value:
Value Percent:
Continuous Index:
Within 8" of Joint: **NO**
Remarks: **Unknown**
