## Profile/Photo Observation Report

Date:	<b>10/20/2021</b>	Weather:		Coding:	<b>PACP 6.0</b>
Pipe Length (ft):		Owner:	<b>Hobart, IN</b>	Pre Clean:	<b>Not Known</b>
P.O.#:	<b>906_1</b>	Surveyor:	<b>M. Pielacha</b>	PSR:	<b>P-1005-002-LS026</b>
Customer:	<b>Hobart, IN</b>	Clean Date:		Shape:	<b>C</b>

Street:	<b>Midwest Service Center</b>	Flow Control:	
City:	<b>Hobart, IN</b>	Year Renewed:	
Location:	<b>Parking Lot</b>	Tape/Media #:	<b>906</b>
Purpose:	<b>Routine Assessment</b>	Dia/Height:	<b>8"</b>
Use:	<b>Sanitary</b>	Material:	<b>PVC</b>
Drain Area:		Lining:	
Category:	<b>NA</b>		
Comment:

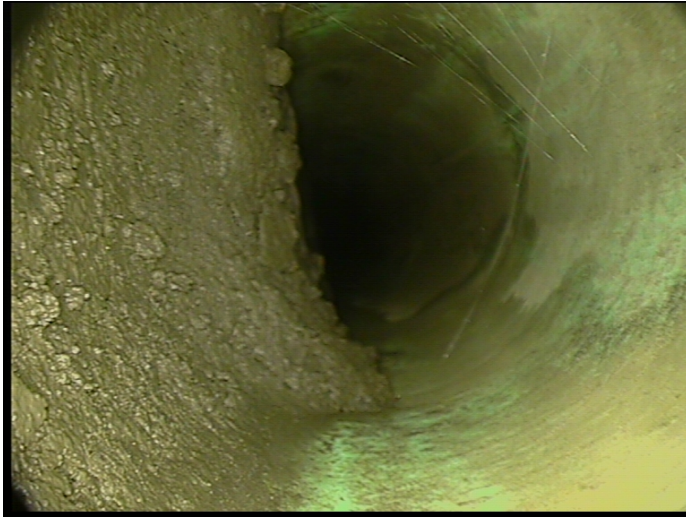
Code: **MWL**  
Description: **Water Level**

Distance (ft): **.0**  
Structural Grade: **0**  
O&M Grade: **0**  
Clock Start/From:  
Clock To:  
1st Value:  
2nd Value:  
Value Percent: **0.000**  
Continuous Index:  
Within 8" of Joint: **NO**  
Remarks:

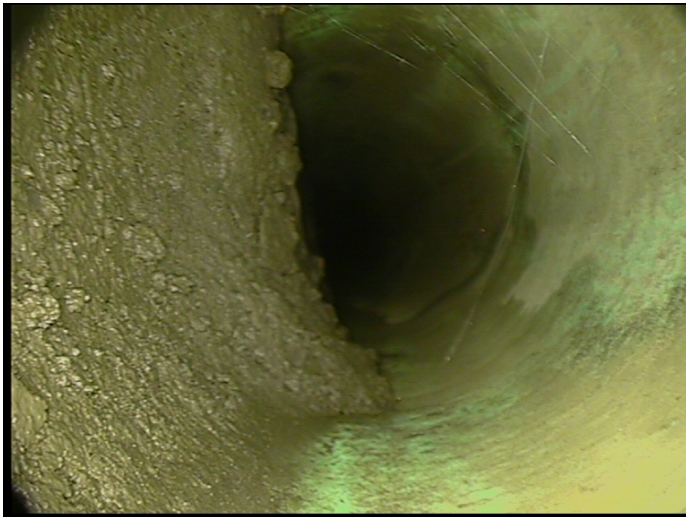
Code: **DSF**  
Description: **Deposits Settled Fine**

Distance (ft): **.0**  
Structural Grade: **0**  
O&M Grade: **3**  
Clock Start/From: **4**  
Clock To: **8**  
1st Value:  
2nd Value:  
Value Percent: **15.000**  
Continuous Index: **S01**  
Within 8" of Joint: **YES**  
Remarks:

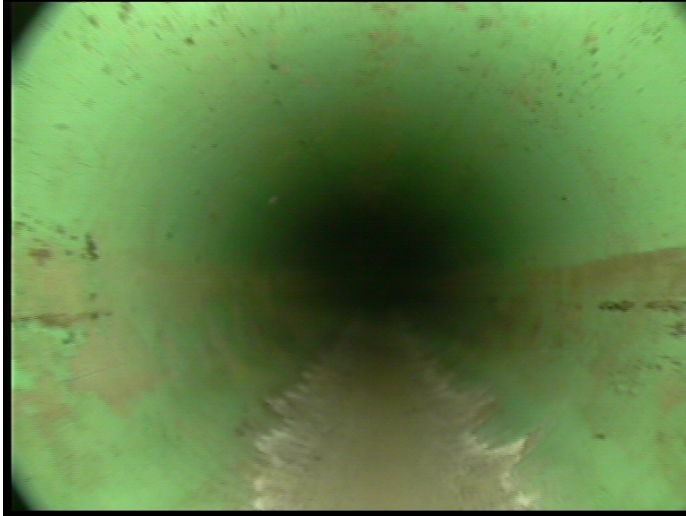
Code: **DSF**  
Description: **Deposits Settled Fine**

Distance (ft): **72.8**  
Structural Grade: **0**  
O&M Grade: **3**  
Clock Start/From: **4**  
Clock To: **8**  
1st Value:  
2nd Value:  
Value Percent: **15.000**  
Continuous Index: **F01**  
Within 8" of Joint: **NO**  
Remarks:

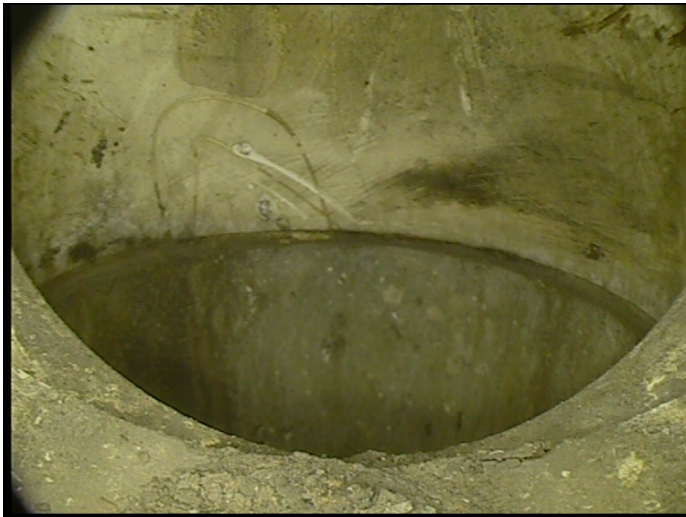
Code: **TF**  
Description: **Tap Factory**

Distance (ft): **98.9**  
Structural Grade: **0**  
O&M Grade: **0**  
Clock Start/From: **6**  
Clock To:  
1st Value: **6.000**  
2nd Value:  
Value Percent:  
Continuous Index:  
Within 8" of Joint: **NO**  
Remarks: **drop conection**

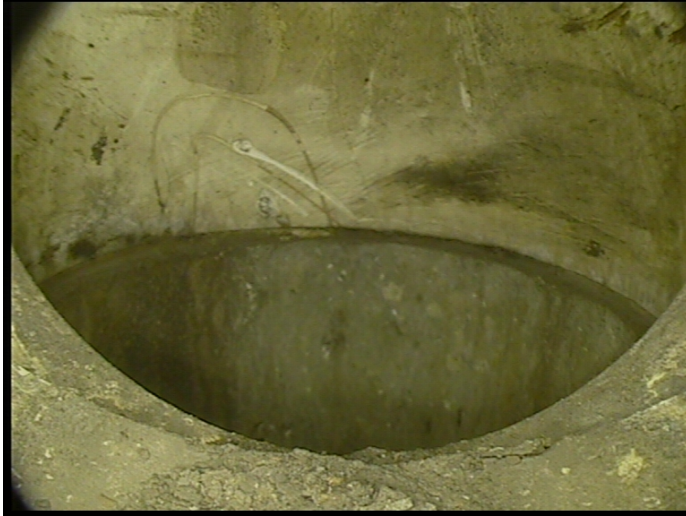
Code:	<b>AMH</b>
Description:	<b>Manhole</b>
Distance (ft):	<b>98.9</b>
Structural Grade:	<b>0</b>
O&M Grade:	<b>0</b>
Clock Start/From:	
Clock To:	
1st Value:	
2nd Value:	
Value Percent:	
Continuous Index:	
Within 8" of Joint:	<b>NO</b>
Remarks:	<b>M-1005-2</b>
