## Profile/Photo Observation Report

Date:	<b>08/09/2022</b>	Weather:		Coding:	<b>PACP 7.0</b>
Pipe Length (ft):	<b>50.0</b>	Owner:	<b>City of Hobart</b>	Pre Clean:	<b>No Pre-Cleaning</b>
P.O.#:	<b>YES502259</b>	Surveyor:	<b>S. Bucklin</b>	PSR:	<b>M-505-011.1-M-505-11</b>
Customer:	<b>City of Hobart</b>	Clean Date:		Shape:	<b>C</b>

Street:	<b>Lake George Drive</b>	Flow Control:	<b>Not Controlled</b>
City:	<b>Hobart, IN</b>	Year Renewed:	
Location:	<b>Local rural streets with light traffic, t</b>	Tape/Media #:	
Purpose:	<b>Routine Assessment</b>	Dia/Height:	<b>15"</b>
Use:	<b>Sanitary Sewage Pipe</b>	Material:	<b>VCP</b>
Drain Area:		Lining:	<b>None</b>
Category:	<b>NA</b>		
Comment:			
Location Details:		Direction of Survey:	<b>Upstream</b>
US MH:	<b>M-505-011.1</b>	DS MH:	<b>M-505-11</b>
		Total Length Surveyed (ft):	<b>39.2</b>

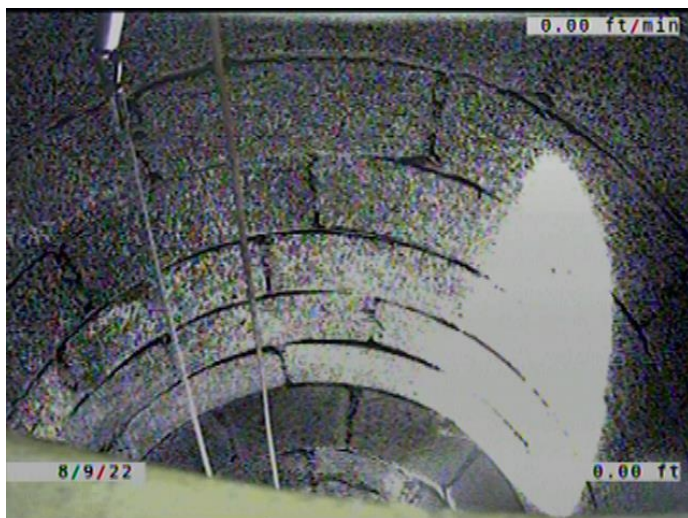
Code: **AMH**  
Description: **Manhole**

Distance (ft): **.0**  
Structural Grade: **0**  
O&M Grade: **0**  
Clock Start/From:  
Clock To:  
1st Value:  
2nd Value:  
Value Percent:  
Continuous Index:  
Within 8" of Joint: **NO**  
Remarks: **M-505-11**

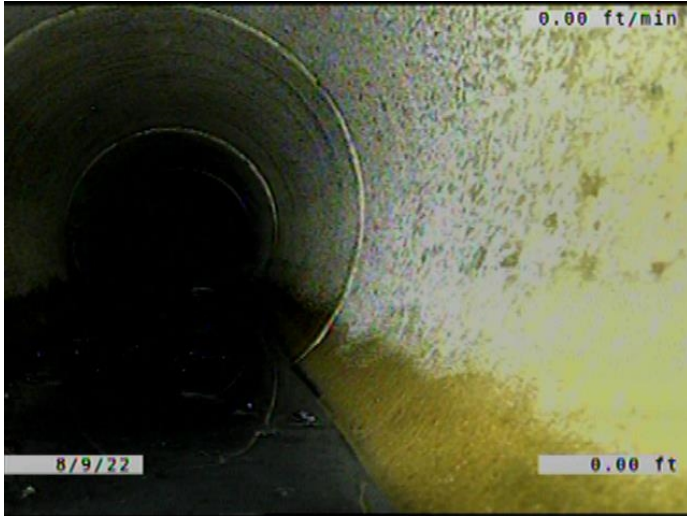
Code: **MWL**  
Description: **Miscellaneous Water Level**

Distance (ft): **.0**  
Structural Grade: **0**  
O&M Grade: **0**  
Clock Start/From:  
Clock To:  
1st Value:  
2nd Value:  
Value Percent: **5.000**  
Continuous Index:  
Within 8" of Joint: **NO**  
Remarks:

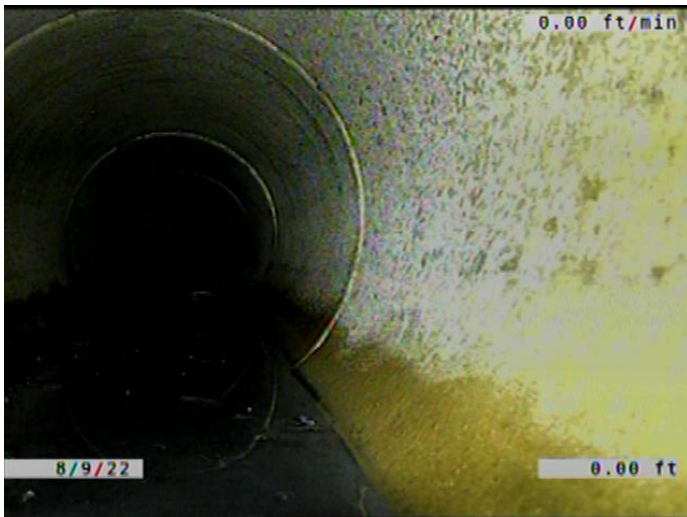
Code: **DSF**  
Description: **Deposits Settled Fine**

Distance (ft): **.0**  
Structural Grade: **0**  
O&M Grade: **2**  
Clock Start/From: **5**  
Clock To: **7**  
1st Value:  
2nd Value:  
Value Percent: **5.000**  
Continuous Index: **S01**  
Within 8" of Joint: **YES**  
Remarks:

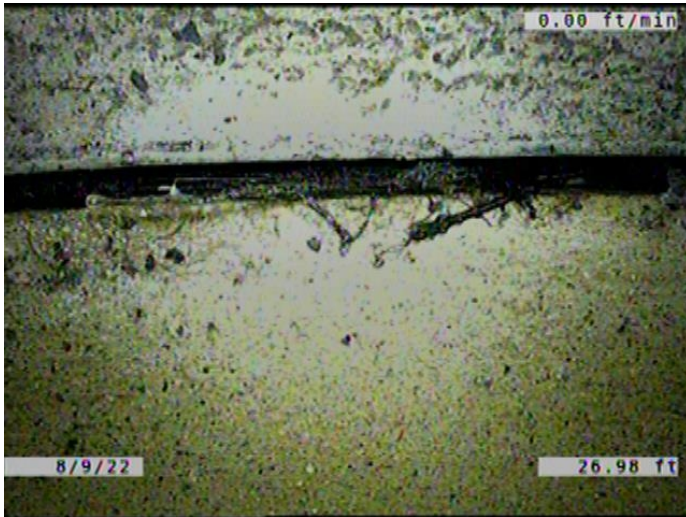
Code: **RFJ**  
 Description: **Roots Fine Joint**

Distance (ft): **27.0**  
 Structural Grade: **0**  
 O&M Grade: **1**  
 Clock Start/From: **9**  
 Clock To: **11**  
 1st Value:  
 2nd Value:  
 Value Percent:  
 Continuous Index:  
 Within 8" of Joint: **YES**  
 Remarks:

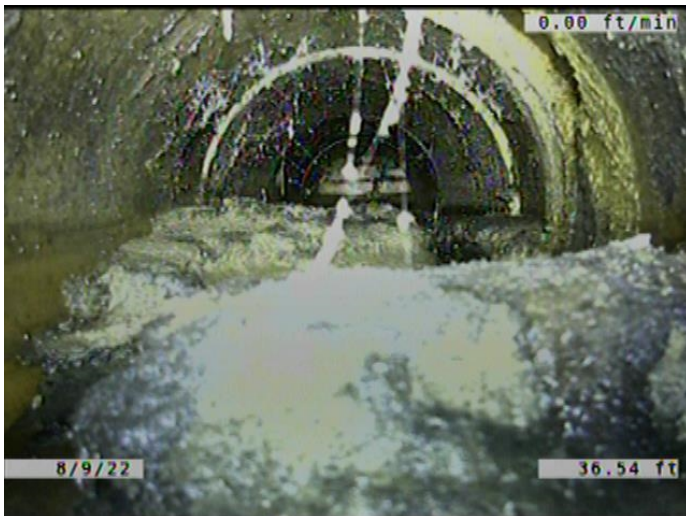
Code: **DSF**  
 Description: **Deposits Settled Fine**

Distance (ft): **36.5**  
 Structural Grade: **0**  
 O&M Grade: **2**  
 Clock Start/From: **5**  
 Clock To: **7**  
 1st Value:  
 2nd Value:  
 Value Percent: **5.000**  
 Continuous Index: **F01**  
 Within 8" of Joint: **YES**  
 Remarks:

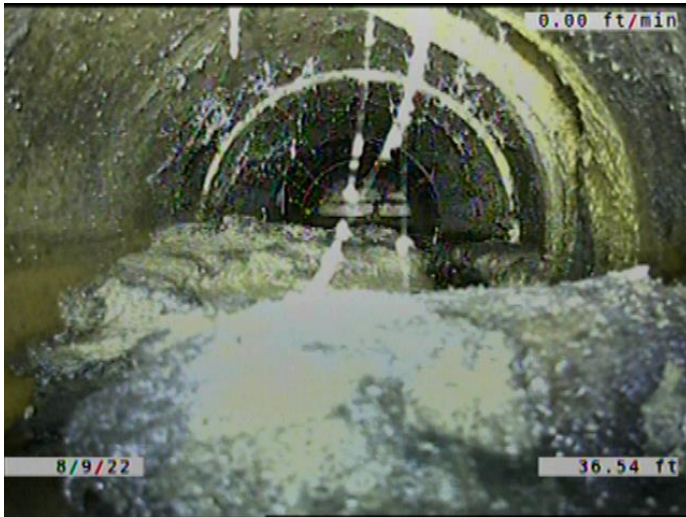
Code: **DSF**  
 Description: **Deposits Settled Fine**

Distance (ft): **36.5**  
 Structural Grade: **0**  
 O&M Grade: **5**  
 Clock Start/From: **3**  
 Clock To: **9**  
 1st Value:  
 2nd Value:  
 Value Percent: **50.000**  
 Continuous Index:  
 Within 8" of Joint: **YES**  
 Remarks:

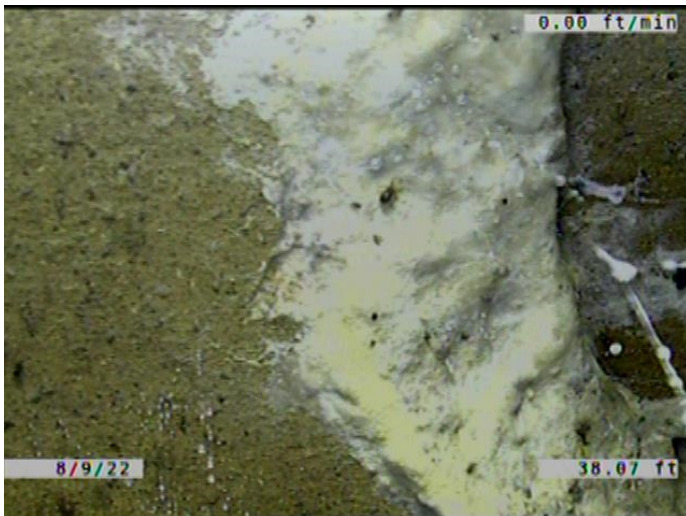
Code: **DAE**  
 Description: **Deposits Attached Encrustation**

Distance (ft): **38.1**  
 Structural Grade: **0**  
 O&M Grade: **2**  
 Clock Start/From: **12**  
 Clock To: **5**  
 1st Value:  
 2nd Value:  
 Value Percent: **5.000**  
 Continuous Index:  
 Within 8" of Joint: **YES**  
 Remarks:

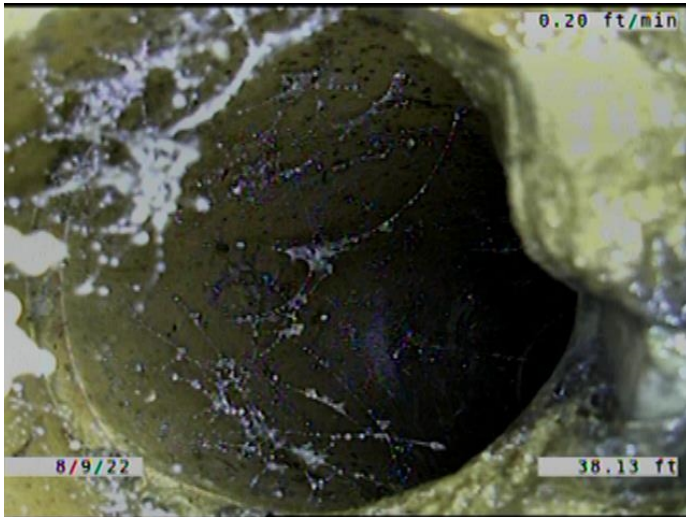
Code: **TBD**  
 Description: **Tap Break-in/Hammer Defective**

Distance (ft): **38.1**  
 Structural Grade: **0**  
 O&M Grade: **3**  
 Clock Start/From: **2**  
 Clock To:  
 1st Value: **6.000**  
 2nd Value:  
 Value Percent:  
 Continuous Index:  
 Within 8" of Joint: **YES**  
 Remarks: **DEFECTIVE**

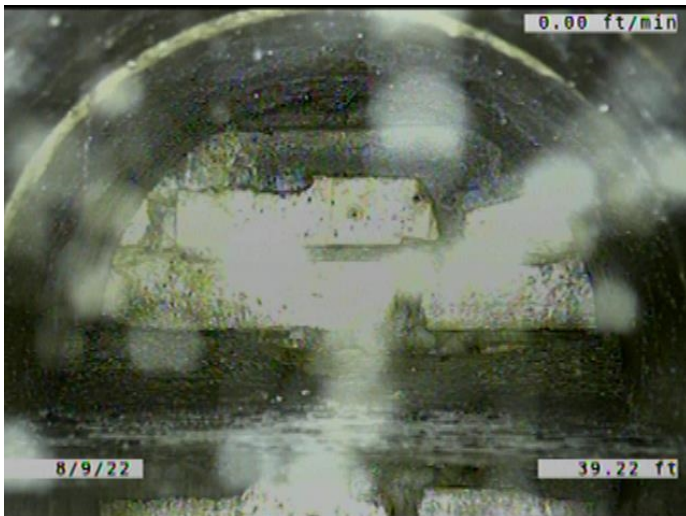
Code: **MSA**  
 Description: **Miscellaneous Survey Abandoned**

Distance (ft): **39.2**  
 Structural Grade: **0**  
 O&M Grade: **0**  
 Clock Start/From:  
 Clock To:  
 1st Value:  
 2nd Value:  
 Value Percent:  
 Continuous Index:  
 Within 8" of Joint: **NO**  
 Remarks: **CAMERA CANT MAKE IT PAST DEBRIS.**
