Profile/Photo Observation Report

Date:	11/10/2021	Weather:		Coding:	PACP 7.0
Pipe Length (ft):	219.1	Owner:	City of Hobart	Pre Clean:	No Pre-Cleaning
P.O.#:	YES502259	Surveyor:	Steven Bucklin	PSR:	M-604-057.1-M-604-057
Customer:	City of Hobart, IN (Red	Clean Date:		Shape:	C

Street:	North Connection Street	Flow Control:	Not Controlled
City:	City of Hobart	Year Renewed:	
Location:	Alley	Tape/Media #:	
Purpose:	Routine Assessment	Dia/Height:	8"
Use:	Sanitary Sewage Pipe	Material:	CP
Drain Area:		Lining:	None
Category:	NA		
Comment:			
Location Details:		Direction of Survey:	Upstream
US MH:	M-604-057.1	DS MH:	M-604-057
		Total Length Surveyed (ft):	219.1

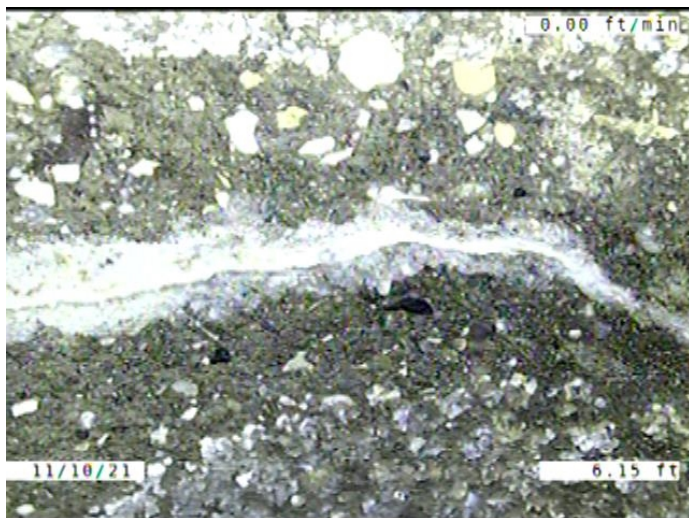
Code: **DAE**
Description: **Deposits Attached Encrustation**

Distance (ft): **6.2**
Structural Grade: **0**
O&M Grade: **2**
Clock Start/From: **9**
Clock To: **11**
1st Value:
2nd Value:
Value Percent: **5.000**
Continuous Index:
Within 8" of Joint: **NO**
Remarks:

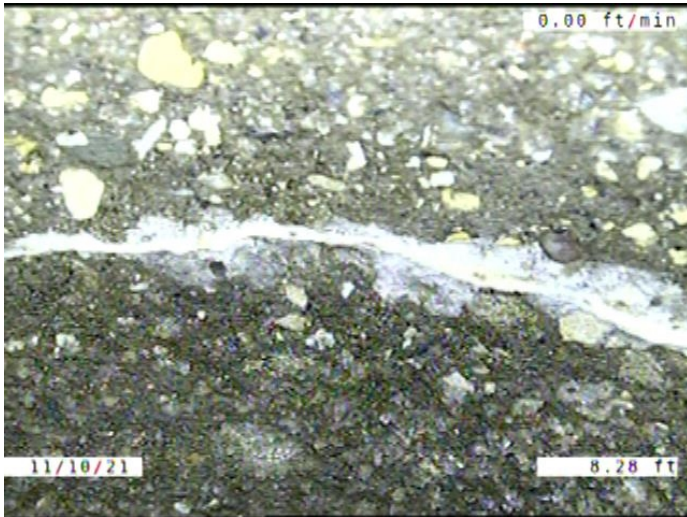
Code: **DAE**
Description: **Deposits Attached Encrustation**

Distance (ft): **8.3**
Structural Grade: **0**
O&M Grade: **2**
Clock Start/From: **12**
Clock To: **3**
1st Value:
2nd Value:
Value Percent: **5.000**
Continuous Index:
Within 8" of Joint: **NO**
Remarks:

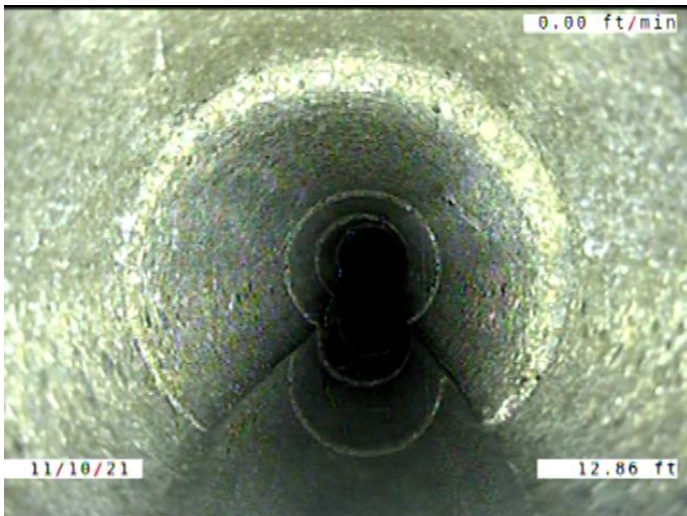
Code: **MWLS**
Description: **Miscellaneous Water Level Sag**

Distance (ft): **12.9**
Structural Grade: **2**
O&M Grade: **0**
Clock Start/From:
Clock To:
1st Value:
2nd Value:
Value Percent: **5.000**
Continuous Index: **S01**
Within 8" of Joint: **NO**
Remarks:

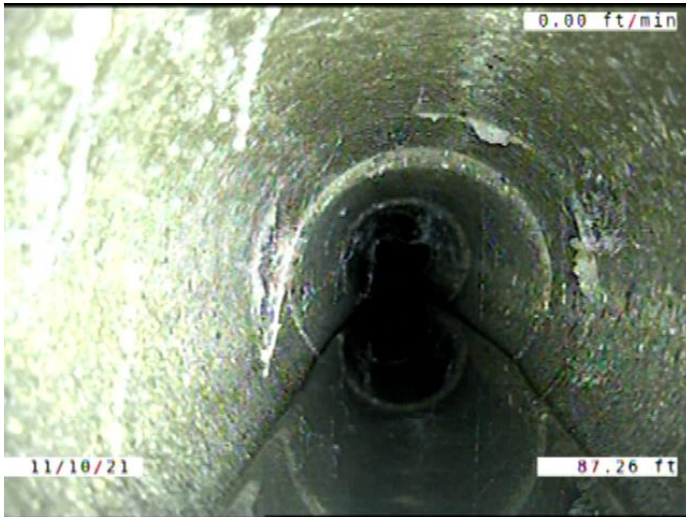
Code: **MWLS**
 Description: **Miscellaneous Water Level Sag**

Distance (ft): **87.3**
 Structural Grade: **2**
 O&M Grade: **0**
 Clock Start/From:
 Clock To:
 1st Value:
 2nd Value:
 Value Percent: **10.000**
 Continuous Index: **S03**
 Within 8" of Joint: **NO**
 Remarks:

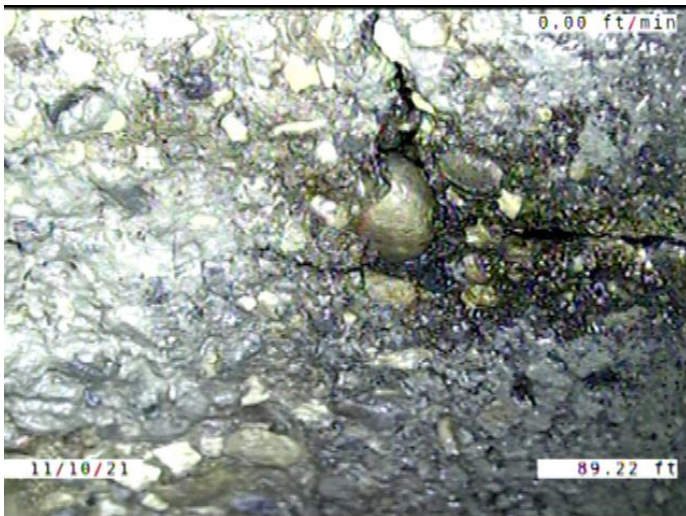
Code: **FM**
 Description: **Fracture Multiple**

Distance (ft): **89.2**
 Structural Grade: **4**
 O&M Grade: **0**
 Clock Start/From: **12**
 Clock To: **12**
 1st Value:
 2nd Value:
 Value Percent:
 Continuous Index:
 Within 8" of Joint: **YES**
 Remarks:

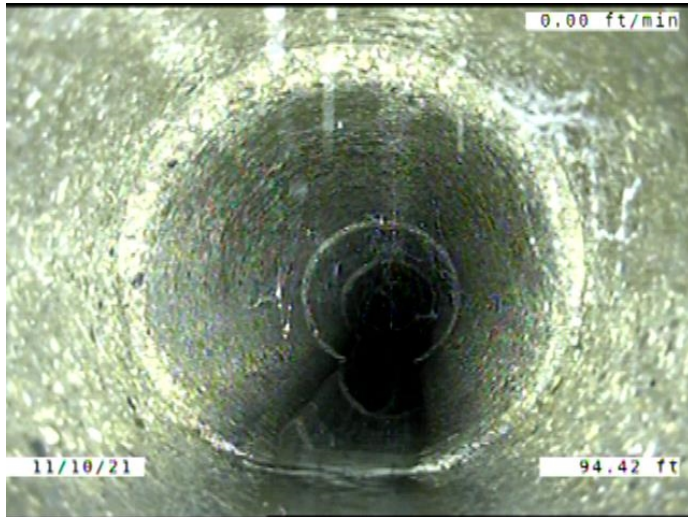
Code: **MWLS**
 Description: **Miscellaneous Water Level Sag**

Distance (ft): **94.4**
 Structural Grade: **2**
 O&M Grade: **0**
 Clock Start/From:
 Clock To:
 1st Value:
 2nd Value:
 Value Percent: **10.000**
 Continuous Index: **F03**
 Within 8" of Joint: **NO**
 Remarks:

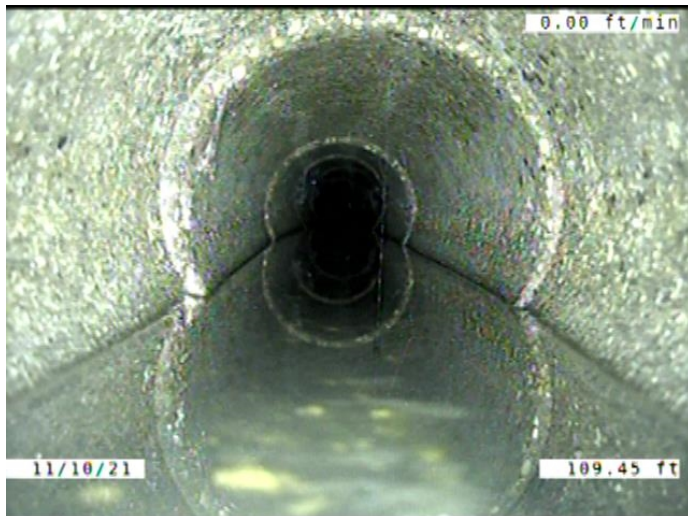
Code: **MWLS**
 Description: **Miscellaneous Water Level Sag**

Distance (ft): **109.4**
 Structural Grade: **2**
 O&M Grade: **0**
 Clock Start/From:
 Clock To:
 1st Value:
 2nd Value:
 Value Percent: **10.000**
 Continuous Index: **S04**
 Within 8" of Joint: **NO**
 Remarks:

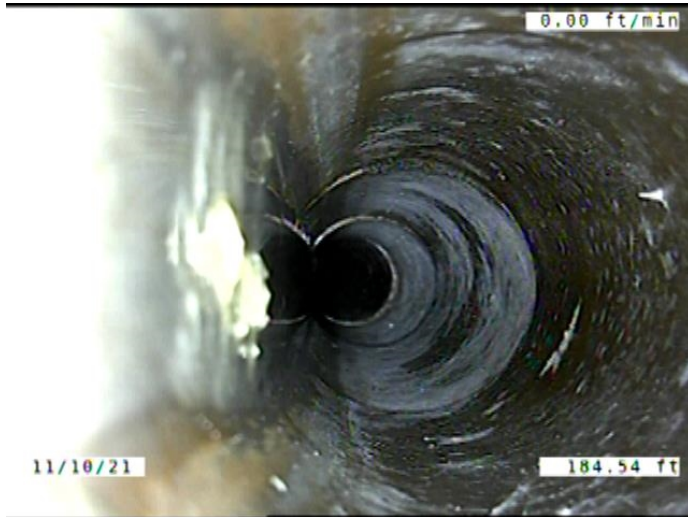
Code: **TBI**
Description: **Tap Break-in Intruding**

Distance (ft): **184.5**
Structural Grade: **0**
O&M Grade: **2**
Clock Start/From: **10**
Clock To:
1st Value: **4.000**
2nd Value: **1.000**
Value Percent:
Continuous Index:
Within 8" of Joint: **YES**
Remarks:

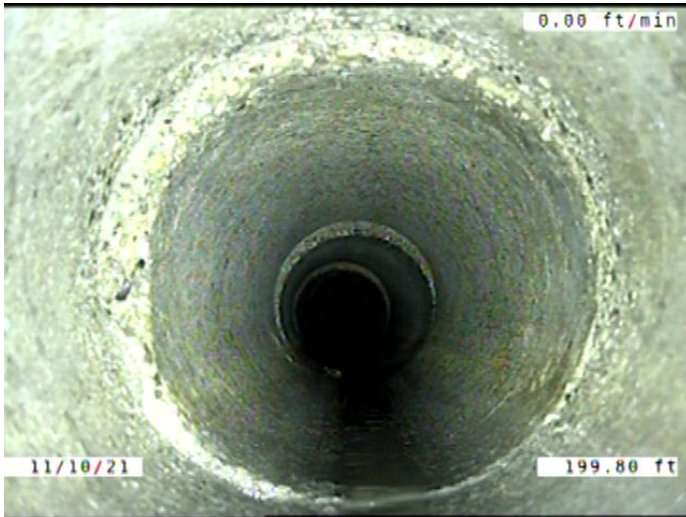
Code: **MWLS**
 Description: **Miscellaneous Water Level Sag**

Distance (ft): **199.8**
 Structural Grade: **2**
 O&M Grade: **0**
 Clock Start/From:
 Clock To:
 1st Value:
 2nd Value:
 Value Percent: **10.000**
 Continuous Index: **F04**
 Within 8" of Joint: **NO**
 Remarks:

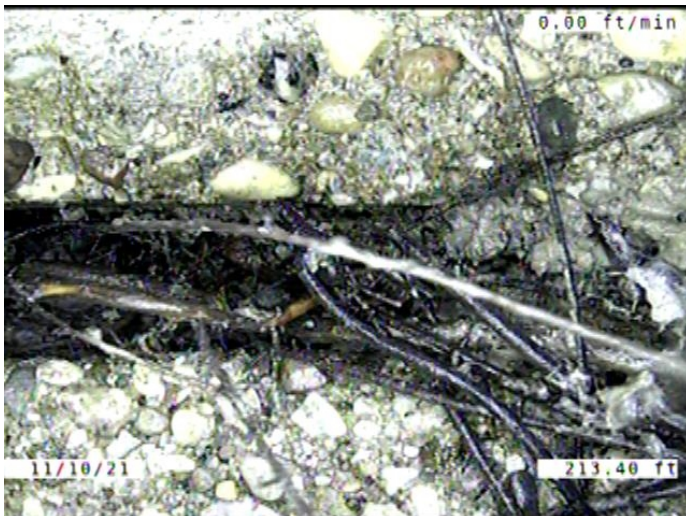
Code: **RFJ**
 Description: **Roots Fine Joint**

Distance (ft): **213.4**
 Structural Grade: **0**
 O&M Grade: **1**
 Clock Start/From: **7**
 Clock To: **11**
 1st Value:
 2nd Value:
 Value Percent:
 Continuous Index:
 Within 8" of Joint: **YES**
 Remarks:

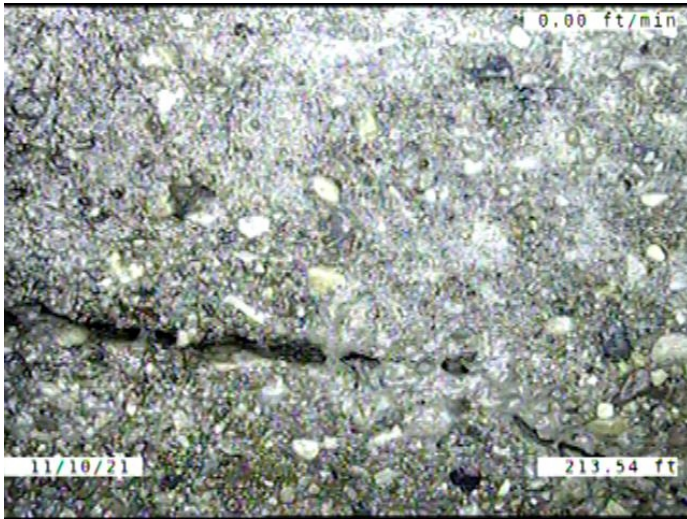
Code: **FM**
Description: **Fracture Multiple**

Distance (ft): **213.5**
Structural Grade: **4**
O&M Grade: **0**
Clock Start/From: **3**
Clock To: **12**
1st Value:
2nd Value:
Value Percent:
Continuous Index:
Within 8" of Joint: **YES**
Remarks:

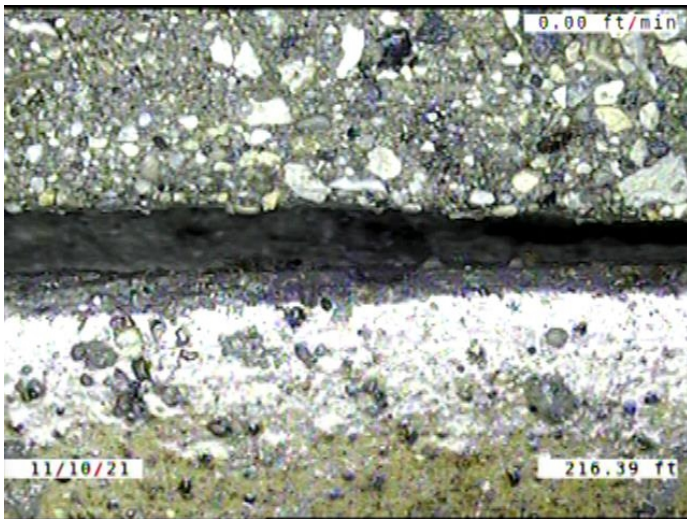
Code: **MMC**
Description: **Miscellaneous Material Change**

Distance (ft): **216.4**
Structural Grade: **0**
O&M Grade: **0**
Clock Start/From:
Clock To:
1st Value:
2nd Value:
Value Percent:
Continuous Index:
Within 8" of Joint: **NO**
Remarks: **CONCRETE TO VCP**
