Profile/Photo Observation Report

Street:	S COUNTY LINE RD	Flow Control:	Not Controlled
City:	Hobart, IN	Year Renewed:	
Location:	Other	Tape/Media #:	
Purpose:	Not Known	Dia/Height:	8"
Use:	Sanitary	Material:	PVC
Drain Area:	NA	Lining:	
Category:	NA		
Comment:

Location Details:		Direction of Survey:	Downstream
US MH:	M-1005-003	DS MH:	M-1005-004
		Total Length Surveyed (ft):	327.5

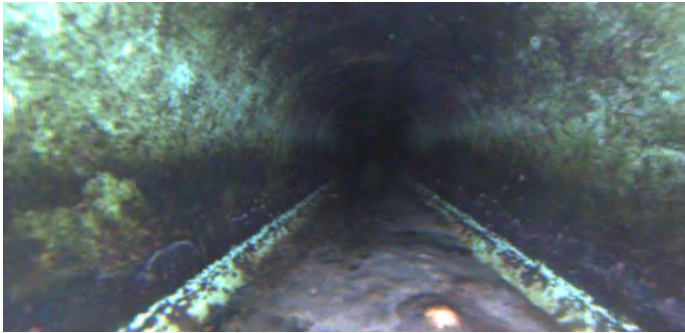
Code: **AMH**
Description: **Manhole**

Distance (ft): **.0**
Structural Grade: **0**
O&M Grade: **0**
Clock Start/From:
Clock To:
1st Value:
2nd Value:
Value Percent:
Continuous Index:
Within 8" of Joint: **NO**
Remarks: **M-1005-003**

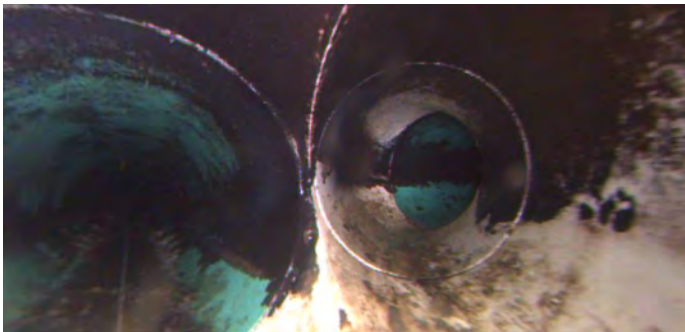
Code: **TF**
Description: **Tap Factory**

Distance (ft): **18.9**
Structural Grade: **0**
O&M Grade: **0**
Clock Start/From: **9**
Clock To:
1st Value: **4.000**
2nd Value:
Value Percent:
Continuous Index:
Within 8" of Joint:
Remarks:

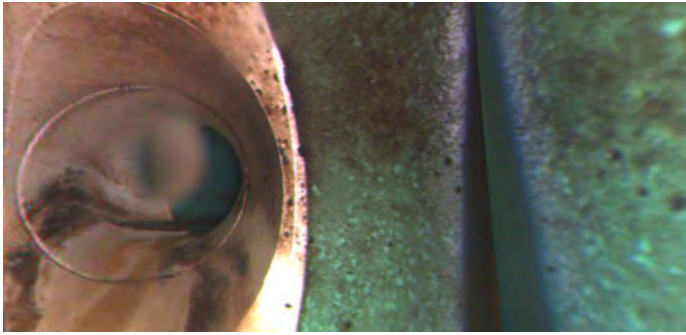
Code: **TF**
Description: **Tap Factory**

Distance (ft): **101.6**
Structural Grade: **0**
O&M Grade: **0**
Clock Start/From: **9**
Clock To:
1st Value: **4.000**
2nd Value:
Value Percent:
Continuous Index:
Within 8" of Joint:
Remarks:

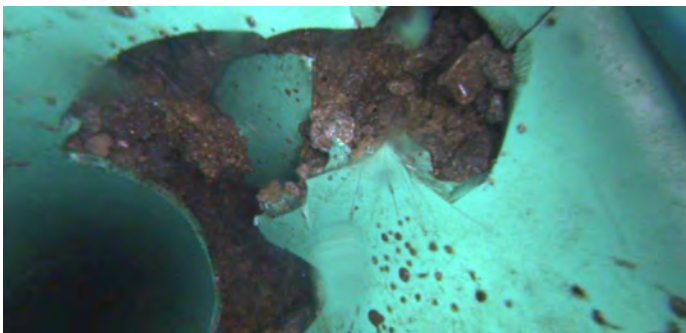
Code: **BSV**
Description: **Broken Soil Visible**

Distance (ft): **150.5**
Structural Grade: **5**
O&M Grade: **0**
Clock Start/From: **10**
Clock To: **12**
1st Value:
2nd Value:
Value Percent:
Continuous Index:
Within 8" of Joint: **YES**
Remarks:

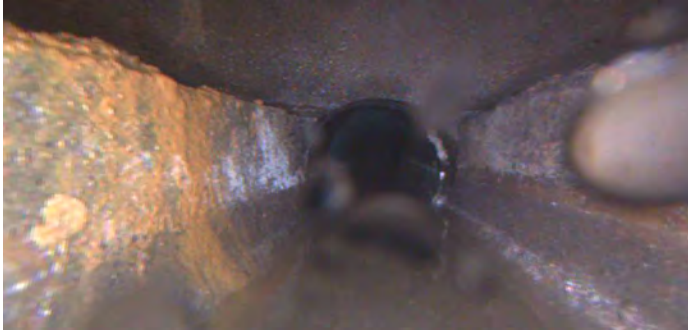
Code:	AMH
Description:	Manhole
Distance (ft):	327.5
Structural Grade:	0
O&M Grade:	0
Clock Start/From:	
Clock To:	
1st Value:	
2nd Value:	
Value Percent:	
Continuous Index:	
Within 8" of Joint:	NO
Remarks:	M-1005-004
