Profile/Photo Observation Report

Date:	03/08/2022	Weather:		Coding:	PACP 7.0
Pipe Length (ft):		Owner:	City of Hobart	Pre Clean:	No Pre-Cleaning
P.O.#:	YES502259	Surveyor:	S. Bucklin	PSR:	M-706-042.2_M-706-015
Customer:	City of Hobart, IN (Red	Clean Date:		Shape:	C

Street:	Water Street	Flow Control:	Not Controlled
City:	Hobart, IN	Year Renewed:	
Location:	Local rural streets with light traffic, t	Tape/Media #:	
Purpose:	Routine Assessment	Dia/Height:	12"
Use:	Sanitary Sewage Pipe	Material:	VCP
Drain Area:		Lining:	None
Category:	NA

Location Details:		Direction of Survey:	Downstream
US MH:	M-706-042.2	DS MH:	M-706-015
		Total Length Surveyed (ft):	26.7

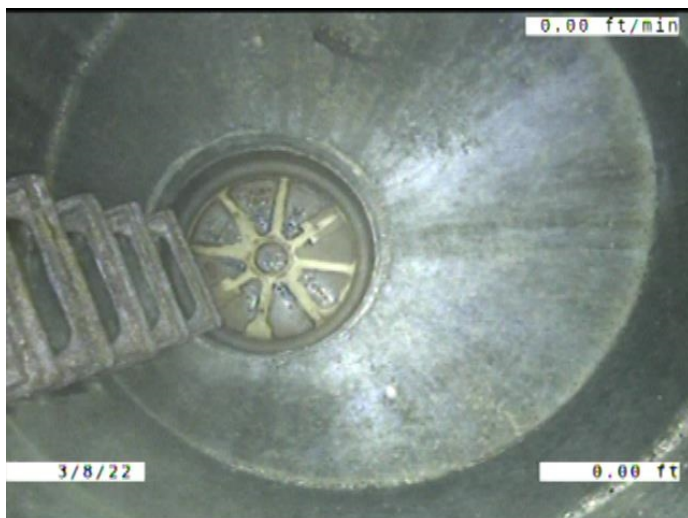
Code: **AMH**
 Description: **Manhole**

Distance (ft): **.0**
 Structural Grade: **0**
 O&M Grade: **0**
 Clock Start/From:
 Clock To:
 1st Value:
 2nd Value:
 Value Percent:
 Continuous Index:
 Within 8" of Joint: **NO**
 Remarks: **M-706-042.2**

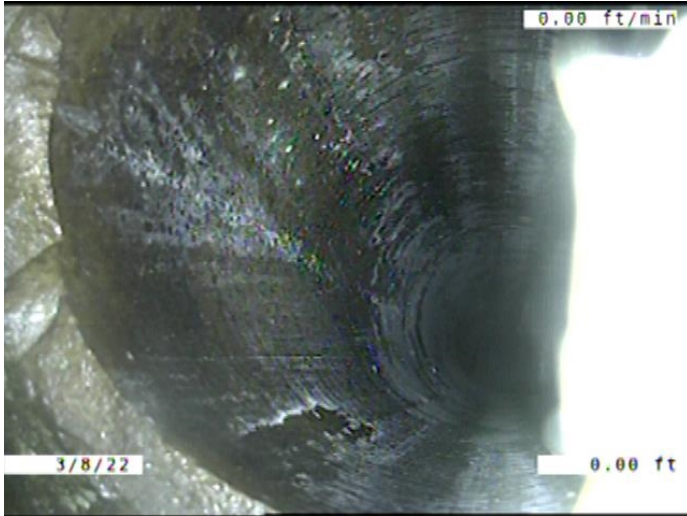
Code: **MWL**
Description: **Miscellaneous Water Level**

Distance (ft): **.0**
Structural Grade: **0**
O&M Grade: **0**
Clock Start/From:
Clock To:
1st Value:
2nd Value:
Value Percent: **15.000**
Continuous Index:
Within 8" of Joint: **NO**
Remarks:

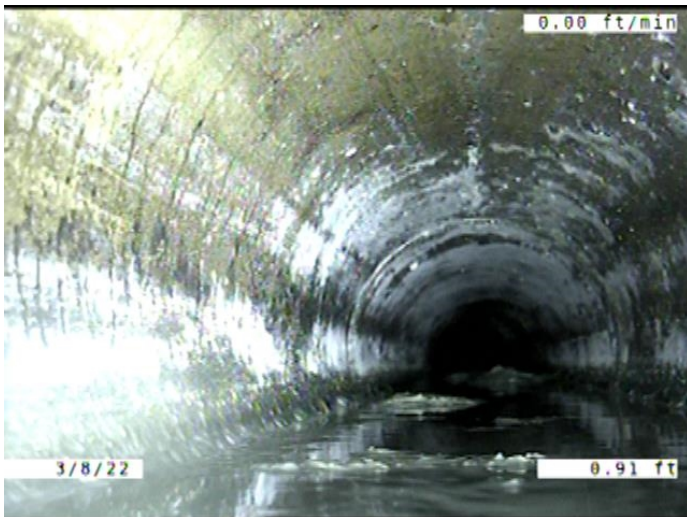
Code: **DSF**
Description: **Deposits Settled Fine**

Distance (ft): **.9**
Structural Grade: **0**
O&M Grade: **3**
Clock Start/From: **4**
Clock To: **8**
1st Value:
2nd Value:
Value Percent: **20.000**
Continuous Index: **S01**
Within 8" of Joint: **YES**
Remarks:

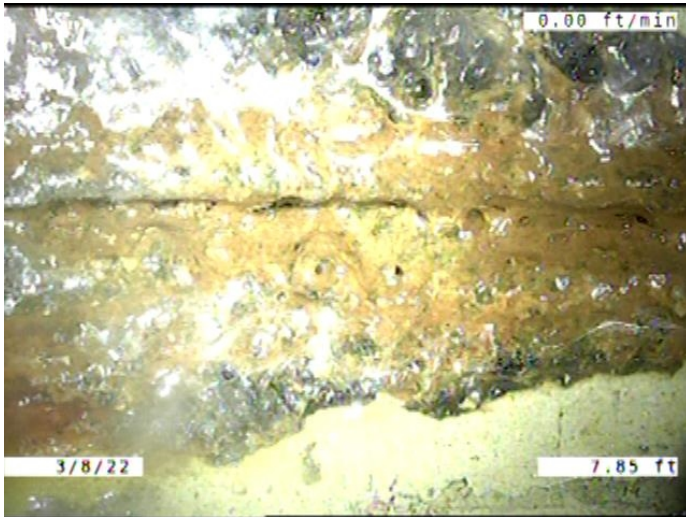
Code: **DAE**
 Description: **Deposits Attached Encrustation**

Distance (ft): **7.8**
 Structural Grade: **0**
 O&M Grade: **2**
 Clock Start/From: **9**
 Clock To: **3**
 1st Value:
 2nd Value:
 Value Percent: **5.000**
 Continuous Index: **S02**
 Within 8" of Joint: **YES**
 Remarks:

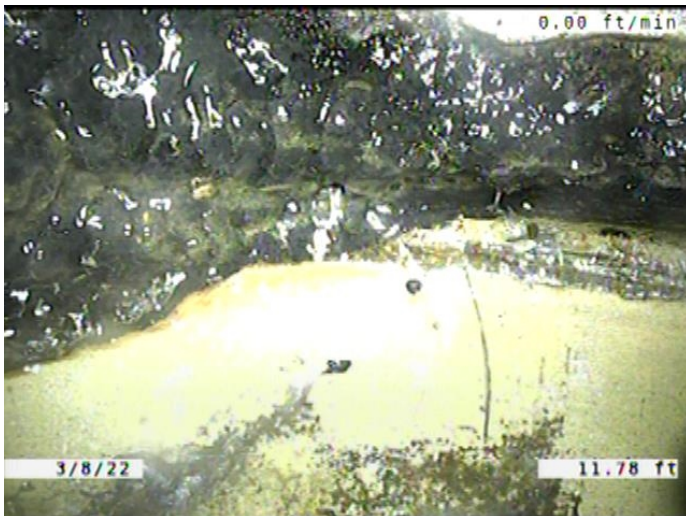
Code: **IRJ**
 Description: **Infiltration Runner Joint**

Distance (ft): **11.8**
 Structural Grade: **0**
 O&M Grade: **4**
 Clock Start/From: **11**
 Clock To:
 1st Value:
 2nd Value:
 Value Percent:
 Continuous Index:
 Within 8" of Joint: **YES**
 Remarks:

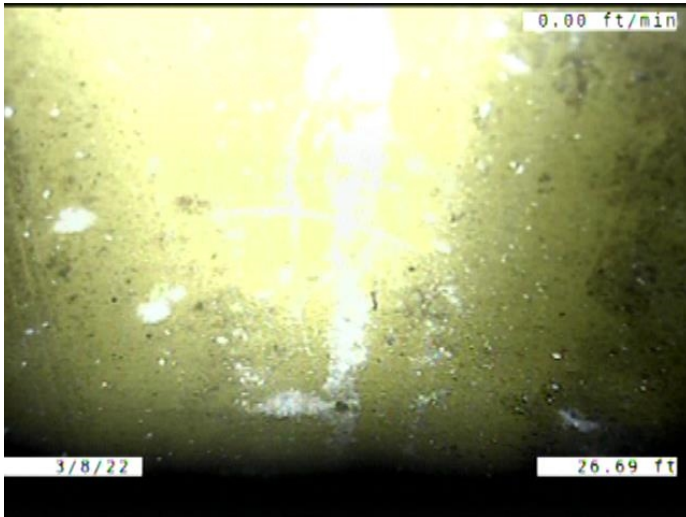
Code: **DSF**
Description: **Deposits Settled Fine**

Distance (ft): **26.7**
Structural Grade: **0**
O&M Grade: **3**
Clock Start/From: **4**
Clock To: **8**
1st Value:
2nd Value:
Value Percent: **20.000**
Continuous Index: **F01**
Within 8" of Joint: **YES**
Remarks:

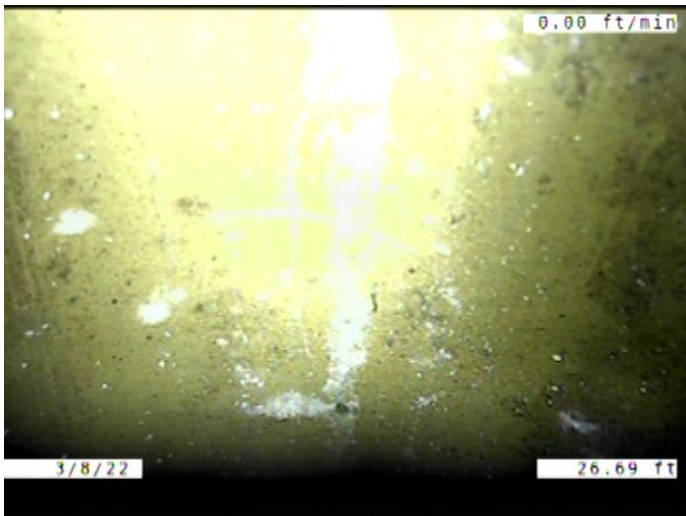
Code: **DAE**
Description: **Deposits Attached Encrustation**

Distance (ft): **26.7**
Structural Grade: **0**
O&M Grade: **2**
Clock Start/From: **9**
Clock To: **3**
1st Value:
2nd Value:
Value Percent: **5.000**
Continuous Index: **F02**
Within 8" of Joint: **YES**
Remarks:

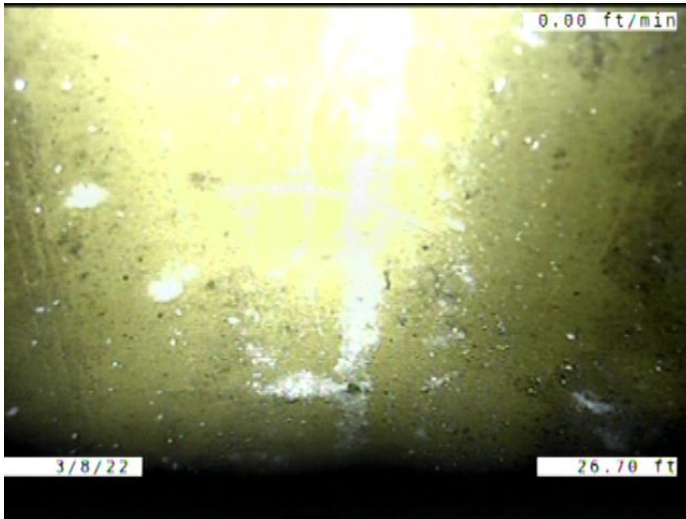
Code:	MSA
Description:	Miscellaneous Survey Abandoned
Distance (ft):	26.7
Structural Grade:	0
O&M Grade:	0
Clock Start/From:	
Clock To:	
1st Value:	
2nd Value:	
Value Percent:	
Continuous Index:	
Within 8" of Joint:	NO
Remarks:	CAMERA CANT MAKE IT PAST DEBRIS.
