Profile/Photo Observation Report

Date:	04/12/2018	Weather:		Coding:	PACP 6.0
Pipe Length (ft):	331.3	Owner:	NA	Pre Clean:	Not Known
P.O.#:		Surveyor:	Jen Costello	PSR:	P-1006-003-002
Customer:		Clean Date:	01/01/1900	Shape:	C

Street:	VERMILLION ST	Flow Control:	Not Controlled
City:	Hobart, IN	Year Renewed:	
Location:	Yard	Tape/Media #:	
Purpose:	Maintenance Related	Dia/Height:	8"
Use:	Sanitary	Material:	PVC
Drain Area:	NA	Lining:	Cured in Place
Category:	NA		
Comment:	flow incorrect.

Location Details:		Direction of Survey:	Downstream
US MH:	M-1006-002	DS MH:	M-1006-003
		Total Length Surveyed (ft):	353.3

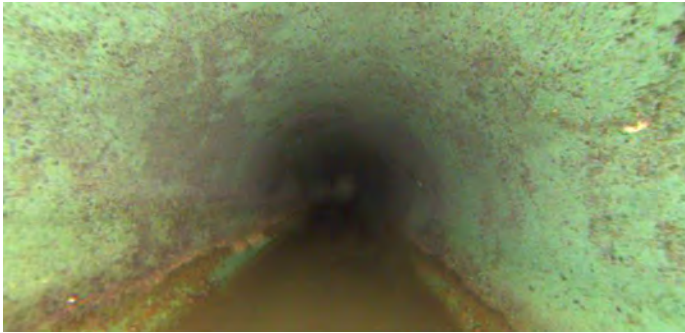
Code:	MWL
Description:	Water Level

Distance (ft):	.0
Structural Grade:	0
O&M Grade:	0
Clock Start/From:	
Clock To:	
1st Value:	
2nd Value:	
Value Percent:	5.000
Continuous Index:	
Within 8" of Joint:	NO
Remarks:

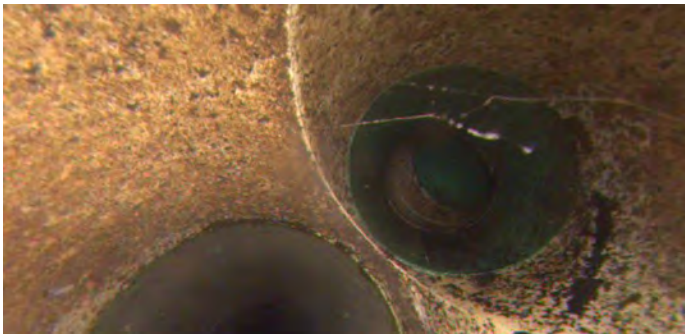
Code:	TF
Description:	Tap Factory

Distance (ft):	9.4
Structural Grade:	0
O&M Grade:	0
Clock Start/From:	10
Clock To:	
1st Value:	4.000
2nd Value:	
Value Percent:	
Continuous Index:	
Within 8" of Joint:	
Remarks:

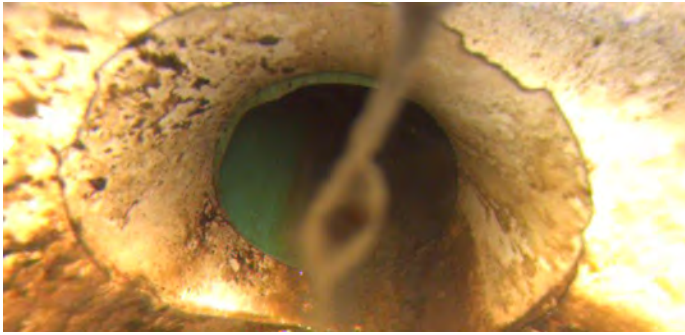
Code: **TF**
Description: **Tap Factory**

Distance (ft): **118.1**
Structural Grade: **0**
O&M Grade: **0**
Clock Start/From: **12**
Clock To:
1st Value: **4.000**
2nd Value:
Value Percent:
Continuous Index:
Within 8" of Joint:
Remarks:

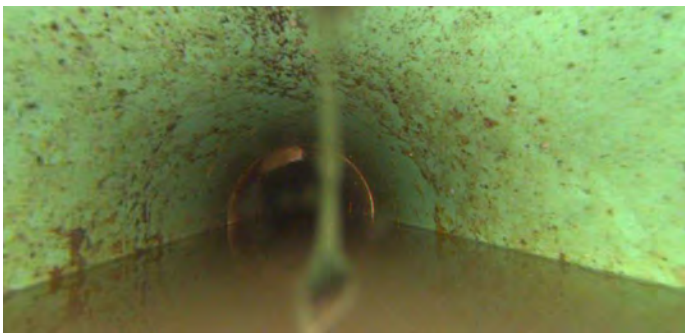
Code: **MWL**
Description: **Water Level**

Distance (ft): **161.7**
Structural Grade: **0**
O&M Grade: **0**
Clock Start/From:
Clock To:
1st Value:
2nd Value:
Value Percent: **40.000**
Continuous Index:
Within 8" of Joint: **NO**
Remarks:

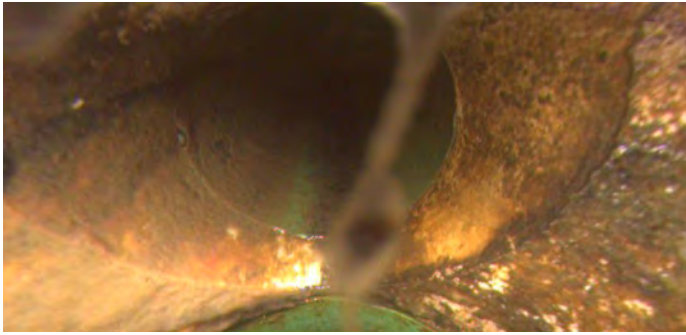
Code: **TF**
Description: **Tap Factory**

Distance (ft): **163.3**
Structural Grade: **0**
O&M Grade: **0**
Clock Start/From: **12**
Clock To:
1st Value: **4.000**
2nd Value:
Value Percent:
Continuous Index:
Within 8" of Joint:
Remarks:

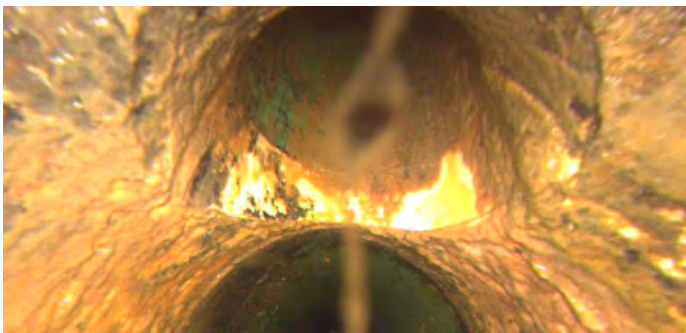
Code: **TF**
Description: **Tap Factory**

Distance (ft): **299.6**
Structural Grade: **0**
O&M Grade: **0**
Clock Start/From: **12**
Clock To:
1st Value: **4.000**
2nd Value:
Value Percent:
Continuous Index:
Within 8" of Joint:
Remarks:

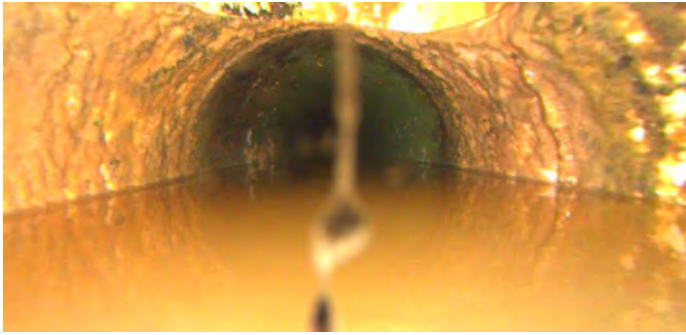
Code: **DAGS**
Description: **Deposits Attached Grease**

Distance (ft): **299.6**
Structural Grade: **0**
O&M Grade: **2**
Clock Start/From: **8**
Clock To: **4**
1st Value:
2nd Value:
Value Percent: **5.000**
Continuous Index:
Within 8" of Joint: **NO**
Remarks:

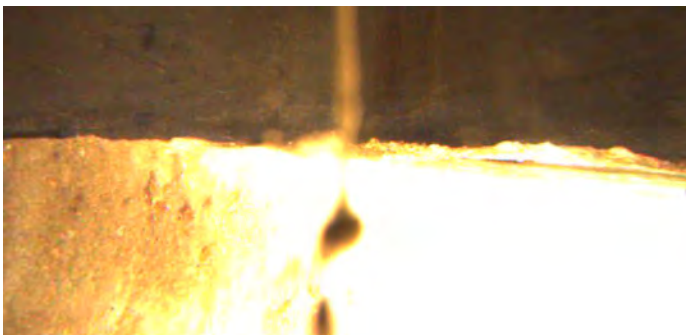
Code: **AMH**
Description: **Manhole**

Distance (ft): **353.3**
Structural Grade: **0**
O&M Grade: **0**
Clock Start/From:
Clock To:
1st Value:
2nd Value:
Value Percent:
Continuous Index:
Within 8" of Joint: **NO**
Remarks: **M-1006-003**
