Profile/Photo Observation Report

Date:	04/12/2018	Weather:		Coding:	PACP 6.0
Pipe Length (ft):	331.3	Owner:	NA	Pre Clean:	Not Known
P.O.#:		Surveyor:	Jen Costello	PSR:	P-1006-003-002
Customer:		Clean Date:	01/01/1900	Shape:	C

Street:	Capitol	Flow Control:	Not Controlled
City:	Hobart, IN	Year Renewed:	
Location:	Yard	Tape/Media #:	
Purpose:	Maintenance Related	Dia/Height:	8"
Use:	Sanitary	Material:	PVC
Drain Area:	NA	Lining:	Cured in Place
Category:	NA		
Comment:	flow incorrect.

Location Details:		Direction of Survey:	Downstream
US MH:	M-1006-002	DS MH:	M-1006-003
		Total Length Surveyed (ft):	353.3

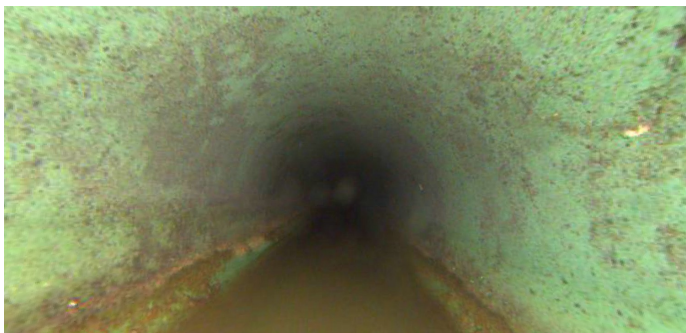
Code: **AMH**
Description: **Manhole**

Distance (ft): **.0**
Structural Grade: **0**
O&M Grade: **0**
Clock Start/From:
Clock To:
1st Value:
2nd Value:
Value Percent:
Continuous Index:
Within 8" of Joint: **NO**
Remarks: **M-1006-002**

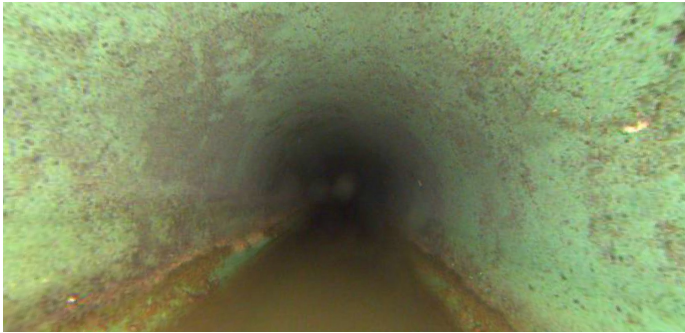
Code:	MWL
Description:	Water Level

Distance (ft):	.0
Structural Grade:	0
O&M Grade:	0
Clock Start/From:	
Clock To:	
1st Value:	
2nd Value:	
Value Percent:	5.000
Continuous Index:	
Within 8" of Joint:	NO
Remarks:

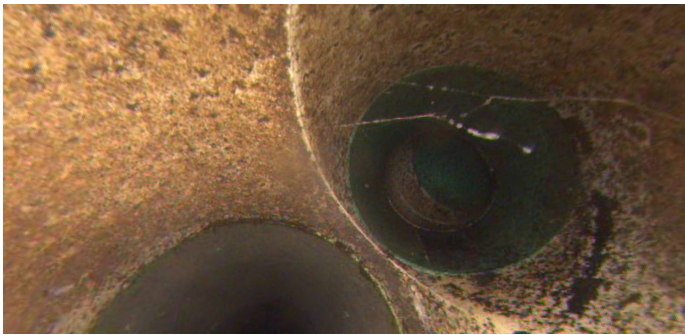
Code:	TF
Description:	Tap Factory

Distance (ft):	9.4
Structural Grade:	0
O&M Grade:	0
Clock Start/From:	10
Clock To:	
1st Value:	4.000
2nd Value:	
Value Percent:	
Continuous Index:	
Within 8" of Joint:	
Remarks:

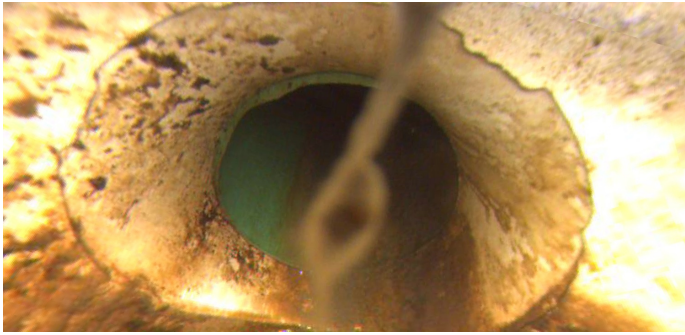
Code: **TF**
Description: **Tap Factory**

Distance (ft): **118.1**
Structural Grade: **0**
O&M Grade: **0**
Clock Start/From: **12**
Clock To:
1st Value: **4.000**
2nd Value:
Value Percent:
Continuous Index:
Within 8" of Joint:
Remarks:

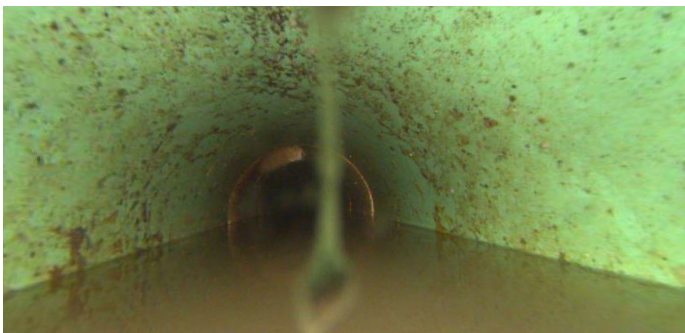
Code: **MWL**
Description: **Water Level**

Distance (ft): **161.7**
Structural Grade: **0**
O&M Grade: **0**
Clock Start/From:
Clock To:
1st Value:
2nd Value:
Value Percent: **40.000**
Continuous Index:
Within 8" of Joint: **NO**
Remarks:

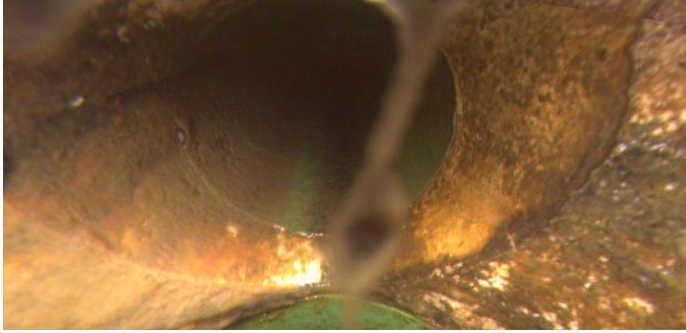
Code: **TF**
Description: **Tap Factory**

Distance (ft): **163.3**
Structural Grade: **0**
O&M Grade: **0**
Clock Start/From: **12**
Clock To:
1st Value: **4.000**
2nd Value:
Value Percent:
Continuous Index:
Within 8" of Joint:
Remarks:

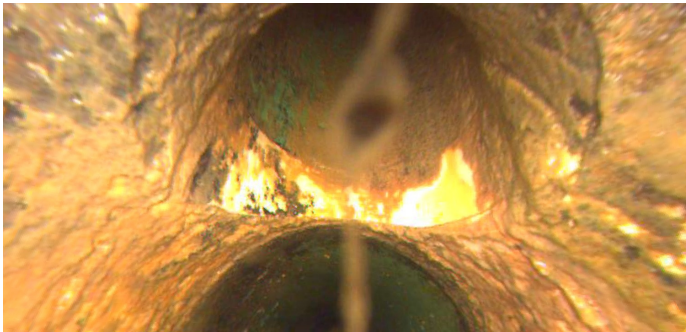
Code: **TF**
Description: **Tap Factory**

Distance (ft): **299.6**
Structural Grade: **0**
O&M Grade: **0**
Clock Start/From: **12**
Clock To:
1st Value: **4.000**
2nd Value:
Value Percent:
Continuous Index:
Within 8" of Joint:
Remarks:

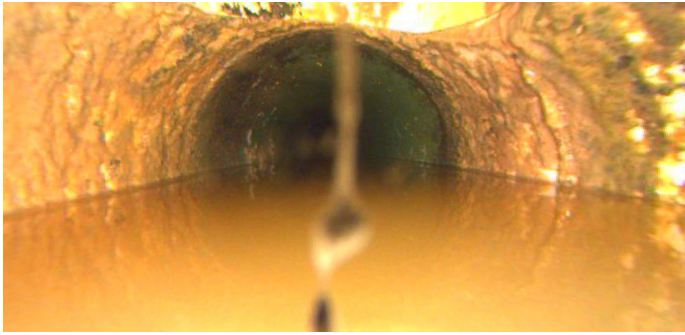
Code: **DAGS**
Description: **Deposits Attached Grease**

Distance (ft): **299.6**
Structural Grade: **0**
O&M Grade: **2**
Clock Start/From: **8**
Clock To: **4**
1st Value:
2nd Value:
Value Percent: **5.000**
Continuous Index:
Within 8" of Joint: **NO**
Remarks:

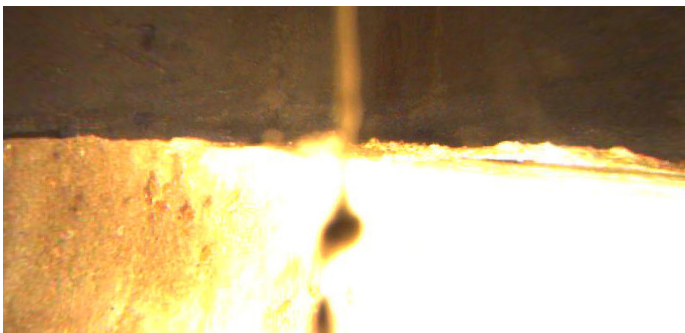
Code: **AMH**
Description: **Manhole**

Distance (ft): **353.3**
Structural Grade: **0**
O&M Grade: **0**
Clock Start/From:
Clock To:
1st Value:
2nd Value:
Value Percent:
Continuous Index:
Within 8" of Joint: **NO**
Remarks: **M-1006-003**
