Profile/Photo Observation Report

Date:	01/31/2023	Weather:		Coding:	PACP 7.0
Pipe Length (ft):	48.0	Owner:	City of Hobart	Pre Clean:	Heavy Cleaning
P.O.#:	YES502259	Surveyor:	S. Bucklin	PSR:	M-805-037.1-M-805-037
Customer:	City of Hobart	Clean Date:	11/30/2022	Shape:	C

Street:	South Liberty Place	Flow Control:	Not Controlled
City:	Hobart, IN	Year Renewed:	
Location:	Local rural streets with light traffic, t	Tape/Media #:	
Purpose:	Routine Assessment	Dia/Height:	12"
Use:	Sanitary Sewage Pipe	Material:	DIP
Drain Area:		Lining:	None
Category:	NA		
Comment:			
Location Details:		Direction of Survey:	Upstream
US MH:	M-805-037.1	DS MH:	M-805-037
		Total Length Surveyed (ft):	46.9

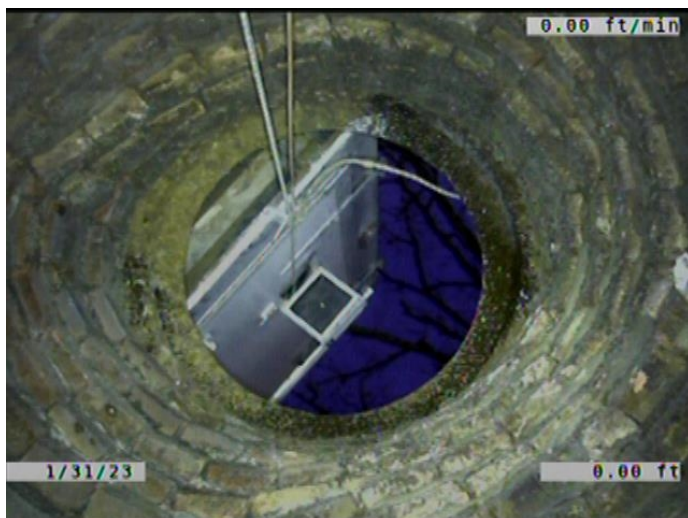
Code: **AMH**
Description: **Manhole**

Distance (ft): **.0**
Structural Grade: **0**
O&M Grade: **0**
Clock Start/From:
Clock To:
1st Value:
2nd Value:
Value Percent:
Continuous Index:
Within 8" of Joint: **NO**
Remarks: **M-805-037**

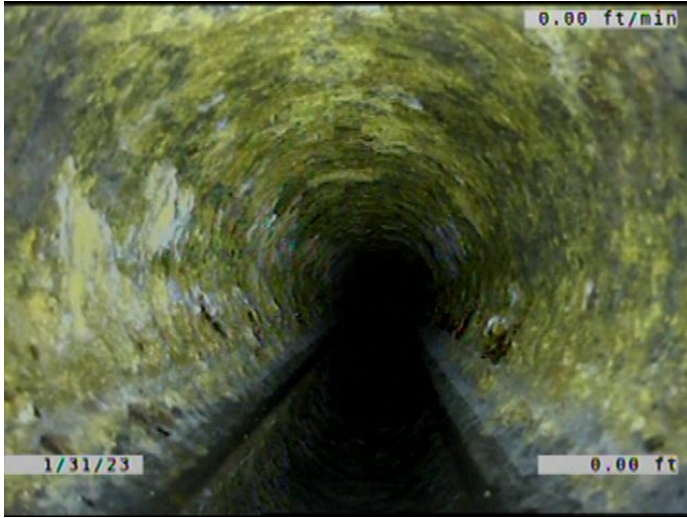
Code: **MWL**
Description: **Miscellaneous Water Level**

Distance (ft): **.0**
Structural Grade: **0**
O&M Grade: **0**
Clock Start/From:
Clock To:
1st Value:
2nd Value:
Value Percent: **5.000**
Continuous Index:
Within 8" of Joint: **NO**
Remarks:

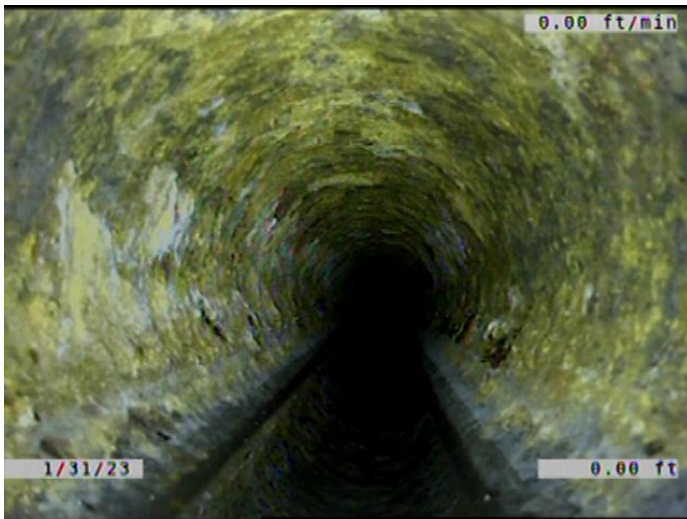
Code: **SSS**
Description: **Surface Damage Surface Spalling**

Distance (ft): **.0**
Structural Grade: **2**
O&M Grade: **0**
Clock Start/From: **7**
Clock To: **5**
1st Value:
2nd Value:
Value Percent:
Continuous Index: **S01**
Within 8" of Joint: **YES**
Remarks:

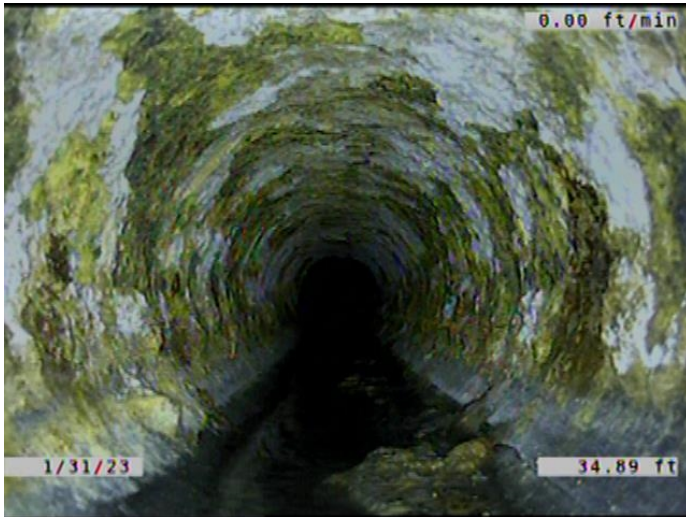
Code: **DSF**
 Description: **Deposits Settled Fine**

Distance (ft): **34.9**
 Structural Grade: **0**
 O&M Grade: **2**
 Clock Start/From: **5**
 Clock To: **7**
 1st Value:
 2nd Value:
 Value Percent: **5.000**
 Continuous Index: **S02**
 Within 8" of Joint: **YES**
 Remarks:

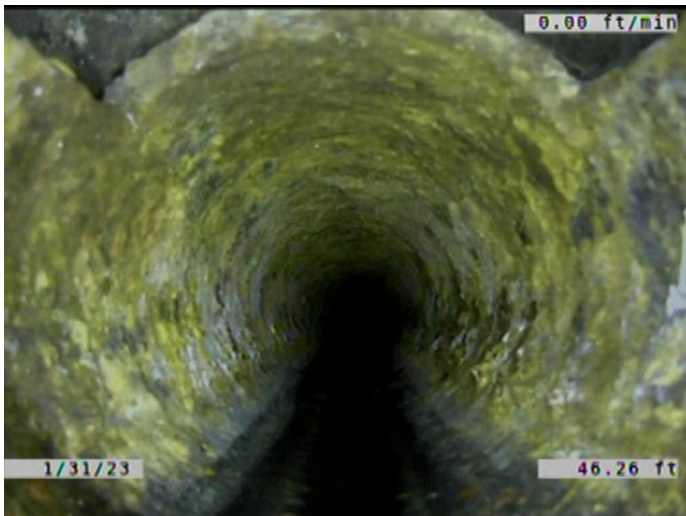
Code: **SSS**
 Description: **Surface Damage Surface Spalling**

Distance (ft): **46.3**
 Structural Grade: **2**
 O&M Grade: **0**
 Clock Start/From: **7**
 Clock To: **5**
 1st Value:
 2nd Value:
 Value Percent:
 Continuous Index: **F01**
 Within 8" of Joint: **YES**
 Remarks:

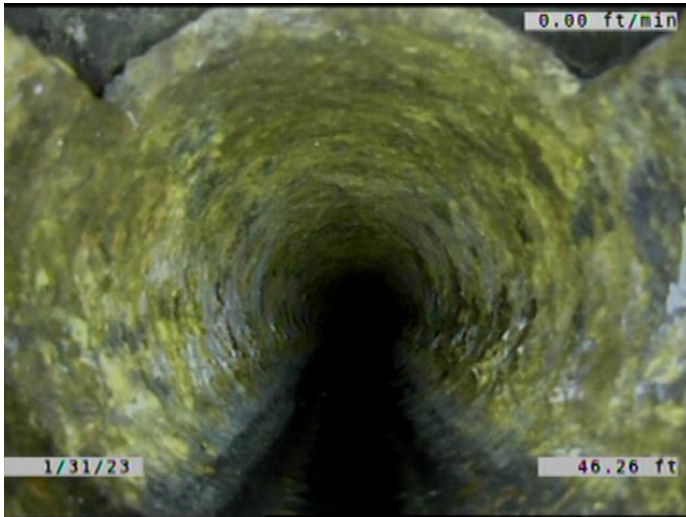
Code: **DSF**
 Description: **Deposits Settled Fine**

Distance (ft): **46.3**
 Structural Grade: **0**
 O&M Grade: **2**
 Clock Start/From: **5**
 Clock To: **7**
 1st Value:
 2nd Value:
 Value Percent: **5.000**
 Continuous Index: **F02**
 Within 8" of Joint: **YES**
 Remarks:

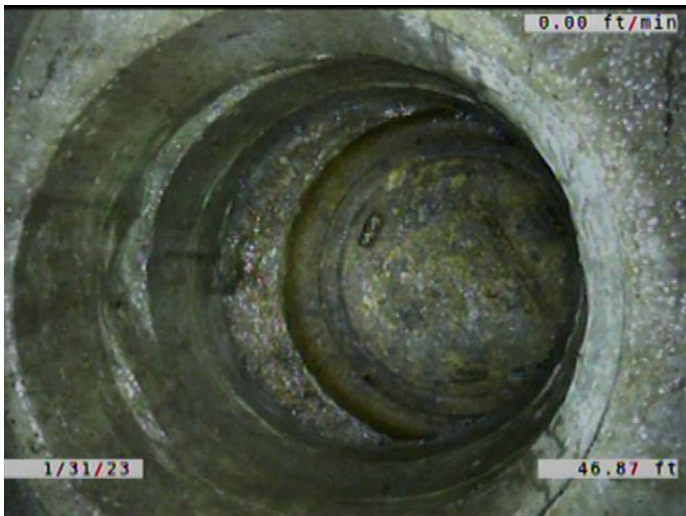
Code: **AMH**
 Description: **Manhole**

Distance (ft): **46.9**
 Structural Grade: **0**
 O&M Grade: **0**
 Clock Start/From:
 Clock To:
 1st Value:
 2nd Value:
 Value Percent:
 Continuous Index:
 Within 8" of Joint: **NO**
 Remarks: **M-805-037.1**
