Profile/Photo Observation Report

Date:	01/31/2023	Weather:		Coding:	PACP 7.0
Pipe Length (ft):	115.0	Owner:	City of Hobart	Pre Clean:	Heavy Cleaning
P.O.#:	YES502259	Surveyor:	S. Bucklin	PSR:	M-805-037.2-M-805-037.
Customer:	City of Hobart	Clean Date:	11/12/2022	Shape:	C

Street:	South Liberty Place	Flow Control:	Not Controlled
City:	Hobart, IN	Year Renewed:	
Location:	Local rural streets with light traffic, t	Tape/Media #:	
Purpose:	Routine Assessment	Dia/Height:	8"
Use:	Sanitary Sewage Pipe	Material:	PVC
Drain Area:		Lining:	None
Category:	NA

Location Details:		Direction of Survey:	Upstream
US MH:	M-805-037.2	DS MH:	M-805-037.1
		Total Length Surveyed (ft):	115.8

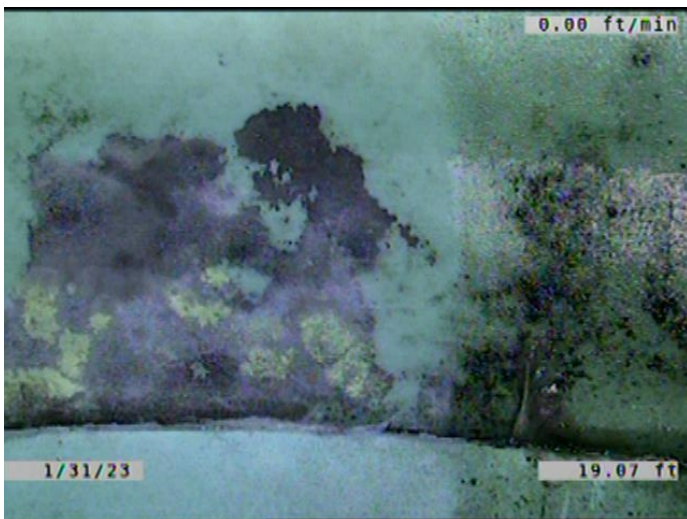
Code: **MGO**
Description: **Miscellaneous General Observation**

Distance (ft): **19.1**
Structural Grade: **0**
O&M Grade: **0**
Clock Start/From:
Clock To:
1st Value:
2nd Value:
Value Percent:
Continuous Index:
Within 8" of Joint: **NO**
Remarks: **JOINT/ PIPES NOT PUSHED ALL THE WAY TOGETHER WHEN INSTALLED**

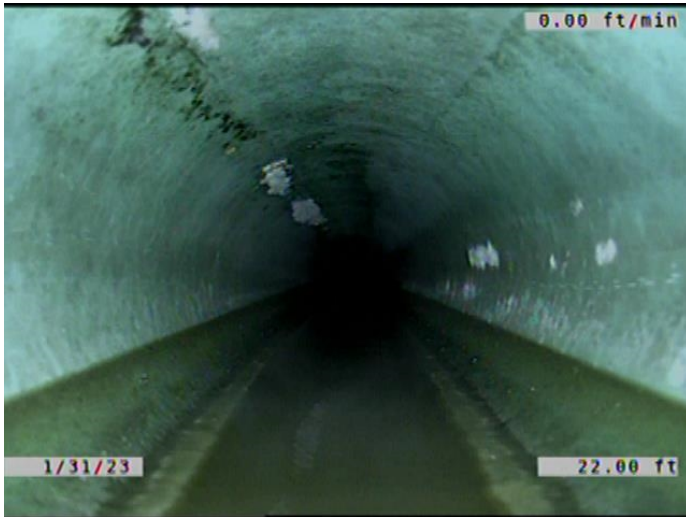
Code: **MWLS**
Description: **Miscellaneous Water Level Sag**

Distance (ft): **22.0**
Structural Grade: **2**
O&M Grade: **0**
Clock Start/From:
Clock To:
1st Value:
2nd Value:
Value Percent: **10.000**
Continuous Index: **S01**
Within 8" of Joint: **NO**
Remarks:

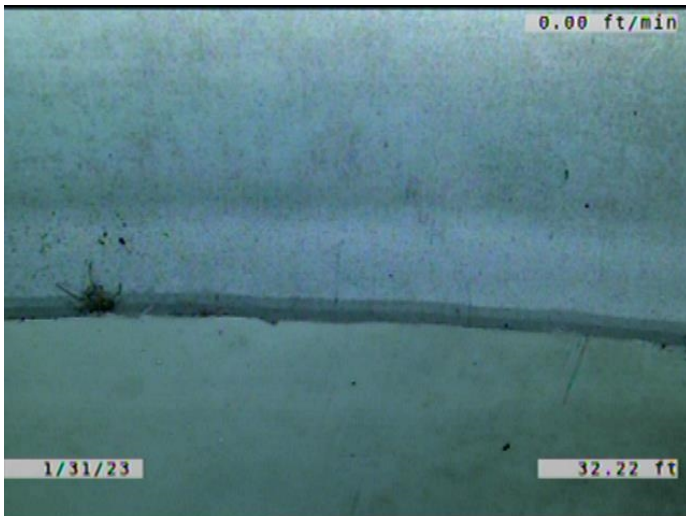
Code: **MGO**
Description: **Miscellaneous General Observation**

Distance (ft): **32.2**
Structural Grade: **0**
O&M Grade: **0**
Clock Start/From:
Clock To:
1st Value:
2nd Value:
Value Percent:
Continuous Index:
Within 8" of Joint: **NO**
Remarks: **JOINT/ PIPES NOT PUSHED ALL THE WAY TOGETHER WHEN INSTALLED**

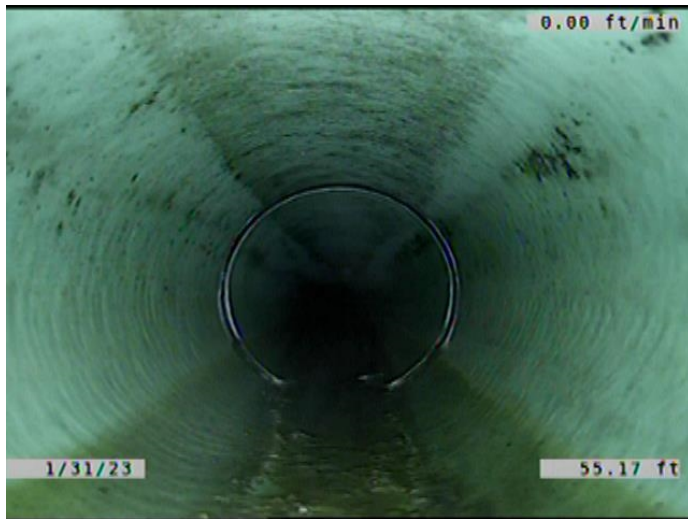
Code: **MWLS**
Description: **Miscellaneous Water Level Sag**

Distance (ft): **55.2**
Structural Grade: **2**
O&M Grade: **0**
Clock Start/From:
Clock To:
1st Value:
2nd Value:
Value Percent: **10.000**
Continuous Index: **F01**
Within 8" of Joint: **NO**
Remarks:

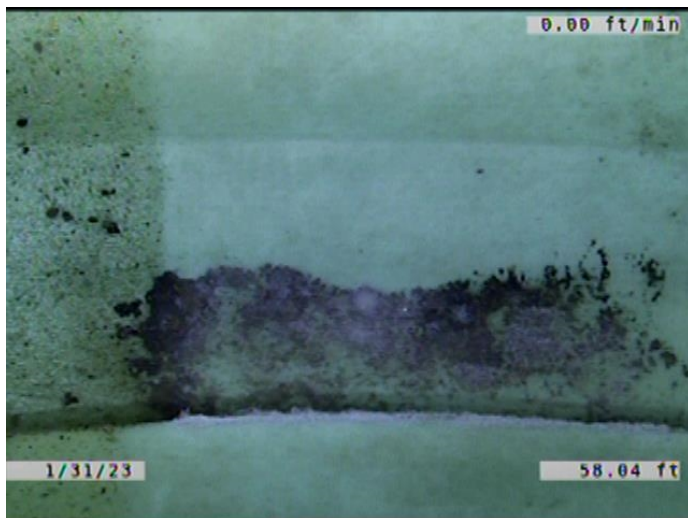
Code: **MGO**
Description: **Miscellaneous General Observation**

Distance (ft): **58.0**
Structural Grade: **0**
O&M Grade: **0**
Clock Start/From:
Clock To:
1st Value:
2nd Value:
Value Percent:
Continuous Index:
Within 8" of Joint: **NO**
Remarks: **JOINT/ PIPES NOT PUSHED ALL THE WAY TOGETHER WHEN INSTALLED**

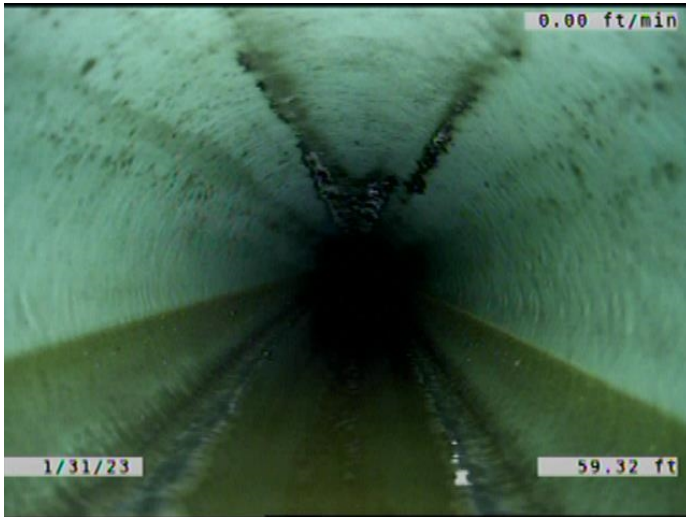
Code: **MWLS**
 Description: **Miscellaneous Water Level Sag**

Distance (ft): **59.3**
 Structural Grade: **2**
 O&M Grade: **0**
 Clock Start/From:
 Clock To:
 1st Value:
 2nd Value:
 Value Percent: **5.000**
 Continuous Index: **S02**
 Within 8" of Joint: **NO**
 Remarks:

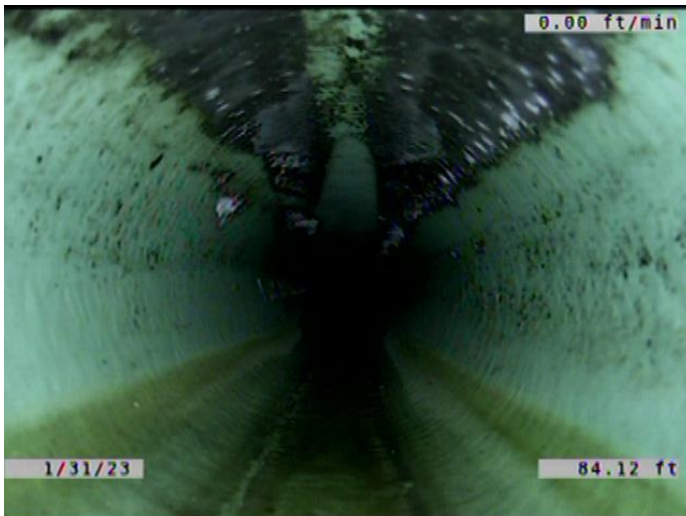
Code: **MWLS**
 Description: **Miscellaneous Water Level Sag**

Distance (ft): **84.1**
 Structural Grade: **2**
 O&M Grade: **0**
 Clock Start/From:
 Clock To:
 1st Value:
 2nd Value:
 Value Percent: **5.000**
 Continuous Index: **F02**
 Within 8" of Joint: **NO**
 Remarks:

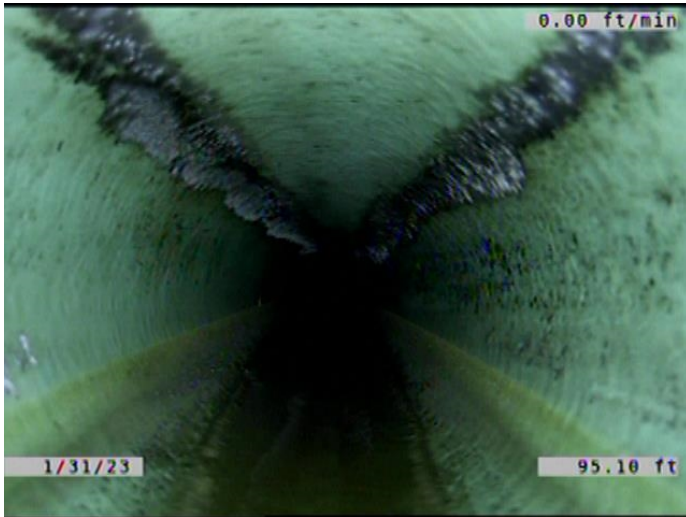
Code: **MWLS**
Description: **Miscellaneous Water Level Sag**

Distance (ft): **95.1**
Structural Grade: **2**
O&M Grade: **0**
Clock Start/From:
Clock To:
1st Value:
2nd Value:
Value Percent: **10.000**
Continuous Index: **S03**
Within 8" of Joint: **NO**
Remarks:

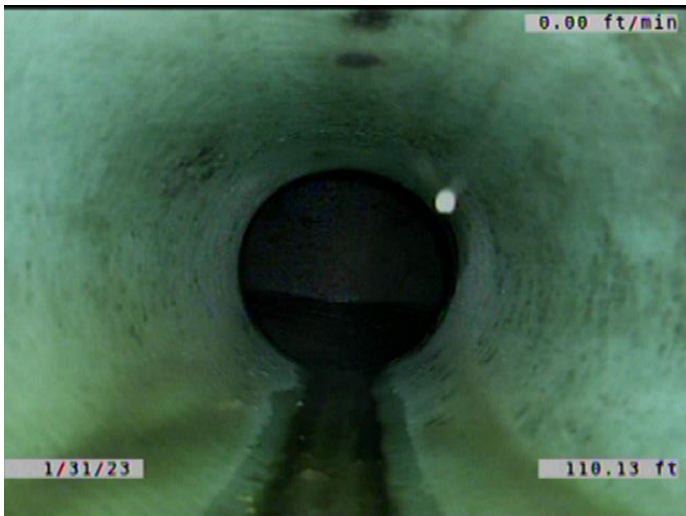
Code: **MWLS**
Description: **Miscellaneous Water Level Sag**

Distance (ft): **110.1**
Structural Grade: **2**
O&M Grade: **0**
Clock Start/From:
Clock To:
1st Value:
2nd Value:
Value Percent: **10.000**
Continuous Index: **F03**
Within 8" of Joint: **NO**
Remarks:

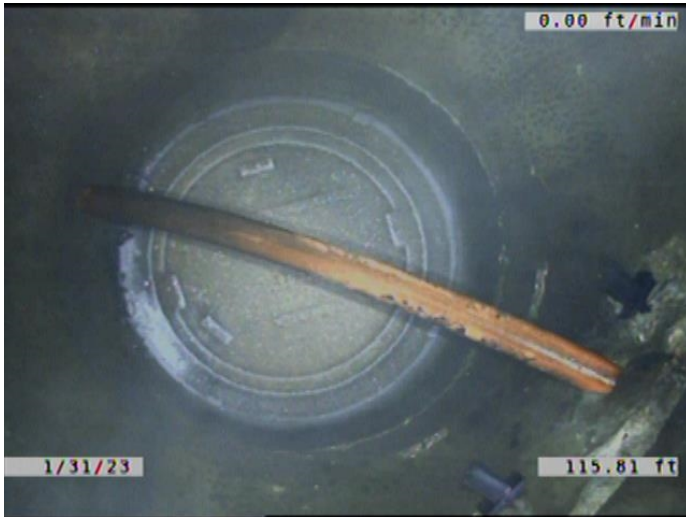
Code:	MGO
Description:	Miscellaneous General Observation
Distance (ft):	115.8
Structural Grade:	0
O&M Grade:	0
Clock Start/From:	
Clock To:	
1st Value:	
2nd Value:	
Value Percent:	
Continuous Index:	
Within 8" of Joint:	NO
Remarks:	LOOKS TO BE FIBER OPTIC CROSS BORED THROUGH THE MANHOLE.
