Profile/Photo Observation Report

Date:	09/10/2022	Weather:		Coding:	PACP 7.0
Pipe Length (ft):	139.0	Owner:	City of Hobart	Pre Clean:	Heavy Cleaning
P.O.#:	YES502259	Surveyor:	S. Bucklin	PSR:	M-907-009.1-M-907.009.
Customer:	City of Hobart	Clean Date:	08/22/2022	Shape:	C

Street:	South Union Street	Flow Control:	Not Controlled
City:	Hobart, IN	Year Renewed:	
Location:	Easement/Right of Way	Tape/Media #:	
Purpose:	Routine Assessment	Dia/Height:	8"
Use:	Sanitary Sewage Pipe	Material:	PVC
Drain Area:		Lining:	None
Category:	NA		
Comment:

Location Details:	EAST OF THE DRIVE WAY CONNECTI	Direction of Survey:	Upstream		
US MH:	M-907-009.1	DS MH:	M-907.009.2	Total Length Surveyed (ft):	139.3

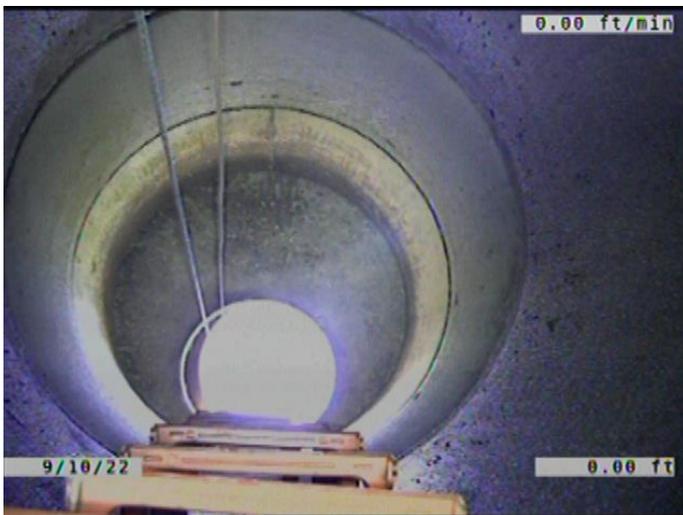
Code: **AMH**
Description: **Manhole**

Distance (ft): **.0**
Structural Grade: **0**
O&M Grade: **0**
Clock Start/From:
Clock To:
1st Value:
2nd Value:
Value Percent:
Continuous Index:
Within 8" of Joint: **NO**
Remarks: **M-907.009.2**

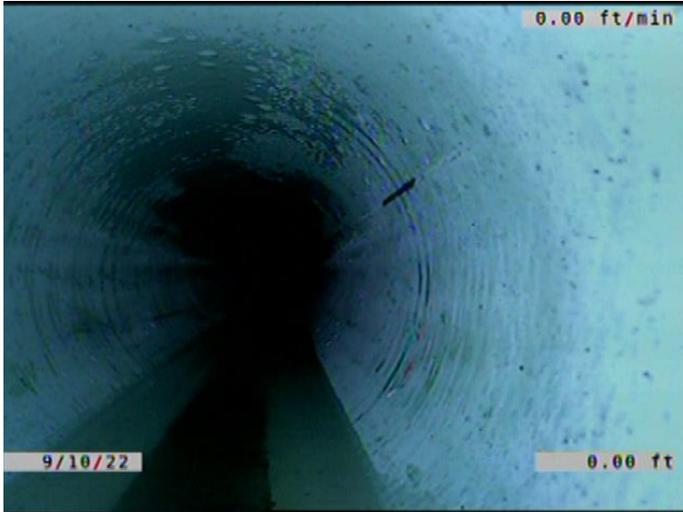
Code: **MWL**
Description: **Miscellaneous Water Level**

Distance (ft): **.0**
Structural Grade: **0**
O&M Grade: **0**
Clock Start/From:
Clock To:
1st Value:
2nd Value:
Value Percent: **5.000**
Continuous Index:
Within 8" of Joint: **NO**
Remarks:

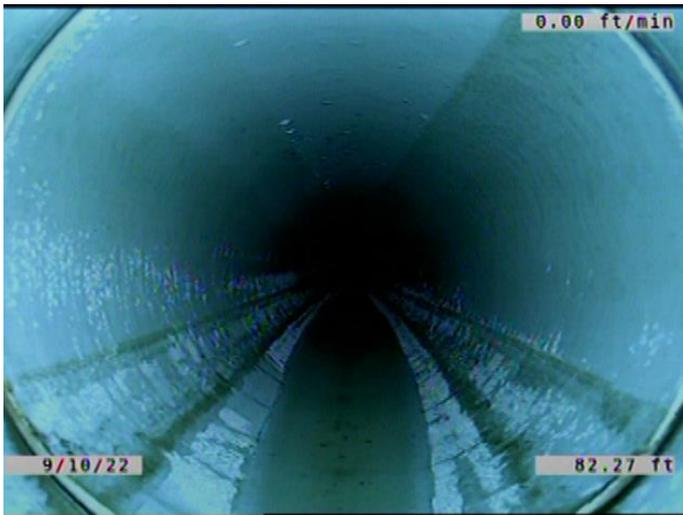
Code: **MWLS**
Description: **Miscellaneous Water Level Sag**

Distance (ft): **82.3**
Structural Grade: **2**
O&M Grade: **0**
Clock Start/From:
Clock To:
1st Value:
2nd Value:
Value Percent: **5.000**
Continuous Index: **S01**
Within 8" of Joint: **NO**
Remarks:

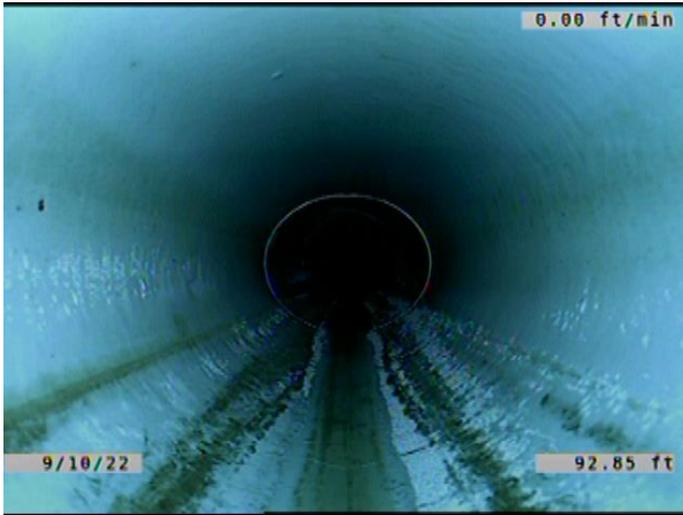
Code: **MWLS**
Description: **Miscellaneous Water Level Sag**

Distance (ft): **92.9**
Structural Grade: **2**
O&M Grade: **0**
Clock Start/From:
Clock To:
1st Value:
2nd Value:
Value Percent: **5.000**
Continuous Index: **F01**
Within 8" of Joint: **NO**
Remarks:

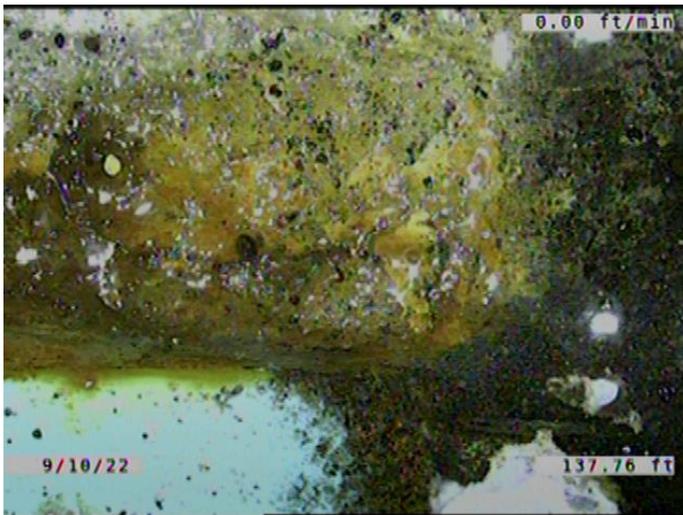
Code: **DAE**
Description: **Deposits Attached Encrustation**

Distance (ft): **137.8**
Structural Grade: **0**
O&M Grade: **2**
Clock Start/From: **1**
Clock To: **11**
1st Value:
2nd Value:
Value Percent: **5.000**
Continuous Index:
Within 8" of Joint: **YES**
Remarks:

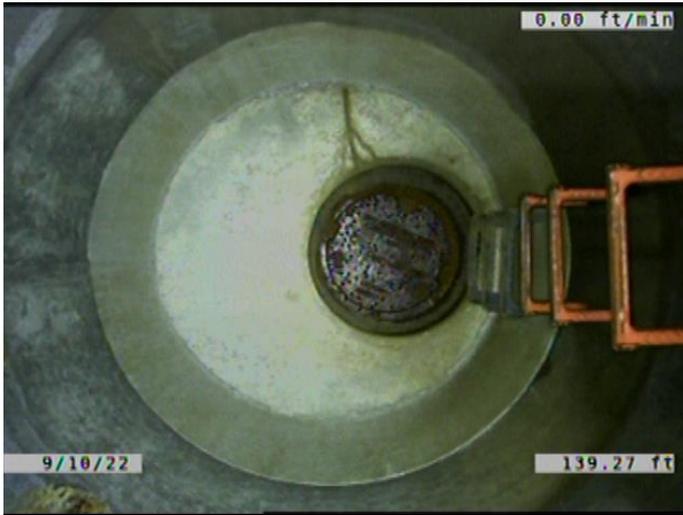
Code: **AMH**
Description: **Manhole**

Distance (ft): **139.3**
Structural Grade: **0**
O&M Grade: **0**
Clock Start/From:
Clock To:
1st Value:
2nd Value:
Value Percent:
Continuous Index:
Within 8" of Joint: **NO**
Remarks: **M-907-009.1**
