Profile/Photo Observation Report

Date: Pipe Length (ft)		Weather:		Coding:	DAGD C O
P.O.#:	264	Owner: Surveyor:	City of Hobart B. Helbling	Pre Clean: PSR:	PACP 6.0 Not Known P-1006-011-012
Customer:	City of Hobart	Clean Date:		Shape:	С
Street:	East State Rt 130		Flow Control:	Not Controlled	
City:	Hobart, IN		Year Renewed:		
Location:	Yard		Tape/Media #:	DEP264	
Purpose:	Routine Assessment		Dia/Height:	15"	
Use:	Sanitary		Material:	PVC	
Drain Area:			Lining:		
Category:	NA				
Comment:	5-21-2018				
Location Detail	s:		Direction of Survey:	Upstream	
US MH:	M-1006-012	DS MH:	M-1006-011	Total Length Surveyed (ft)	: 55.5
O&M Index:	0.00	O&M Quick:	0000	O&M Rating:	0.00
Structural Index:	0.00	 _Structural Qu	uick: 0000	Structural Rating:	0.00

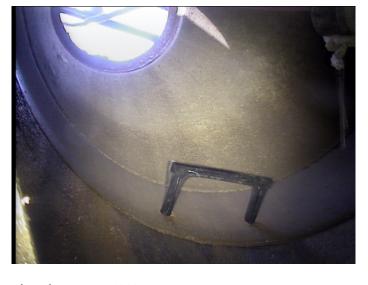
Code:

Description:	Manhole
Distance (ft)	
Distance (ft):	.0
Structural Grade:	0
O&M Grade:	0
Clock Start/From:	
Clock To:	
1st Value:	
2nd Value:	
Value Percent:	
Continuous Index:	
Within 8" of Joint:	NO
Remarks:	M-1006-012

AMH

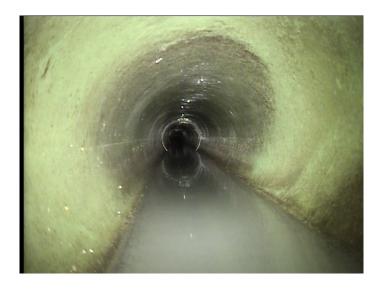
Code: MWL

Description: Water Level

Distance (ft): .0
Structural Grade: 0
O&M Grade: 0

Value Percent: 5.000

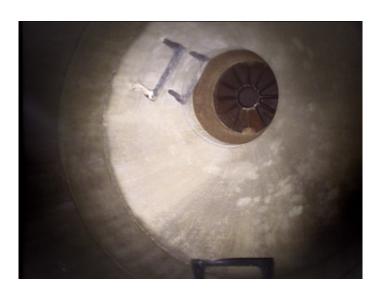
Code: AMH
Description: Manhole

Distance (ft): 55.5
Structural Grade: 0
O&M Grade: 0
Clock Start/From:

Remarks: M-1006-011
