Profile/Photo Observation Report

Street:	East State Road 130	Flow Control:	Not Controlled
City:	Hobart, IN	Year Renewed:	
Location:	Yard	Tape/Media #:	DEP266
Purpose:	Routine Assessment	Dia/Height:	15"
Use:	Sanitary	Material:	PVC
Drain Area:		Lining:	
Category:	NA		
Comment:	5-21-2018		
Location Details:		Direction of Survey:	Upstream
US MH:	M-1006-014	DS MH:	M-1006-013
		Total Length Surveyed (ft):	3.5

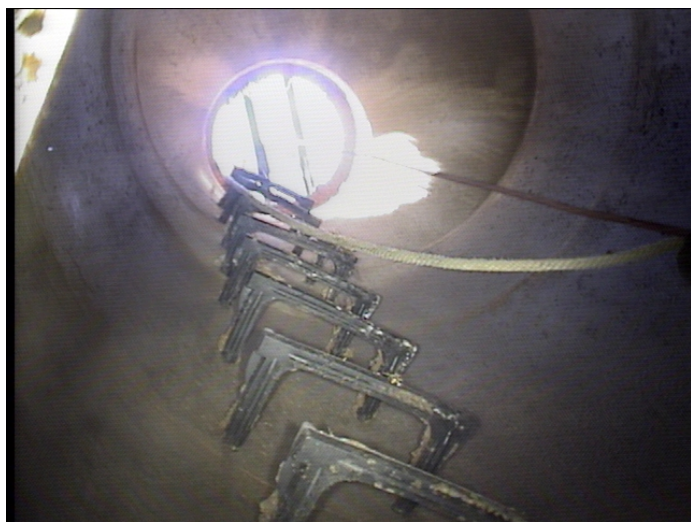
Code: **AMH**
Description: **Manhole**

Distance (ft): **.0**
Structural Grade: **0**
O&M Grade: **0**
Clock Start/From:
Clock To:
1st Value:
2nd Value:
Value Percent:
Continuous Index:
Within 8" of Joint: **NO**
Remarks: **M-1006-014**

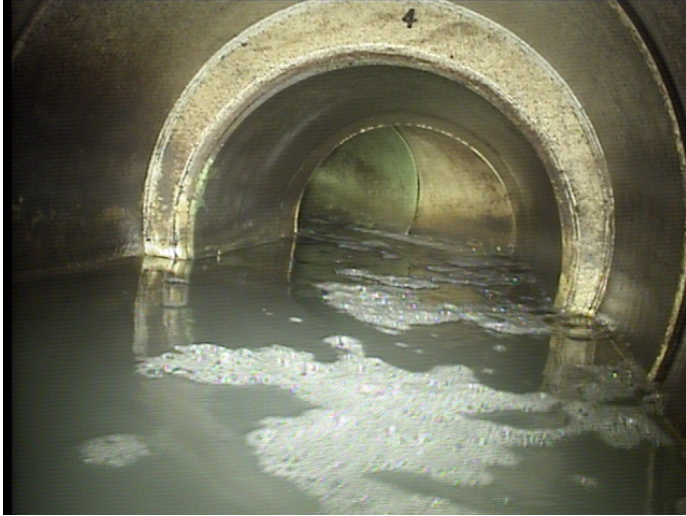
Code: **MWL**
Description: **Water Level**

Distance (ft): **.0**
Structural Grade: **0**
O&M Grade: **0**
Clock Start/From:
Clock To:
1st Value:
2nd Value:
Value Percent: **15.000**
Continuous Index:
Within 8" of Joint: **NO**
Remarks:

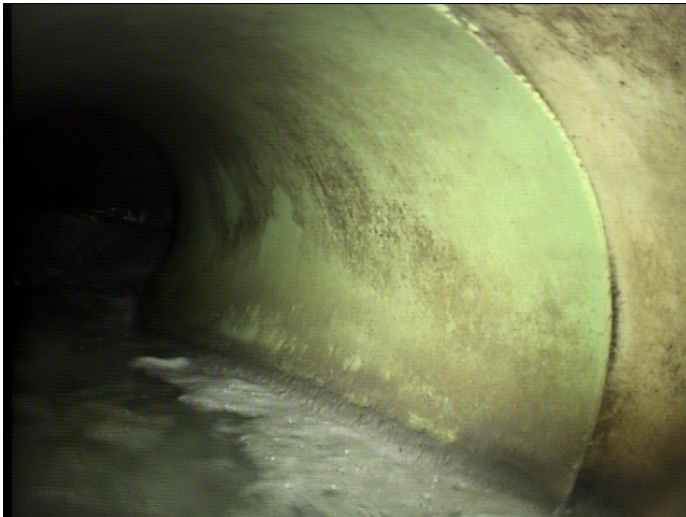
Code: **LL**
Description: **Alignment Left**

Distance (ft): **3.5**
Structural Grade: **0**
O&M Grade: **4**
Clock Start/From:
Clock To:
1st Value:
2nd Value:
Value Percent: **50.000**
Continuous Index:
Within 8" of Joint: **NO**
Remarks:

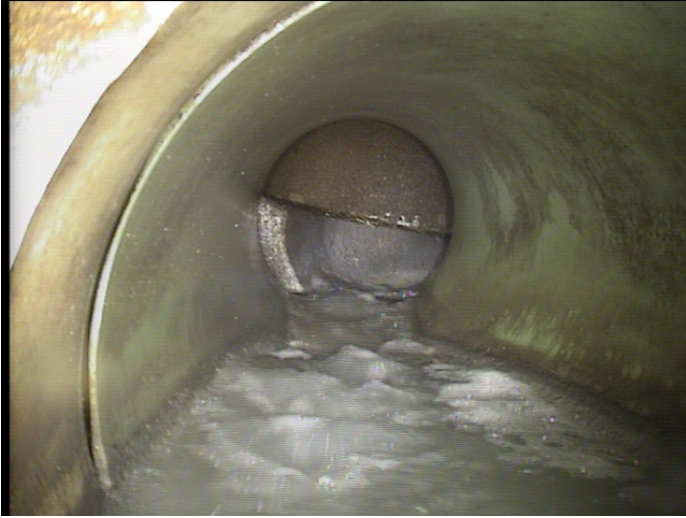
Code:	AMH
Description:	Manhole
Distance (ft):	3.5
Structural Grade:	0
O&M Grade:	0
Clock Start/From:	
Clock To:	
1st Value:	
2nd Value:	
Value Percent:	
Continuous Index:	
Within 8" of Joint:	NO
Remarks:	M-1006-013
