## Profile/Photo Observation Report

Street:	<b>OFF HOWARD ST</b>	Flow Control:	<b>Not Controlled</b>
City:	<b>Hobart, IN</b>	Year Renewed:	
Location:	<b>Light Highway</b>	Tape/Media #:	
Purpose:	<b>Routine Assessment</b>	Dia/Height:	<b>10"</b>
Use:	<b>Sanitary</b>	Material:	<b>VCP</b>
Drain Area:	<b>NA</b>	Lining:	
Category:	<b>NA</b>		
Comment:

Location Details:		Direction of Survey:	<b>Upstream</b>
US MH:	<b>M-103-002</b>	DS MH:	<b>M-103-001</b>
		Total Length Surveyed (ft):	<b>243.9</b>

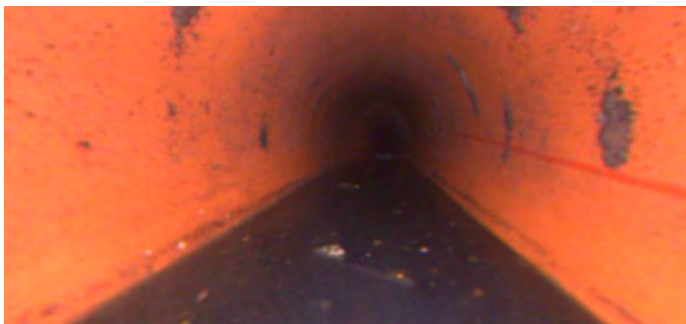
Code: **AMH**  
Description: **Manhole**

Distance (ft): **.0**  
Structural Grade: **0**  
O&M Grade: **0**  
Clock Start/From:  
Clock To:  
1st Value:  
2nd Value:  
Value Percent:  
Continuous Index:  
Within 8" of Joint: **NO**  
Remarks: **M-103-001**

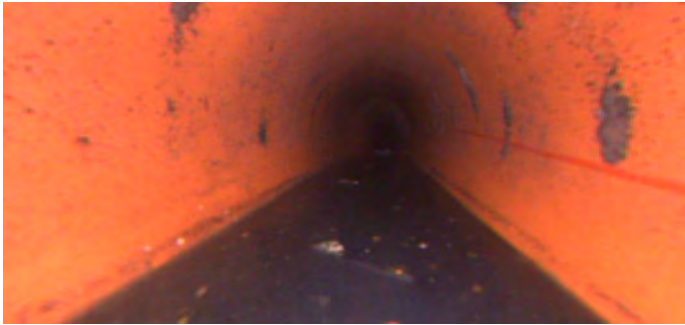
Code:	<b>MWL</b>
Description:	<b>Water Level</b>

Distance (ft):	<b>.0</b>
Structural Grade:	<b>0</b>
O&M Grade:	<b>0</b>
Clock Start/From:	
Clock To:	
1st Value:	
2nd Value:	
Value Percent:	<b>10.000</b>
Continuous Index:	
Within 8" of Joint:	<b>NO</b>
Remarks:

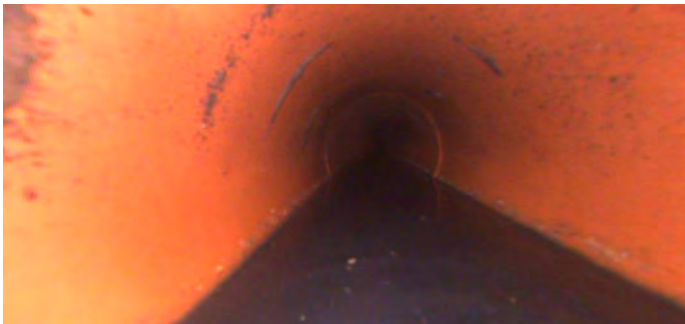
Code:	<b>DAZ</b>
Description:	<b>Deposits Attached Other</b>

Distance (ft):	<b>13.1</b>
Structural Grade:	<b>0</b>
O&M Grade:	<b>2</b>
Clock Start/From:	<b>7</b>
Clock To:	<b>5</b>
1st Value:	
2nd Value:	
Value Percent:	<b>5.000</b>
Continuous Index:	<b>S01</b>
Within 8" of Joint:	<b>YES</b>
Remarks:	<b>WANDER</b>

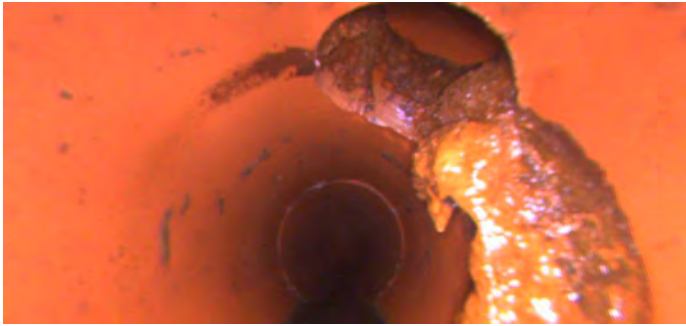
Code: **TF**  
Description: **Tap Factory**

Distance (ft): **35.4**  
Structural Grade: **0**  
O&M Grade: **0**  
Clock Start/From: **1**  
Clock To:  
1st Value: **4.000**  
2nd Value:  
Value Percent:  
Continuous Index:  
Within 8" of Joint:  
Remarks:

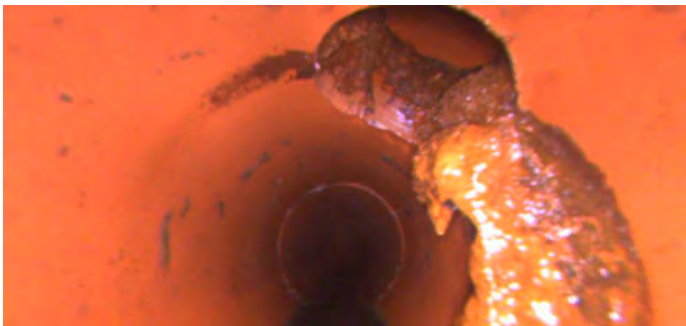
Code: **DAE**  
Description: **Deposits Attached Encrustation**

Distance (ft): **35.4**  
Structural Grade: **0**  
O&M Grade: **2**  
Clock Start/From: **1**  
Clock To: **5**  
1st Value:  
2nd Value:  
Value Percent: **10.000**  
Continuous Index:  
Within 8" of Joint: **NO**  
Remarks:

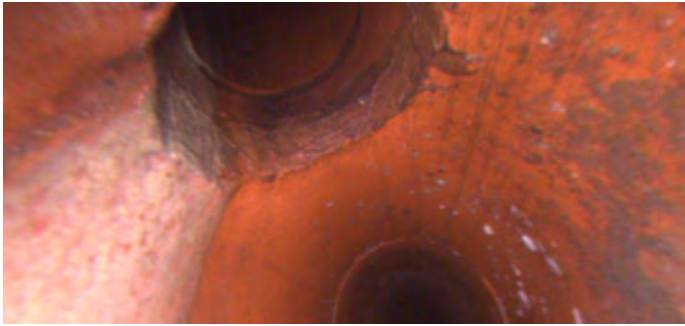
Code: **TF**  
Description: **Tap Factory**

Distance (ft): **42.7**  
Structural Grade: **0**  
O&M Grade: **0**  
Clock Start/From: **11**  
Clock To:  
1st Value: **4.000**  
2nd Value:  
Value Percent:  
Continuous Index:  
Within 8" of Joint:  
Remarks:

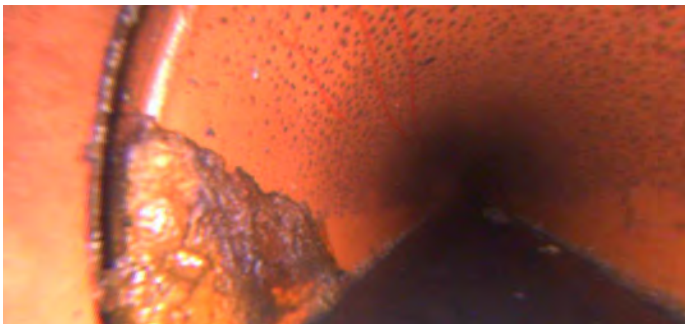
Code: **DAE**  
Description: **Deposits Attached Encrustation**

Distance (ft): **79.2**  
Structural Grade: **0**  
O&M Grade: **2**  
Clock Start/From: **7**  
Clock To: **8**  
1st Value:  
2nd Value:  
Value Percent: **5.000**  
Continuous Index:  
Within 8" of Joint: **YES**  
Remarks:

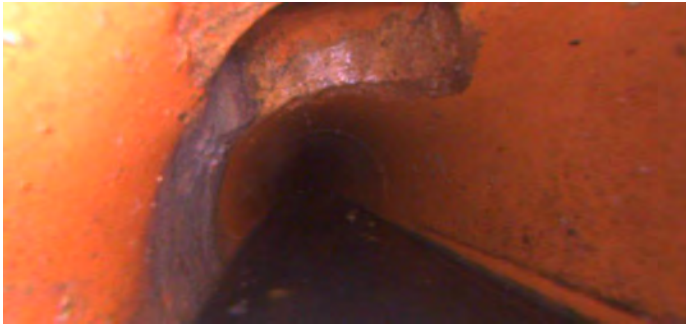
Code: **TF**  
Description: **Tap Factory**

Distance (ft): **99.7**  
Structural Grade: **0**  
O&M Grade: **0**  
Clock Start/From: **11**  
Clock To:  
1st Value: **4.000**  
2nd Value:  
Value Percent:  
Continuous Index:  
Within 8" of Joint:  
Remarks:

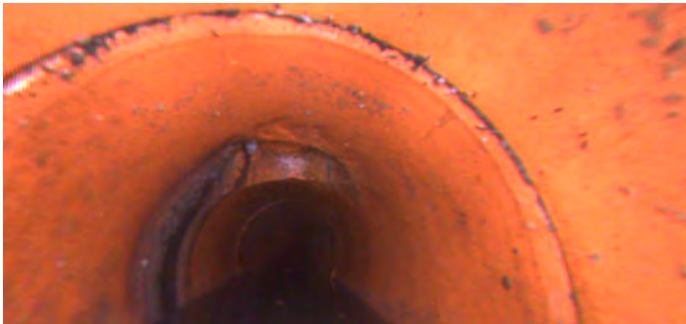
Code: **TF**  
Description: **Tap Factory**

Distance (ft): **136.8**  
Structural Grade: **0**  
O&M Grade: **0**  
Clock Start/From: **12**  
Clock To:  
1st Value: **4.000**  
2nd Value:  
Value Percent:  
Continuous Index:  
Within 8" of Joint:  
Remarks:

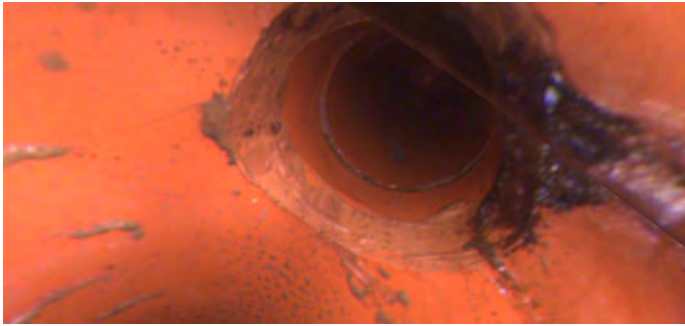
Code: **TF**  
Description: **Tap Factory**

Distance (ft): **160.1**  
Structural Grade: **0**  
O&M Grade: **0**  
Clock Start/From: **1**  
Clock To:  
1st Value: **4.000**  
2nd Value:  
Value Percent:  
Continuous Index:  
Within 8" of Joint:  
Remarks:

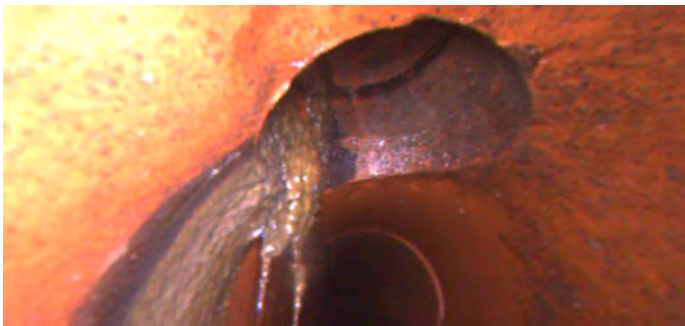
Code: **TF**  
Description: **Tap Factory**

Distance (ft): **197.6**  
Structural Grade: **0**  
O&M Grade: **0**  
Clock Start/From: **11**  
Clock To:  
1st Value: **4.000**  
2nd Value:  
Value Percent:  
Continuous Index:  
Within 8" of Joint:  
Remarks:

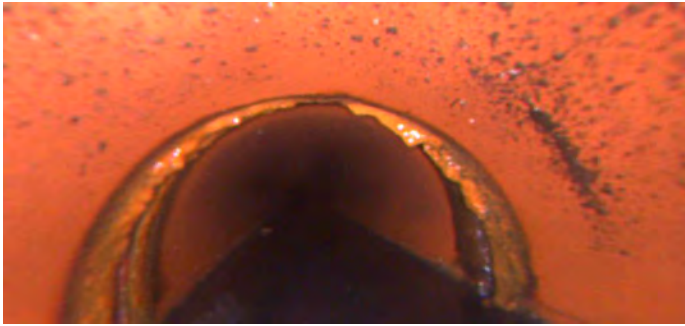
Code: **DAE**  
Description: **Deposits Attached Encrustation**

Distance (ft): **208.5**  
Structural Grade: **0**  
O&M Grade: **2**  
Clock Start/From: **7**  
Clock To: **5**  
1st Value:  
2nd Value:  
Value Percent: **5.000**  
Continuous Index:  
Within 8" of Joint: **YES**  
Remarks:

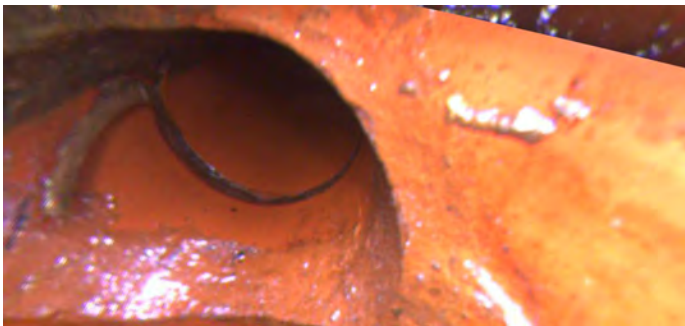
Code: **TF**  
Description: **Tap Factory**

Distance (ft): **235.0**  
Structural Grade: **0**  
O&M Grade: **0**  
Clock Start/From: **12**  
Clock To:  
1st Value: **4.000**  
2nd Value:  
Value Percent:  
Continuous Index:  
Within 8" of Joint:  
Remarks:

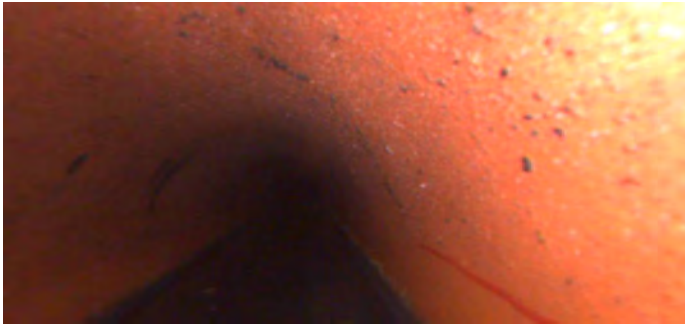
Code: **MSA**  
Description: **Abandoned Survey**

Distance (ft): **243.9**  
Structural Grade: **0**  
O&M Grade: **0**  
Clock Start/From:  
Clock To:  
1st Value:  
2nd Value:  
Value Percent:  
Continuous Index:  
Within 8" of Joint: **NO**  
Remarks: **ROBOT HAS STOPPED**

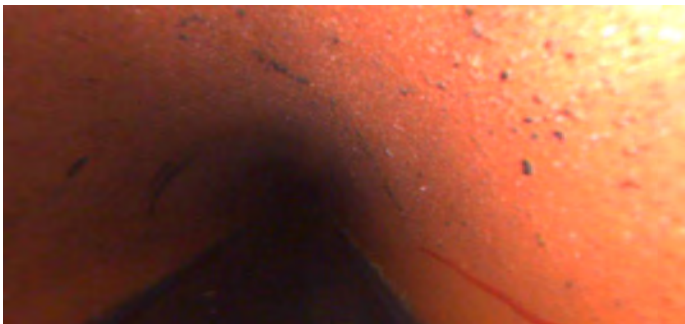
Code: **DAZ**  
Description: **Deposits Attached Other**

Distance (ft): **243.9**  
Structural Grade: **0**  
O&M Grade: **2**  
Clock Start/From: **7**  
Clock To: **5**  
1st Value:  
2nd Value:  
Value Percent: **5.000**  
Continuous Index: **F01**  
Within 8" of Joint: **YES**  
Remarks: **WANDER**
