## Profile/Photo Observation Report

Street:	<b>Howard St.</b>	Flow Control:	<b>Not Controlled</b>
City:	<b>Hobart, IN</b>	Year Renewed:	
Location:	<b>Light Highway</b>	Tape/Media #:	
Purpose:	<b>Routine Assessment</b>	Dia/Height:	<b>10"</b>
Use:	<b>Sanitary</b>	Material:	<b>VCP</b>
Drain Area:	<b>NA</b>	Lining:	
Category:	<b>NA</b>		
Comment:

Location Details:		Direction of Survey:	<b>Upstream</b>
US MH:	<b>M-103-002</b>	DS MH:	<b>M-103-001</b>
		Total Length Surveyed (ft):	<b>243.9</b>

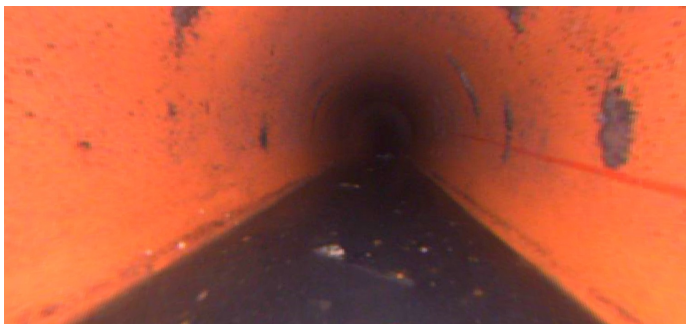
Code: **AMH**  
Description: **Manhole**

Distance (ft): **.0**  
Structural Grade: **0**  
O&M Grade: **0**  
Clock Start/From:  
Clock To:  
1st Value:  
2nd Value:  
Value Percent:  
Continuous Index:  
Within 8" of Joint: **NO**  
Remarks: **M-103-001**

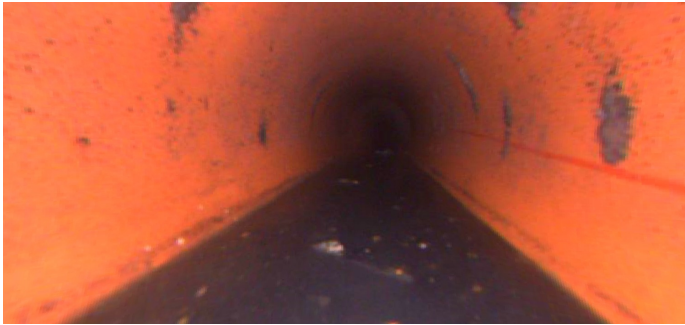
Code:	<b>MWL</b>
Description:	<b>Water Level</b>

Distance (ft):	<b>.0</b>
Structural Grade:	<b>0</b>
O&M Grade:	<b>0</b>
Clock Start/From:	
Clock To:	
1st Value:	
2nd Value:	
Value Percent:	<b>10.000</b>
Continuous Index:	
Within 8" of Joint:	<b>NO</b>
Remarks:

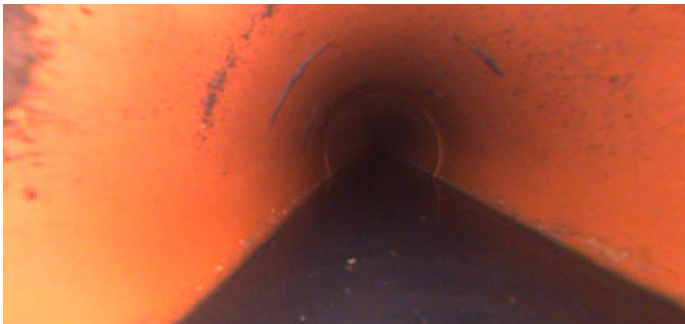
Code:	<b>DAZ</b>
Description:	<b>Deposits Attached Other</b>

Distance (ft):	<b>13.1</b>
Structural Grade:	<b>0</b>
O&M Grade:	<b>2</b>
Clock Start/From:	<b>7</b>
Clock To:	<b>5</b>
1st Value:	
2nd Value:	
Value Percent:	<b>5.000</b>
Continuous Index:	<b>S01</b>
Within 8" of Joint:	<b>YES</b>
Remarks:	<b>WANDER</b>

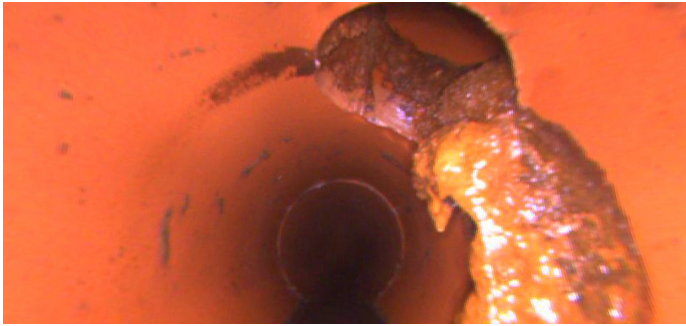
Code: **TF**  
Description: **Tap Factory**

Distance (ft): **35.4**  
Structural Grade: **0**  
O&M Grade: **0**  
Clock Start/From: **1**  
Clock To:  
1st Value: **4.000**  
2nd Value:  
Value Percent:  
Continuous Index:  
Within 8" of Joint:  
Remarks:

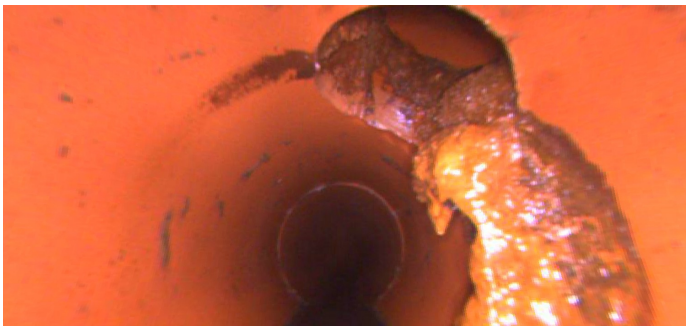
Code: **DAE**  
Description: **Deposits Attached Encrustation**

Distance (ft): **35.4**  
Structural Grade: **0**  
O&M Grade: **2**  
Clock Start/From: **1**  
Clock To: **5**  
1st Value:  
2nd Value:  
Value Percent: **10.000**  
Continuous Index:  
Within 8" of Joint: **NO**  
Remarks:

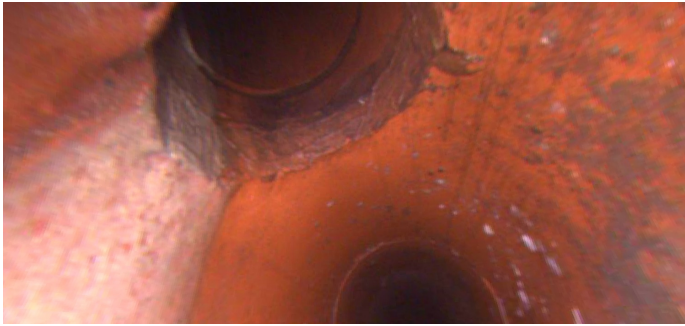
Code: **TF**  
Description: **Tap Factory**

Distance (ft): **42.7**  
Structural Grade: **0**  
O&M Grade: **0**  
Clock Start/From: **11**  
Clock To:  
1st Value: **4.000**  
2nd Value:  
Value Percent:  
Continuous Index:  
Within 8" of Joint:  
Remarks:

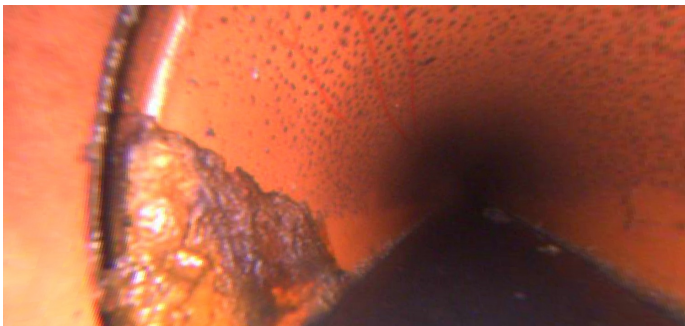
Code: **DAE**  
Description: **Deposits Attached Encrustation**

Distance (ft): **79.2**  
Structural Grade: **0**  
O&M Grade: **2**  
Clock Start/From: **7**  
Clock To: **8**  
1st Value:  
2nd Value:  
Value Percent: **5.000**  
Continuous Index:  
Within 8" of Joint: **YES**  
Remarks:

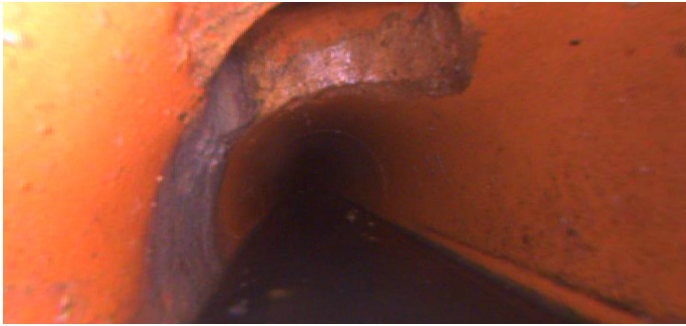
Code: **TF**  
Description: **Tap Factory**

Distance (ft): **99.7**  
Structural Grade: **0**  
O&M Grade: **0**  
Clock Start/From: **11**  
Clock To:  
1st Value: **4.000**  
2nd Value:  
Value Percent:  
Continuous Index:  
Within 8" of Joint:  
Remarks:

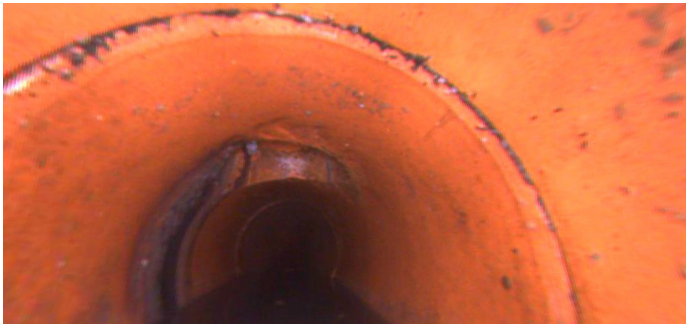
Code: **TF**  
Description: **Tap Factory**

Distance (ft): **136.8**  
Structural Grade: **0**  
O&M Grade: **0**  
Clock Start/From: **12**  
Clock To:  
1st Value: **4.000**  
2nd Value:  
Value Percent:  
Continuous Index:  
Within 8" of Joint:  
Remarks:

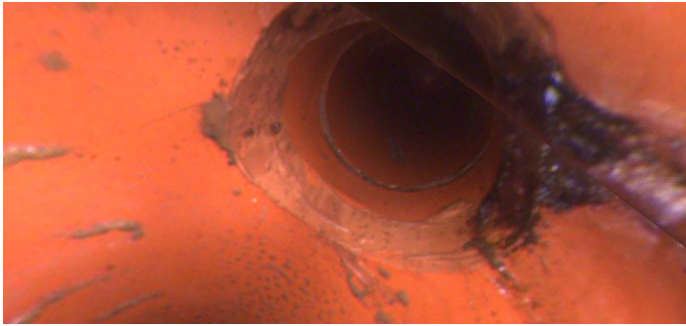
Code: **TF**  
Description: **Tap Factory**

Distance (ft): **160.1**  
Structural Grade: **0**  
O&M Grade: **0**  
Clock Start/From: **1**  
Clock To:  
1st Value: **4.000**  
2nd Value:  
Value Percent:  
Continuous Index:  
Within 8" of Joint:  
Remarks:

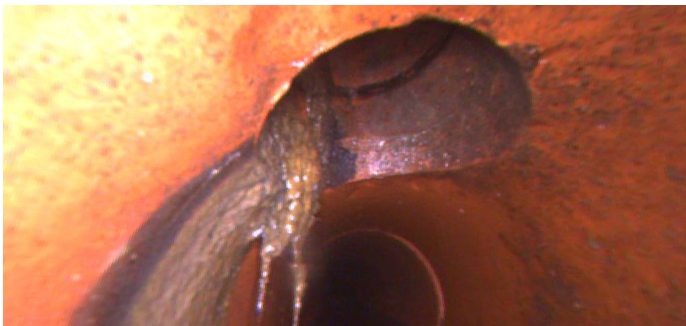
Code: **TF**  
Description: **Tap Factory**

Distance (ft): **197.6**  
Structural Grade: **0**  
O&M Grade: **0**  
Clock Start/From: **11**  
Clock To:  
1st Value: **4.000**  
2nd Value:  
Value Percent:  
Continuous Index:  
Within 8" of Joint:  
Remarks:

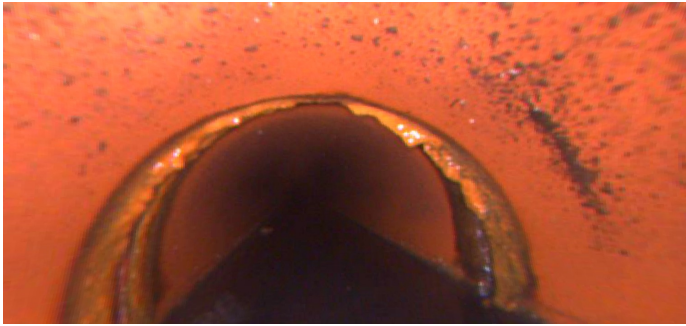
Code: **DAE**  
Description: **Deposits Attached Encrustation**

Distance (ft): **208.5**  
Structural Grade: **0**  
O&M Grade: **2**  
Clock Start/From: **7**  
Clock To: **5**  
1st Value:  
2nd Value:  
Value Percent: **5.000**  
Continuous Index:  
Within 8" of Joint: **YES**  
Remarks:

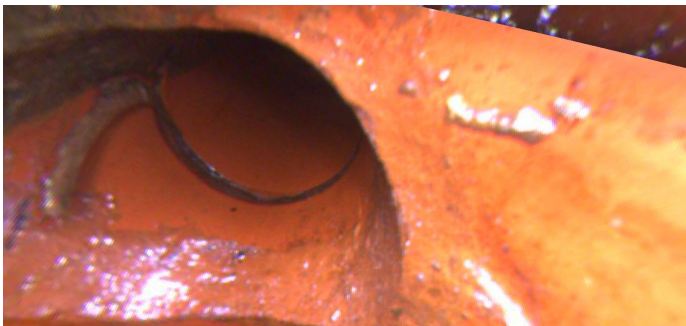
Code: **TF**  
Description: **Tap Factory**

Distance (ft): **235.0**  
Structural Grade: **0**  
O&M Grade: **0**  
Clock Start/From: **12**  
Clock To:  
1st Value: **4.000**  
2nd Value:  
Value Percent:  
Continuous Index:  
Within 8" of Joint:  
Remarks:

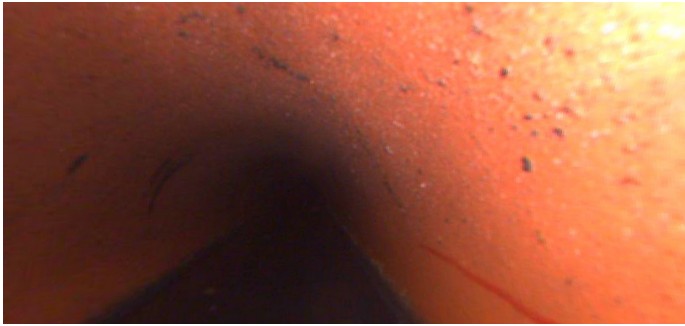
Code: **MSA**  
Description: **Abandoned Survey**

Distance (ft): **243.9**  
Structural Grade: **0**  
O&M Grade: **0**  
Clock Start/From:  
Clock To:  
1st Value:  
2nd Value:  
Value Percent:  
Continuous Index:  
Within 8" of Joint: **NO**  
Remarks: **ROBOT HAS STOPPED**

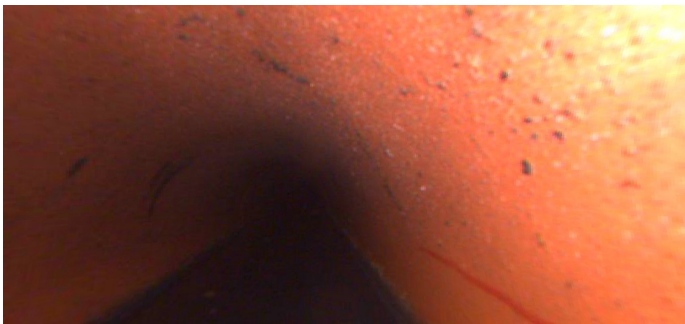
Code: **DAZ**  
Description: **Deposits Attached Other**

Distance (ft): **243.9**  
Structural Grade: **0**  
O&M Grade: **2**  
Clock Start/From: **7**  
Clock To: **5**  
1st Value:  
2nd Value:  
Value Percent: **5.000**  
Continuous Index: **F01**  
Within 8" of Joint: **YES**  
Remarks: **WANDER**
