Profile/Photo Observation Report

Street:	e 40th av	Flow Control:	Not Controlled
City:	Hobart, IN	Year Renewed:	
Location:	Other	Tape/Media #:	
Purpose:	Not Known	Dia/Height:	10"
Use:	Sanitary	Material:	VCP
Drain Area:	NA	Lining:	
Category:	NA		
Comment:

Location Details:		Direction of Survey:	Downstream
US MH:	M-103-003	DS MH:	M-103-002
		Total Length Surveyed (ft):	25.6

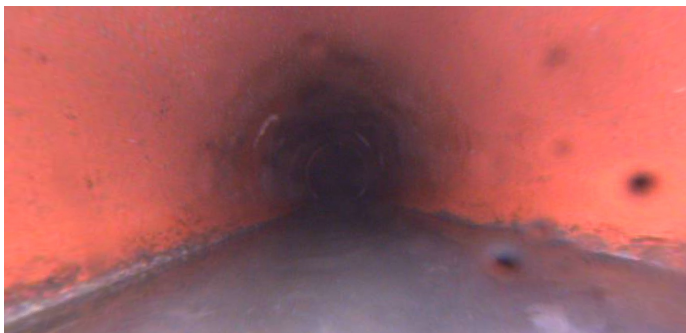
Code: **AMH**
Description: **Manhole**

Distance (ft): **.0**
Structural Grade: **0**
O&M Grade: **0**
Clock Start/From:
Clock To:
1st Value:
2nd Value:
Value Percent:
Continuous Index:
Within 8" of Joint: **NO**
Remarks: **M-103-003**

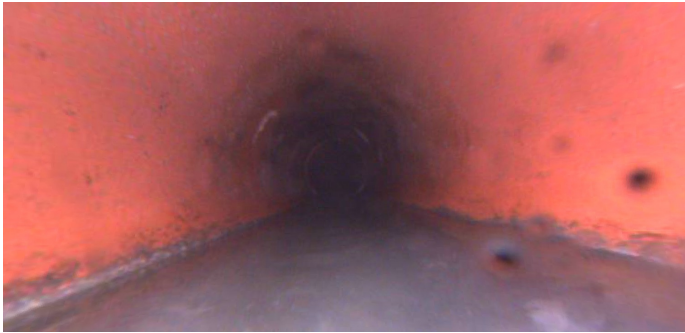
Code:	MWL
Description:	Water Level

Distance (ft):	.0
Structural Grade:	0
O&M Grade:	0
Clock Start/From:	
Clock To:	
1st Value:	
2nd Value:	
Value Percent:	20.000
Continuous Index:	
Within 8" of Joint:	NO
Remarks:

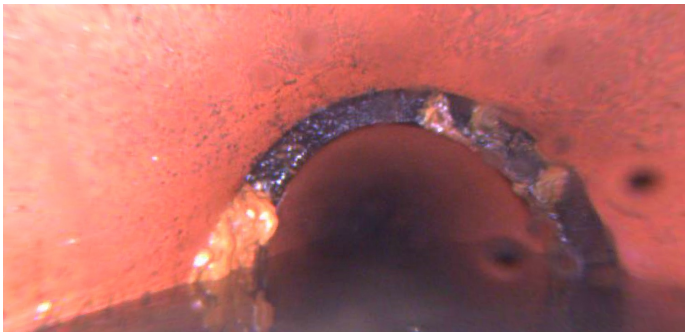
Code:	DAE
Description:	Deposits Attached Encrustation

Distance (ft):	19.6
Structural Grade:	0
O&M Grade:	2
Clock Start/From:	8
Clock To:	4
1st Value:	
2nd Value:	
Value Percent:	5.000
Continuous Index:	
Within 8" of Joint:	YES
Remarks:

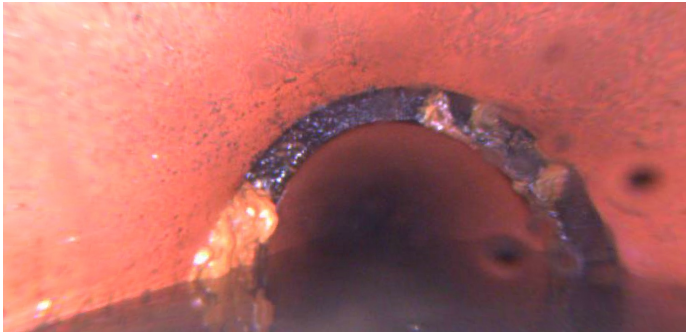
Code: **MWL**
Description: **Water Level**

Distance (ft): **19.6**
Structural Grade: **0**
O&M Grade: **0**
Clock Start/From:
Clock To:
1st Value:
2nd Value:
Value Percent: **40.000**
Continuous Index:
Within 8" of Joint: **NO**
Remarks:

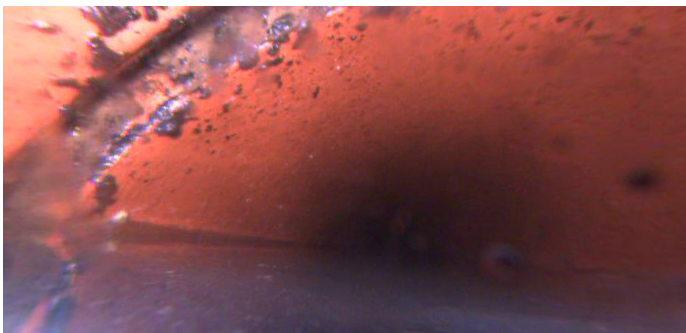
Code: **MSA**
Description: **Abandoned Survey**

Distance (ft): **25.6**
Structural Grade: **0**
O&M Grade: **0**
Clock Start/From:
Clock To:
1st Value:
2nd Value:
Value Percent:
Continuous Index:
Within 8" of Joint: **NO**
Remarks: **HIGH WATER**
