## Profile/Photo Observation Report

Street:	<b>E 40TH AVE</b>	Flow Control:	<b>Not Controlled</b>
City:	<b>Hobart, IN</b>	Year Renewed:	
Location:	<b>Light Highway</b>	Tape/Media #:	
Purpose:	<b>Routine Assessment</b>	Dia/Height:	<b>10"</b>
Use:	<b>Sanitary</b>	Material:	<b>VCP</b>
Drain Area:	<b>NA</b>	Lining:	
Category:	<b>NA</b>		
Comment:

Location Details:		Direction of Survey:	<b>Downstream</b>
US MH:	<b>M-103-003</b>	DS MH:	<b>M-103-002</b>
		Total Length Surveyed (ft):	<b>20.7</b>

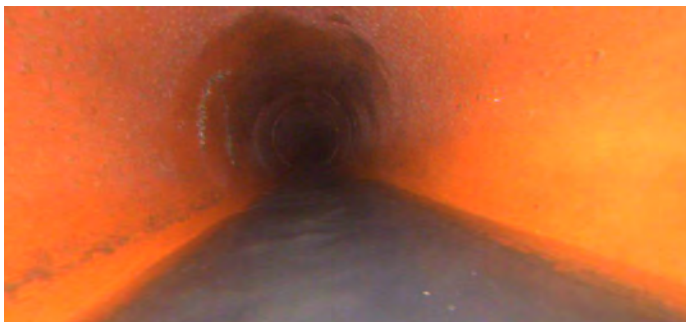
Code: **AMH**  
Description: **Manhole**

Distance (ft): **.0**  
Structural Grade: **0**  
O&M Grade: **0**  
Clock Start/From:  
Clock To:  
1st Value:  
2nd Value:  
Value Percent:  
Continuous Index:  
Within 8" of Joint: **NO**  
Remarks: **M-103-003**

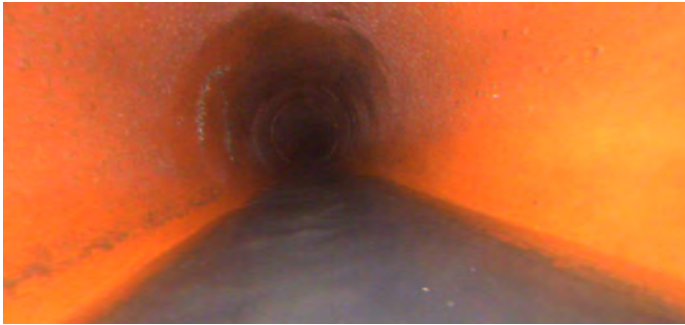
Code:	<b>MWL</b>
Description:	<b>Water Level</b>

Distance (ft):	<b>.0</b>
Structural Grade:	<b>0</b>
O&M Grade:	<b>0</b>
Clock Start/From:	
Clock To:	
1st Value:	
2nd Value:	
Value Percent:	<b>5.000</b>
Continuous Index:	
Within 8" of Joint:	<b>NO</b>
Remarks:

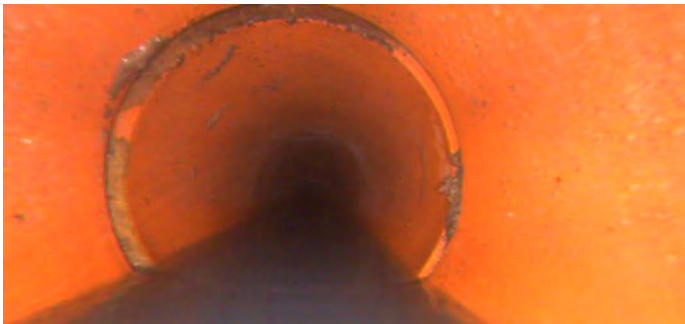
Code:	<b>RFJ</b>
Description:	<b>Roots Fine Joint</b>

Distance (ft):	<b>14.1</b>
Structural Grade:	<b>0</b>
O&M Grade:	<b>1</b>
Clock Start/From:	<b>3</b>
Clock To:	<b>4</b>
1st Value:	
2nd Value:	
Value Percent:	
Continuous Index:	
Within 8" of Joint:	<b>YES</b>
Remarks:

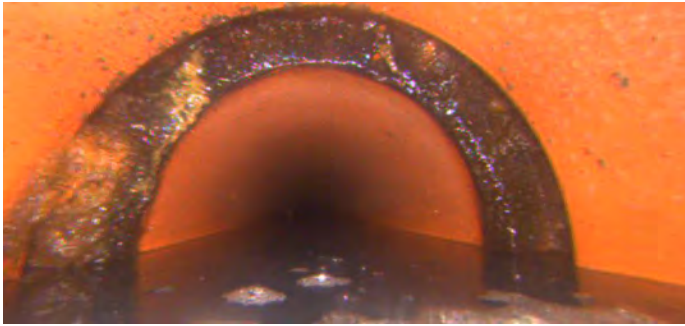
Code: **DAE**  
Description: **Deposits Attached Encrustation**

Distance (ft): **19.5**  
Structural Grade: **0**  
O&M Grade: **3**  
Clock Start/From: **8**  
Clock To: **4**  
1st Value:  
2nd Value:  
Value Percent: **15.000**  
Continuous Index:  
Within 8" of Joint: **YES**  
Remarks:
