## Profile/Photo Observation Report

Street:	<b>40th. Ave.</b>	Flow Control:	<b>Not Controlled</b>
City:	<b>Hobart, IN</b>	Year Renewed:	
Location:	<b>Light Highway</b>	Tape/Media #:	
Purpose:	<b>Routine Assessment</b>	Dia/Height:	<b>10"</b>
Use:	<b>Sanitary</b>	Material:	<b>VCP</b>
Drain Area:	<b>NA</b>	Lining:	
Category:	<b>NA</b>		
Comment:

Location Details:		Direction of Survey:	<b>Downstream</b>
US MH:	<b>M-103-003</b>	DS MH:	<b>M-103-002</b>
		Total Length Surveyed (ft):	<b>20.7</b>

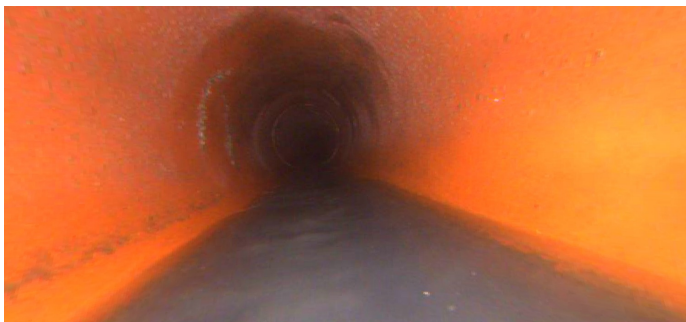
Code: **AMH**  
Description: **Manhole**

Distance (ft): **.0**  
Structural Grade: **0**  
O&M Grade: **0**  
Clock Start/From:  
Clock To:  
1st Value:  
2nd Value:  
Value Percent:  
Continuous Index:  
Within 8" of Joint: **NO**  
Remarks: **M-103-003**

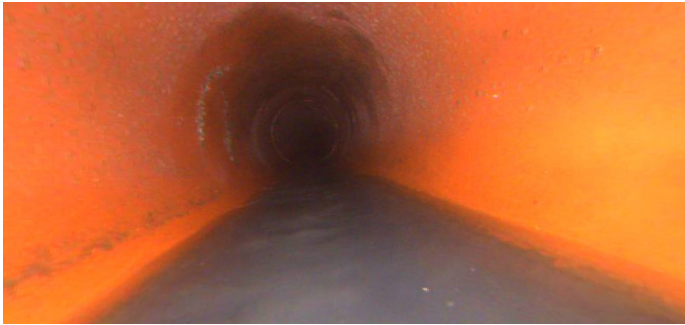
Code:	<b>MWL</b>
Description:	<b>Water Level</b>

Distance (ft):	<b>.0</b>
Structural Grade:	<b>0</b>
O&M Grade:	<b>0</b>
Clock Start/From:	
Clock To:	
1st Value:	
2nd Value:	
Value Percent:	<b>5.000</b>
Continuous Index:	
Within 8" of Joint:	<b>NO</b>
Remarks:

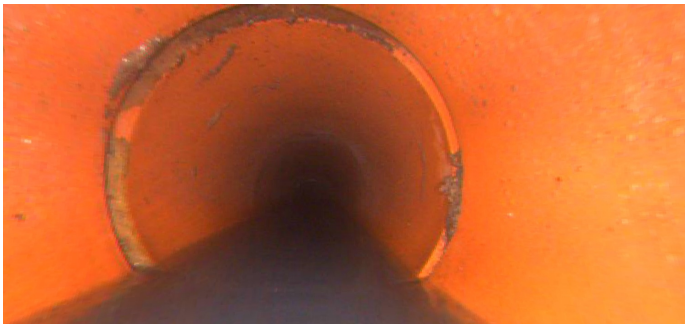
Code:	<b>RFJ</b>
Description:	<b>Roots Fine Joint</b>

Distance (ft):	<b>14.1</b>
Structural Grade:	<b>0</b>
O&M Grade:	<b>1</b>
Clock Start/From:	<b>3</b>
Clock To:	<b>4</b>
1st Value:	
2nd Value:	
Value Percent:	
Continuous Index:	
Within 8" of Joint:	<b>YES</b>
Remarks:

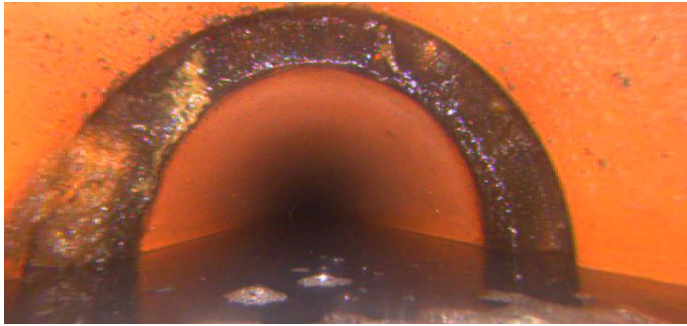
Code:	<b>DAE</b>
Description:	<b>Deposits Attached Encrustation</b>
Distance (ft):	<b>19.5</b>
Structural Grade:	<b>0</b>
O&M Grade:	<b>3</b>
Clock Start/From:	<b>8</b>
Clock To:	<b>4</b>
1st Value:	
2nd Value:	
Value Percent:	<b>15.000</b>
Continuous Index:	
Within 8" of Joint:	<b>YES</b>
Remarks:
