Profile/Photo Observation Report

| Street: | E 40TH AVE | Flow Control: | Not Controlled |
| City: | Hobart, IN | Year Renewed: | |

| US MH: | M-103-004 | DS MH: | M-103-003 |

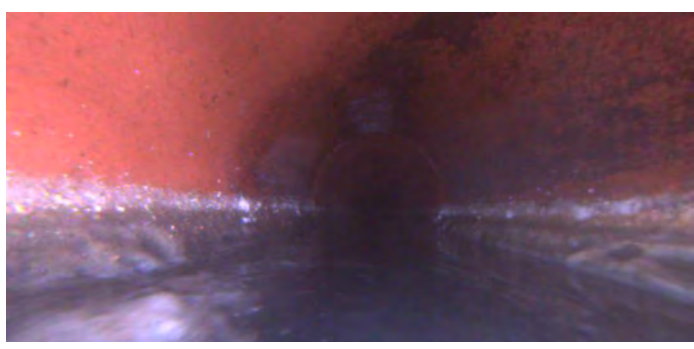
Code: **AMH**
Description: **Manhole**

Distance (ft): **.0**
Structural Grade: **0**
O&M Grade: **0**
Clock Start/From:
Clock To:
1st Value:
2nd Value:
Value Percent:
Continuous Index:
Within 8" of Joint: **NO**
Remarks: **M-103-003**

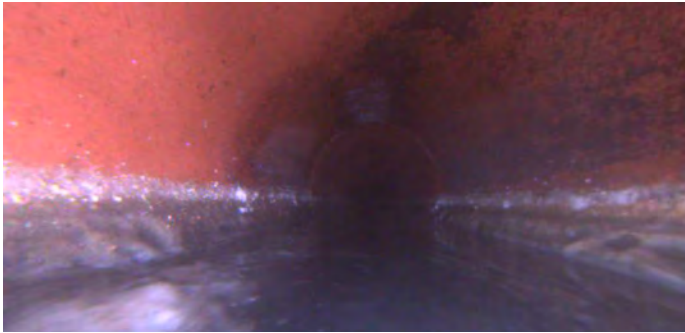
| Code: | MWL |
| Description: | Water Level |

| Distance (ft): | .0 |
| Value Percent: | 30.000 |

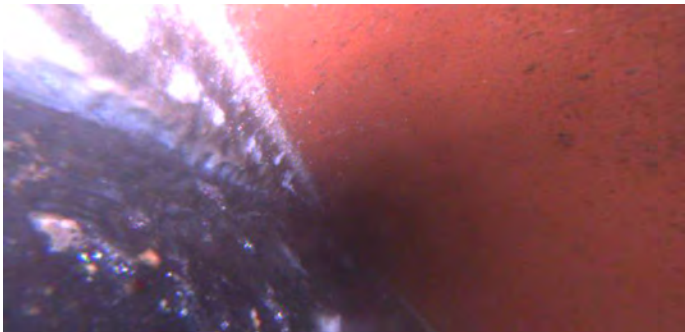
| Code: | MSA |
| Description: | Abandoned Survey |

| Distance (ft): | 5.8 |
| Remarks: | overturned |
