Profile/Photo Observation Report

Date:	04/06/2018	Weather:		Coding:	PACP 6.0
Pipe Length (ft):	268.0	Owner:	NA	Pre Clean:	Not Known
P.O.#:		Surveyor:	Jen Costello	PSR:	P-103-003-004
Customer:		Clean Date:	01/01/1900	Shape:	C

Location Details:		Direction of Survey:	Upstream
US MH:	M-103-004	DS MH:	M-103-003
		Total Length Surveyed (ft):	5.8

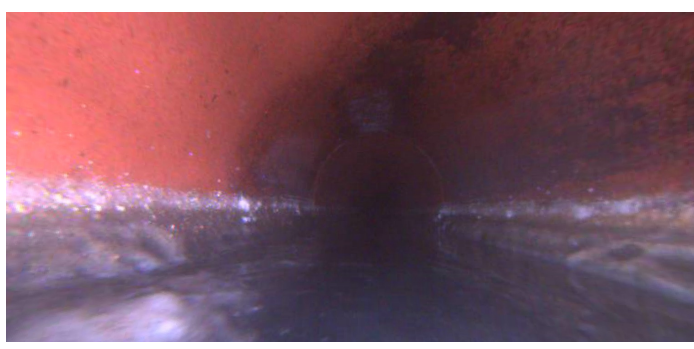
Code: **AMH**
Description: **Manhole**

Distance (ft): **.0**
Structural Grade: **0**
O&M Grade: **0**
Clock Start/From:
Clock To:
1st Value:
2nd Value:
Value Percent:
Continuous Index:
Within 8" of Joint: **NO**
Remarks: **M-103-003**

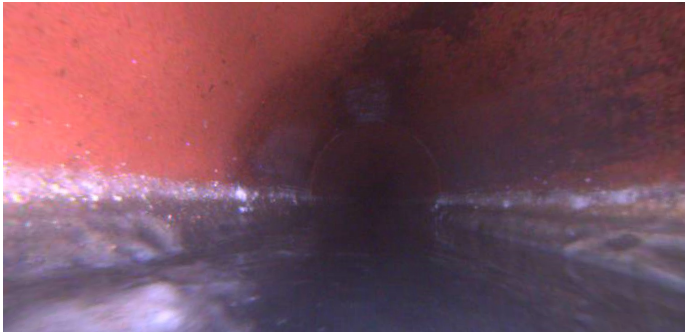
Code:	MWL
Description:	Water Level

Distance (ft):	.0
Structural Grade:	0
O&M Grade:	0
Clock Start/From:	
Clock To:	
1st Value:	
2nd Value:	
Value Percent:	30.000
Continuous Index:	
Within 8" of Joint:	NO
Remarks:

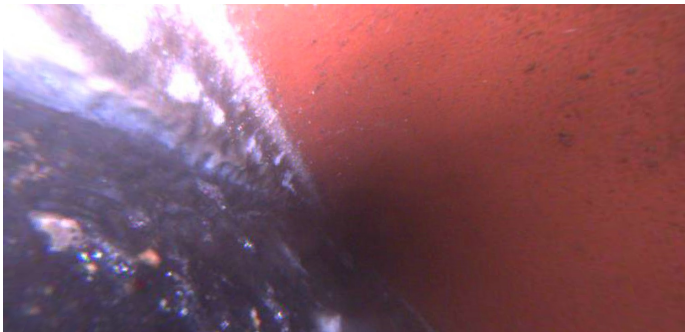
Code:	MSA
Description:	Abandoned Survey

Distance (ft):	5.8
Structural Grade:	0
O&M Grade:	0
Clock Start/From:	
Clock To:	
1st Value:	
2nd Value:	
Value Percent:	
Continuous Index:	
Within 8" of Joint:	NO
Remarks:	overturned
