## Profile/Photo Observation Report

Street:	<b>E 40TH AVE</b>	Flow Control:	<b>Not Controlled</b>
City:	<b>Hobart, IN</b>	Year Renewed:	
Location:	<b>Light Highway</b>	Tape/Media #:	
Purpose:	<b>Routine Assessment</b>	Dia/Height:	<b>10"</b>
Use:	<b>Sanitary</b>	Material:	<b>VCP</b>
Drain Area:	<b>NA</b>	Lining:	
Category:	<b>NA</b>		
Comment:

Location Details:		Direction of Survey:	<b>Upstream</b>
US MH:	<b>M-103-004</b>	DS MH:	<b>M-103-003</b>
		Total Length Surveyed (ft):	<b>11.5</b>

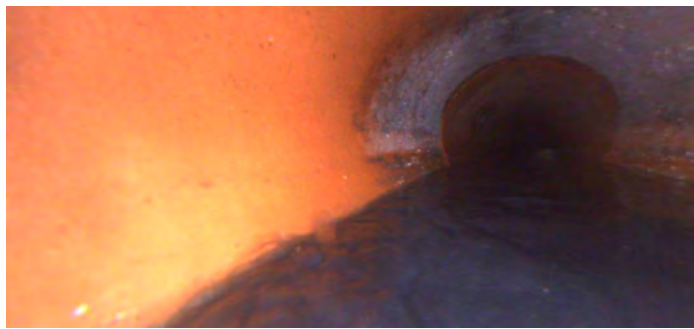
Code: **AMH**  
Description: **Manhole**

Distance (ft): **.0**  
Structural Grade: **0**  
O&M Grade: **0**  
Clock Start/From:  
Clock To:  
1st Value:  
2nd Value:  
Value Percent:  
Continuous Index:  
Within 8" of Joint: **NO**  
Remarks: **M-103-003**

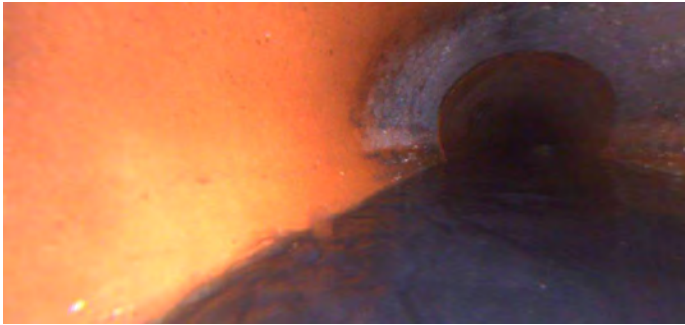
Code:	<b>MWL</b>
Description:	<b>Water Level</b>

Distance (ft):	<b>.0</b>
Structural Grade:	<b>0</b>
O&M Grade:	<b>0</b>
Clock Start/From:	
Clock To:	
1st Value:	
2nd Value:	
Value Percent:	<b>5.000</b>
Continuous Index:	
Within 8" of Joint:	<b>NO</b>
Remarks:

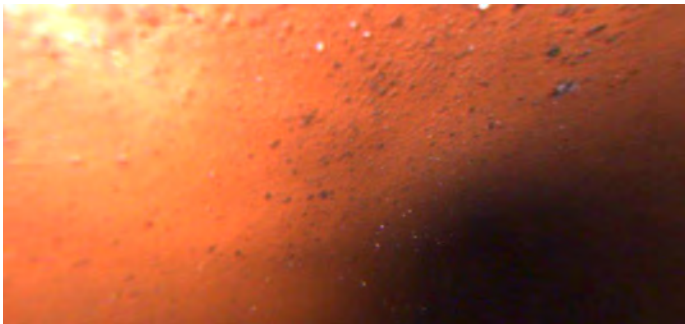
Code:	<b>MSA</b>
Description:	<b>Abandoned Survey</b>

Distance (ft):	<b>11.5</b>
Structural Grade:	<b>0</b>
O&M Grade:	<b>0</b>
Clock Start/From:	
Clock To:	
1st Value:	
2nd Value:	
Value Percent:	
Continuous Index:	
Within 8" of Joint:	<b>NO</b>
Remarks:	<b>camera stopped</b>
