## Profile/Photo Observation Report

Street:	<b>40th. Ave.</b>	Flow Control:	<b>Not Controlled</b>
City:	<b>Hobart, IN</b>	Year Renewed:	
Location:	<b>Light Highway</b>	Tape/Media #:	
Purpose:	<b>Routine Assessment</b>	Dia/Height:	<b>10"</b>
Use:	<b>Sanitary</b>	Material:	<b>VCP</b>
Drain Area:	<b>NA</b>	Lining:	
Category:	<b>NA</b>		
Comment:

Location Details:		Direction of Survey:	<b>Upstream</b>
US MH:	<b>M-103-004</b>	DS MH:	<b>M-103-003</b>
		Total Length Surveyed (ft):	<b>11.5</b>

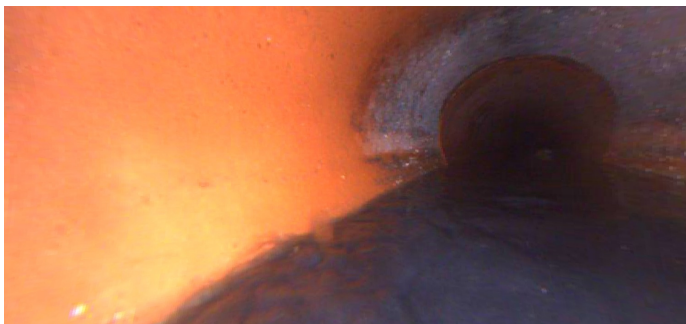
Code: **AMH**  
Description: **Manhole**

Distance (ft): **.0**  
Structural Grade: **0**  
O&M Grade: **0**  
Clock Start/From:  
Clock To:  
1st Value:  
2nd Value:  
Value Percent:  
Continuous Index:  
Within 8" of Joint: **NO**  
Remarks: **M-103-003**

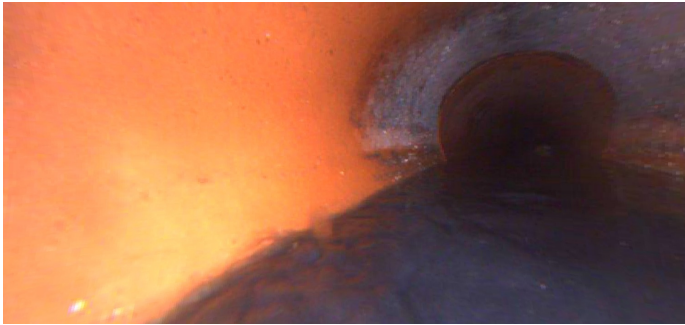
Code:	<b>MWL</b>
Description:	<b>Water Level</b>

Distance (ft):	<b>.0</b>
Structural Grade:	<b>0</b>
O&M Grade:	<b>0</b>
Clock Start/From:	
Clock To:	
1st Value:	
2nd Value:	
Value Percent:	<b>5.000</b>
Continuous Index:	
Within 8" of Joint:	<b>NO</b>
Remarks:

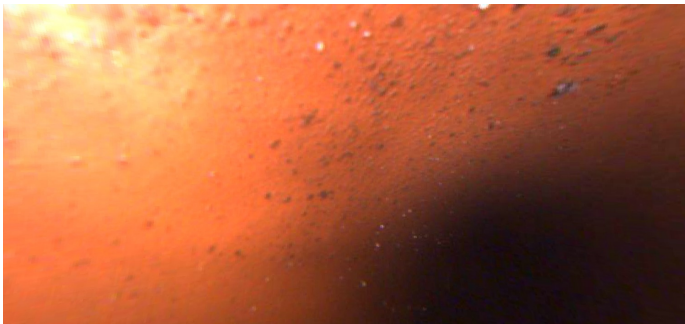
Code:	<b>MSA</b>
Description:	<b>Abandoned Survey</b>

Distance (ft):	<b>11.5</b>
Structural Grade:	<b>0</b>
O&M Grade:	<b>0</b>
Clock Start/From:	
Clock To:	
1st Value:	
2nd Value:	
Value Percent:	
Continuous Index:	
Within 8" of Joint:	<b>NO</b>
Remarks:	<b>camera stopped</b>
