## Profile/Photo Observation Report

Date:	<b>10/16/2021</b>	Weather:		Coding:	<b>PACP 6.0</b>
Pipe Length (ft):		Owner:	<b>Hobart, IN</b>	Pre Clean:	<b>Not Known</b>
P.O.#:	<b>829_1</b>	Surveyor:	<b>M. Pielacha</b>	PSR:	<b>P-103-005-006</b>
Customer:	<b>Hobart, IN</b>	Clean Date:		Shape:	<b>C</b>

Street:	<b>Off Colbourne Street</b>	Flow Control:	
City:	<b>Hobart, IN</b>	Year Renewed:	
Location:	<b>Alley</b>	Tape/Media #:	<b>829</b>
Purpose:	<b>Routine Assessment</b>	Dia/Height:	<b>8"</b>
Use:	<b>Sanitary</b>	Material:	<b>VCP</b>
Drain Area:		Lining:

US MH: **M-103-6** DS MH: **M-103-5** Total Length Surveyed (ft): **84.2**

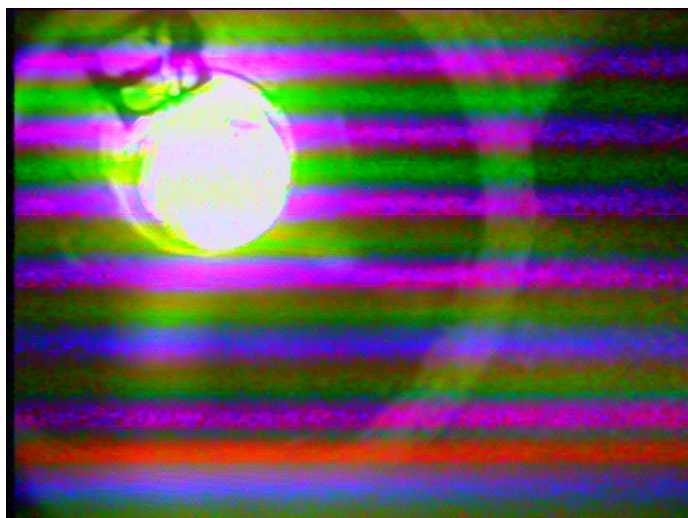
Code: **AMH**  
 Description: **Manhole**

Distance (ft): **.0**  
 Structural Grade: **0**  
 O&M Grade: **0**  
 Clock Start/From:  
 Clock To:  
 1st Value:  
 2nd Value:  
 Value Percent:  
 Continuous Index:  
 Within 8" of Joint: **NO**  
 Remarks: **M-103-5**

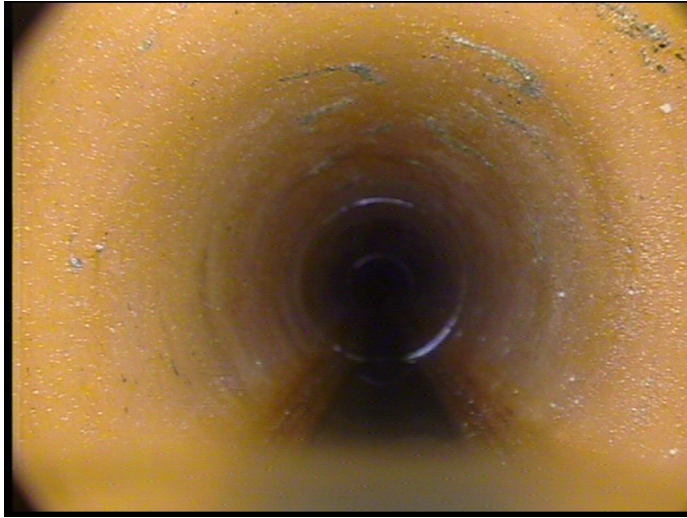
Code:	<b>MWL</b>
Description:	<b>Water Level</b>
Distance (ft):	<b>.0</b>
Structural Grade:	<b>0</b>
O&M Grade:	<b>0</b>
Clock Start/From:	
Clock To:	
1st Value:	
2nd Value:	
Value Percent:	<b>5.000</b>
Continuous Index:	
Within 8" of Joint:	<b>NO</b>
Remarks:

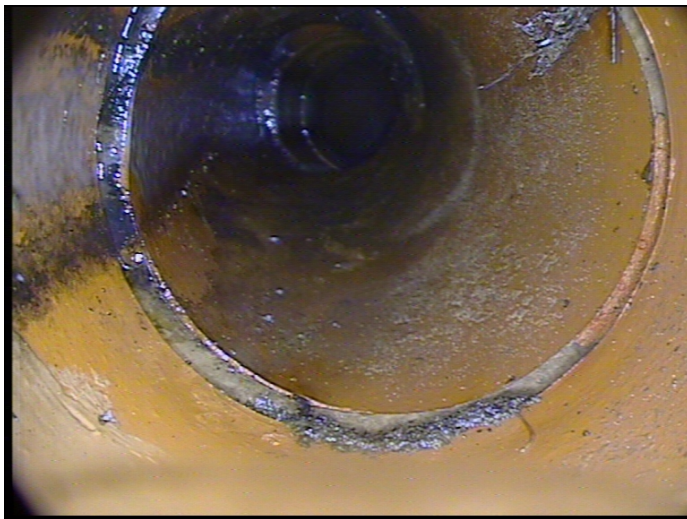
Code:	<b>TF</b>
Description:	<b>Tap Factory</b>
Distance (ft):	<b>41.6</b>
Structural Grade:	<b>0</b>
O&M Grade:	<b>0</b>
Clock Start/From:	<b>10</b>
Clock To:	
1st Value:	<b>4.000</b>
2nd Value:	
Value Percent:	
Continuous Index:	
Within 8" of Joint:	<b>NO</b>
Remarks:

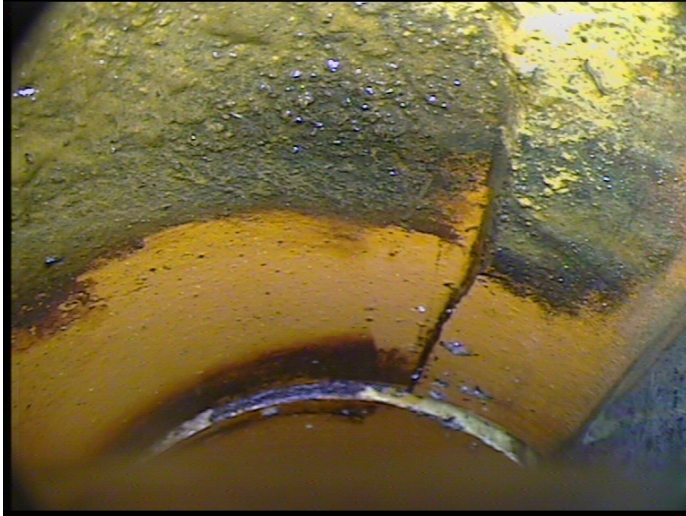
Code:	<b>FC</b>
Description:	<b>Fracture Circumferential</b>
Distance (ft):	<b>47.2</b>
Structural Grade:	<b>2</b>
O&M Grade:	<b>0</b>
Clock Start/From:	<b>11</b>
Clock To:	<b>3</b>
1st Value:	
2nd Value:	
Value Percent:	
Continuous Index:	
Within 8" of Joint:	<b>YES</b>
Remarks:

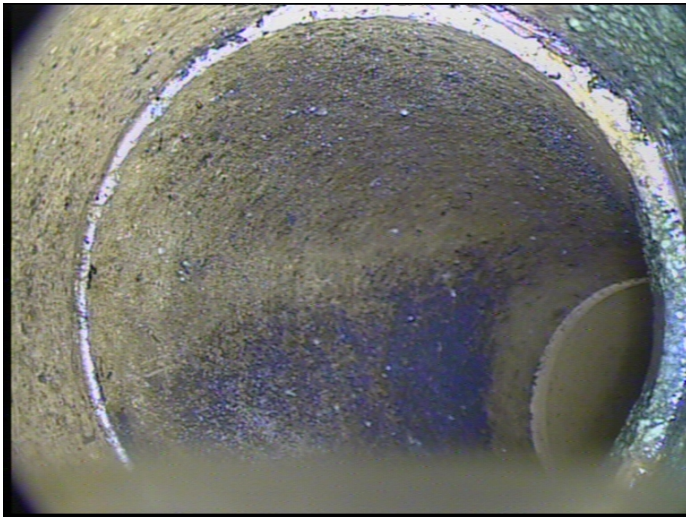
Code:	<b>TB</b>
Description:	<b>Tap Break-in</b>
Distance (ft):	<b>51.8</b>
Structural Grade:	<b>0</b>
O&M Grade:	<b>0</b>
Clock Start/From:	<b>2</b>
Clock To:	
1st Value:	<b>4.000</b>
2nd Value:	
Value Percent:	
Continuous Index:	
Within 8" of Joint:	<b>NO</b>
Remarks:

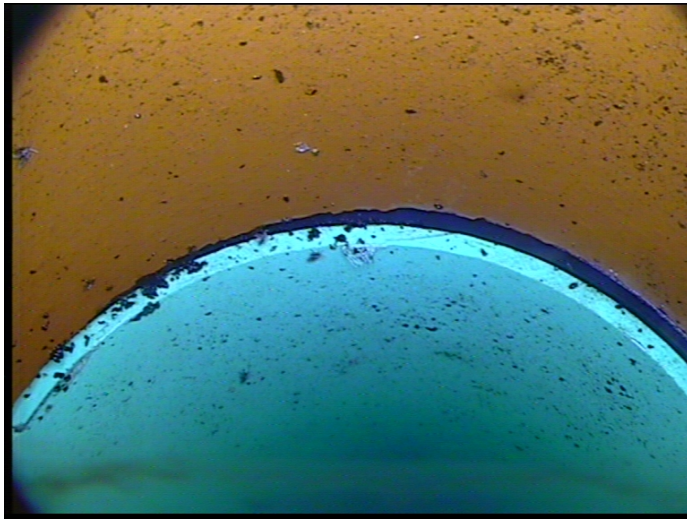
Code: **MMC**  
Description: **Material Change**

Distance (ft): **56.6**  
Structural Grade: **0**  
O&M Grade: **0**  
Clock Start/From:  
Clock To:  
1st Value:  
2nd Value:  
Value Percent:  
Continuous Index:  
Within 8" of Joint: **NO**  
Remarks: **pvc**

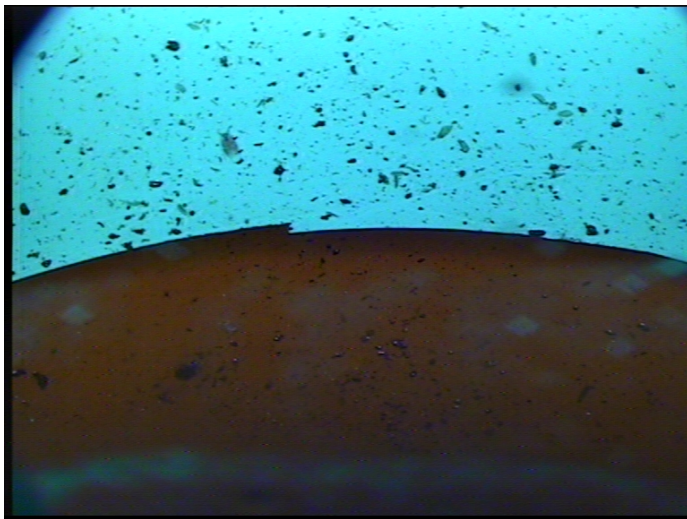
Code: **MMC**  
Description: **Material Change**

Distance (ft): **67.1**  
Structural Grade: **0**  
O&M Grade: **0**  
Clock Start/From:  
Clock To:  
1st Value:  
2nd Value:  
Value Percent:  
Continuous Index:  
Within 8" of Joint: **NO**  
Remarks: **vcp**

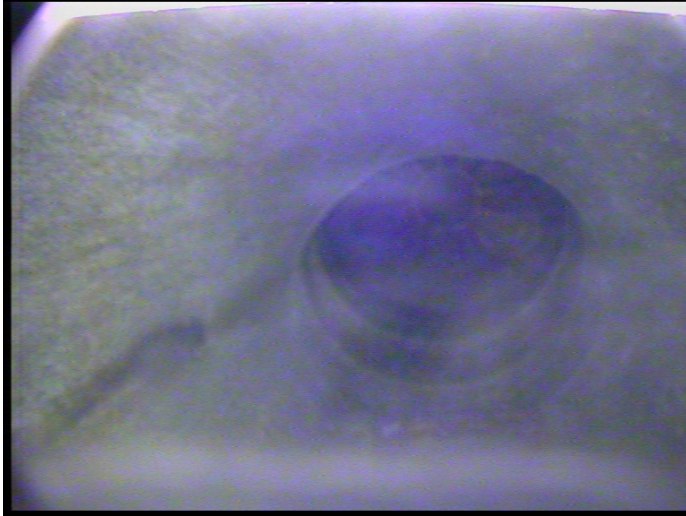
Code:	<b>AMH</b>
Description:	<b>Manhole</b>
Distance (ft):	<b>84.2</b>
Structural Grade:	<b>0</b>
O&M Grade:	<b>0</b>
Clock Start/From:	
Clock To:	
1st Value:	
2nd Value:	
Value Percent:	
Continuous Index:	
Within 8" of Joint:	<b>NO</b>
Remarks:	<b>M-103-6</b>
