Profile/Photo Observation Report

Date:	09/27/2018	Weather:		Coding:	PACP 6.0
Pipe Length (ft):	160.8	Owner:	NA	Pre Clean:	Not Known
P.O.#:		Surveyor:	Selasie Honu	PSR:	P-103-006-007
Customer:		Clean Date:	01/01/1900	Shape:	C

Street:	HOWARD ST	Flow Control:	Not Controlled
City:	Hobart, IN	Year Renewed:	
Location:	Light Highway	Tape/Media #:	
Purpose:	Routine Assessment	Dia/Height:	10"
Use:	Sanitary	Material:	VCP
Drain Area:	NA	Lining:	
Category:	NA		
Comment:

Location Details:		Direction of Survey:	Downstream
US MH:	M-103-007	DS MH:	M-103-006
		Total Length Surveyed (ft):	156.4

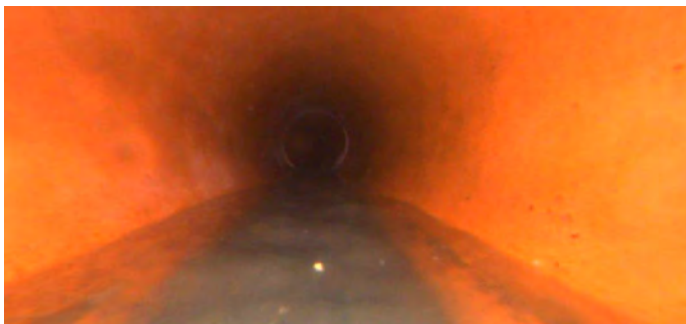
Code: **AMH**
Description: **Manhole**

Distance (ft): **.0**
Structural Grade: **0**
O&M Grade: **0**
Clock Start/From:
Clock To:
1st Value:
2nd Value:
Value Percent:
Continuous Index:
Within 8" of Joint: **NO**
Remarks: **M-103-007**

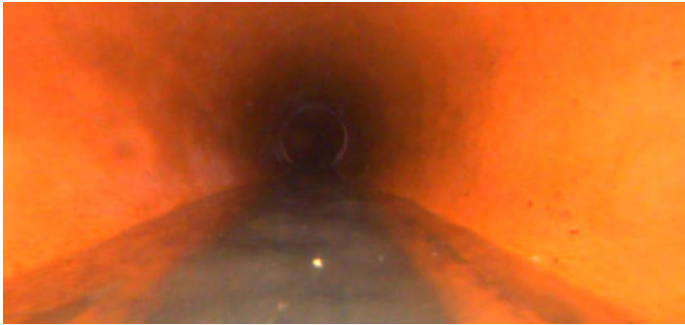
Code:	MWL
Description:	Water Level

Distance (ft):	.0
Structural Grade:	0
O&M Grade:	0
Clock Start/From:	
Clock To:	
1st Value:	
2nd Value:	
Value Percent:	5.000
Continuous Index:	
Within 8" of Joint:	NO
Remarks:

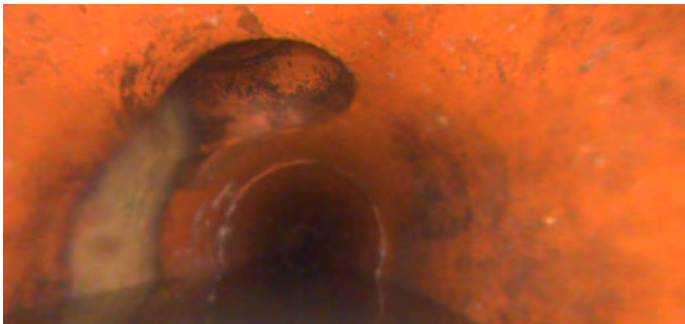
Code:	TF
Description:	Tap Factory

Distance (ft):	55.5
Structural Grade:	0
O&M Grade:	0
Clock Start/From:	12
Clock To:	
1st Value:	4.000
2nd Value:	
Value Percent:	
Continuous Index:	
Within 8" of Joint:	
Remarks:

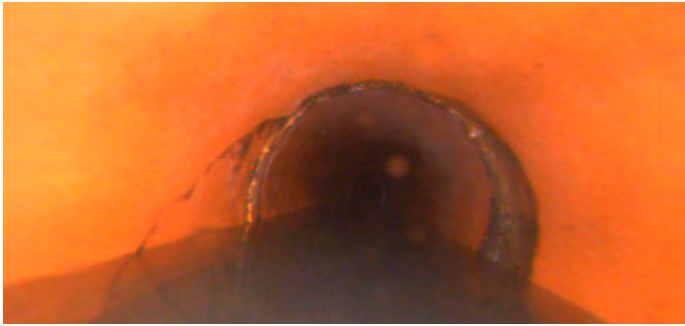
Code: **FC**
Description: **Fracture Circumferential**

Distance (ft): **66.2**
Structural Grade: **2**
O&M Grade: **0**
Clock Start/From: **8**
Clock To: **10**
1st Value:
2nd Value:
Value Percent:
Continuous Index:
Within 8" of Joint: **YES**
Remarks:

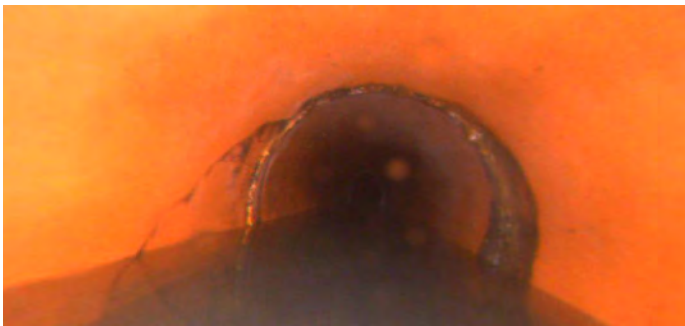
Code: **IS**
Description: **Infil Stain**

Distance (ft): **66.2**
Structural Grade: **0**
O&M Grade: **0**
Clock Start/From: **8**
Clock To: **10**
1st Value:
2nd Value:
Value Percent:
Continuous Index:
Within 8" of Joint: **YES**
Remarks:

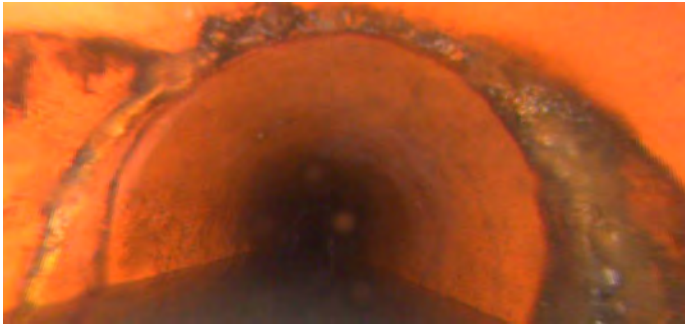
Code: **FC**
Description: **Fracture Circumferential**

Distance (ft): **66.6**
Structural Grade: **2**
O&M Grade: **0**
Clock Start/From: **9**
Clock To: **12**
1st Value:
2nd Value:
Value Percent:
Continuous Index:
Within 8" of Joint: **YES**
Remarks:

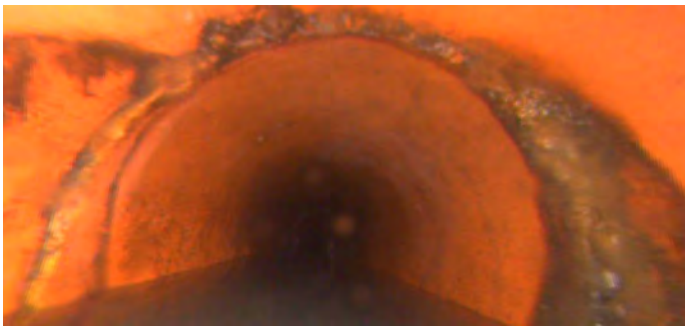
Code: **DAE**
Description: **Deposits Attached Encrustation**

Distance (ft): **66.6**
Structural Grade: **0**
O&M Grade: **3**
Clock Start/From: **11**
Clock To: **4**
1st Value:
2nd Value:
Value Percent: **20.000**
Continuous Index:
Within 8" of Joint: **YES**
Remarks:

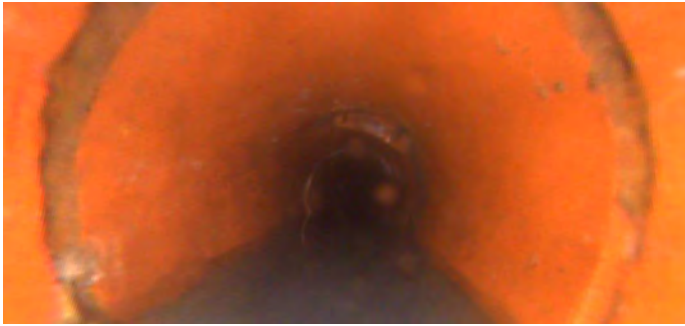
Code: **TF**
Description: **Tap Factory**

Distance (ft): **86.9**
Structural Grade: **0**
O&M Grade: **0**
Clock Start/From: **1**
Clock To:
1st Value: **4.000**
2nd Value:
Value Percent:
Continuous Index:
Within 8" of Joint:
Remarks:

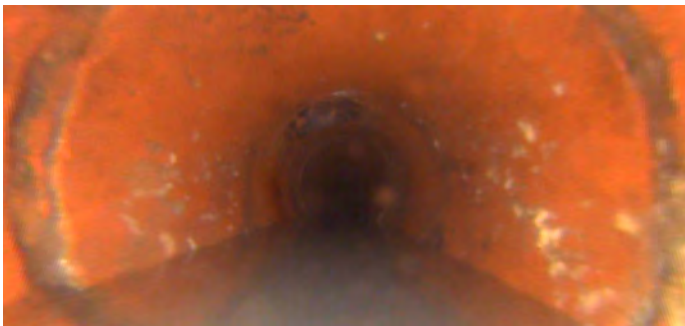
Code: **TF**
Description: **Tap Factory**

Distance (ft): **109.4**
Structural Grade: **0**
O&M Grade: **0**
Clock Start/From: **12**
Clock To:
1st Value: **4.000**
2nd Value:
Value Percent:
Continuous Index:
Within 8" of Joint:
Remarks:

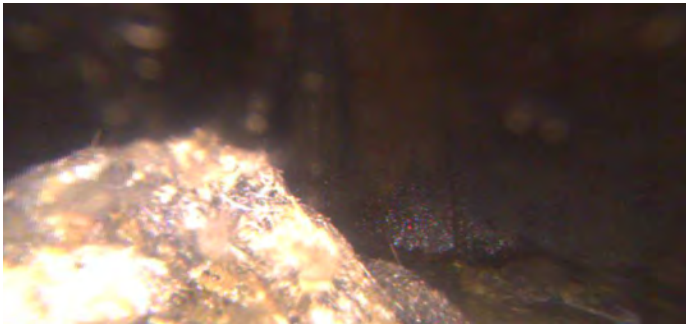
Code: **AMH**
Description: **Manhole**

Distance (ft): **156.4**
Structural Grade: **0**
O&M Grade: **0**
Clock Start/From:
Clock To:
1st Value:
2nd Value:
Value Percent:
Continuous Index:
Within 8" of Joint: **NO**
Remarks: **M-103-006**
