Profile/Photo Observation Report

Street:	Howard St.	Flow Control:	Not Controlled
City:	Hobart, IN	Year Renewed:	
Location:	Light Highway	Tape/Media #:	
Purpose:	Routine Assessment	Dia/Height:	10"
Use:	Sanitary	Material:	VCP
Drain Area:	NA	Lining:	
Category:	NA		
Comment:

Location Details:		Direction of Survey:	Downstream
US MH:	M-103-007	DS MH:	M-103-006
		Total Length Surveyed (ft):	156.4

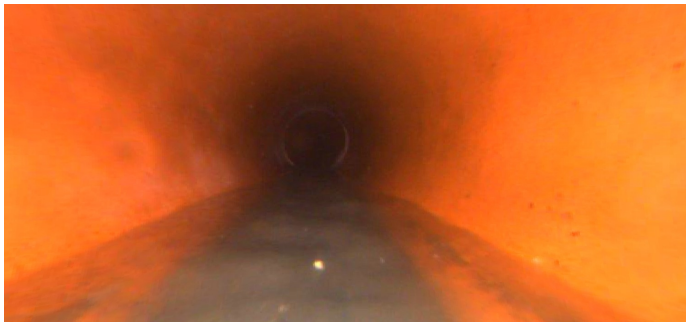
Code: **AMH**
Description: **Manhole**

Distance (ft): **.0**
Structural Grade: **0**
O&M Grade: **0**
Clock Start/From:
Clock To:
1st Value:
2nd Value:
Value Percent:
Continuous Index:
Within 8" of Joint: **NO**
Remarks: **M-103-007**

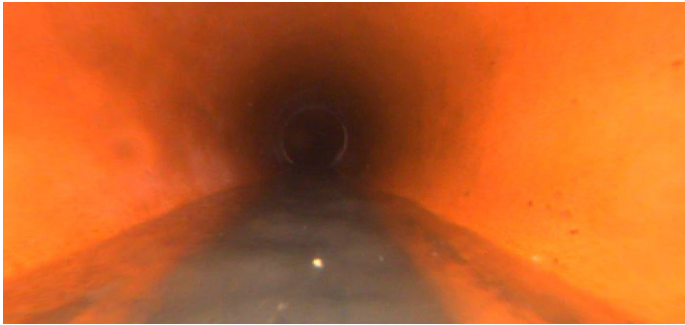
Code:	MWL
Description:	Water Level

Distance (ft):	.0
Structural Grade:	0
O&M Grade:	0
Clock Start/From:	
Clock To:	
1st Value:	
2nd Value:	
Value Percent:	5.000
Continuous Index:	
Within 8" of Joint:	NO
Remarks:

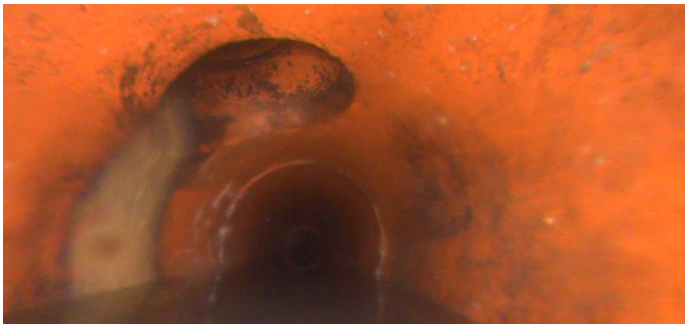
Code:	TF
Description:	Tap Factory

Distance (ft):	55.5
Structural Grade:	0
O&M Grade:	0
Clock Start/From:	12
Clock To:	
1st Value:	4.000
2nd Value:	
Value Percent:	
Continuous Index:	
Within 8" of Joint:	
Remarks:

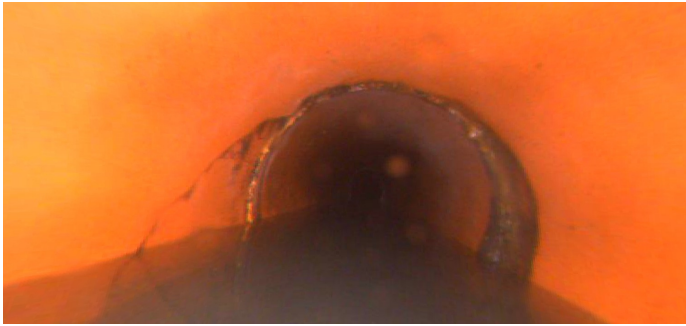
Code: **FC**
Description: **Fracture Circumferential**

Distance (ft): **66.2**
Structural Grade: **2**
O&M Grade: **0**
Clock Start/From: **8**
Clock To: **10**
1st Value:
2nd Value:
Value Percent:
Continuous Index:
Within 8" of Joint: **YES**
Remarks:

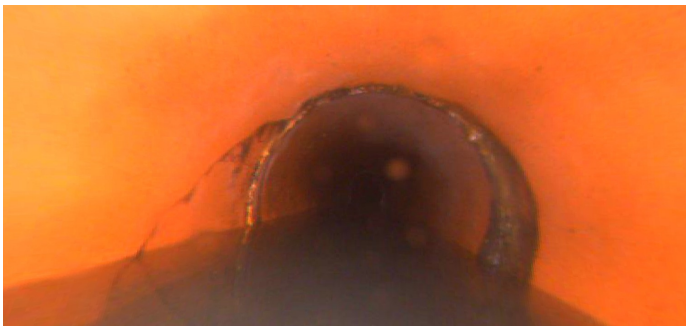
Code: **IS**
Description: **Infil Stain**

Distance (ft): **66.2**
Structural Grade: **0**
O&M Grade: **0**
Clock Start/From: **8**
Clock To: **10**
1st Value:
2nd Value:
Value Percent:
Continuous Index:
Within 8" of Joint: **YES**
Remarks:

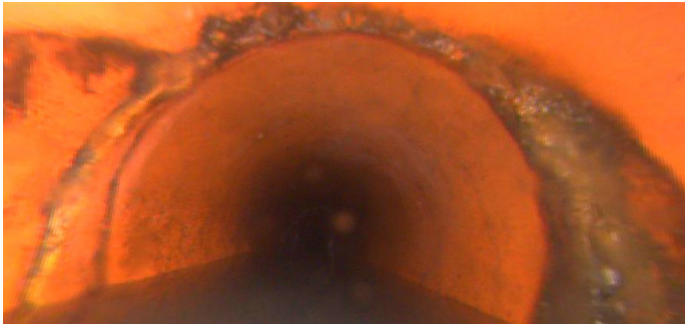
Code: **FC**
Description: **Fracture Circumferential**

Distance (ft): **66.6**
Structural Grade: **2**
O&M Grade: **0**
Clock Start/From: **9**
Clock To: **12**
1st Value:
2nd Value:
Value Percent:
Continuous Index:
Within 8" of Joint: **YES**
Remarks:

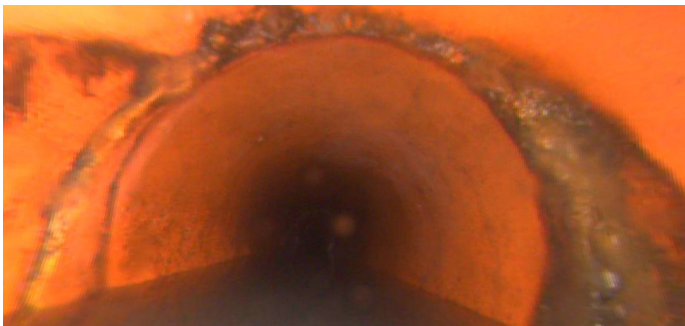
Code: **DAE**
Description: **Deposits Attached Encrustation**

Distance (ft): **66.6**
Structural Grade: **0**
O&M Grade: **3**
Clock Start/From: **11**
Clock To: **4**
1st Value:
2nd Value:
Value Percent: **20.000**
Continuous Index:
Within 8" of Joint: **YES**
Remarks:

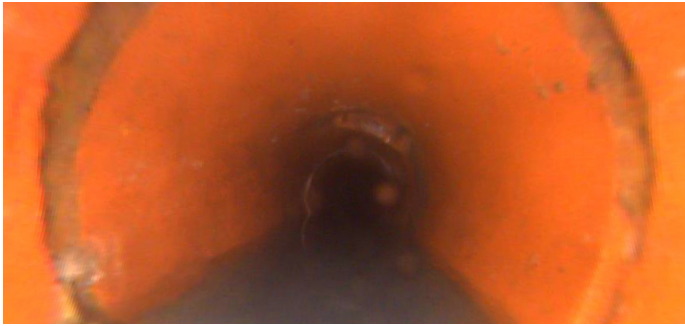
Code: **TF**
Description: **Tap Factory**

Distance (ft): **86.9**
Structural Grade: **0**
O&M Grade: **0**
Clock Start/From: **1**
Clock To:
1st Value: **4.000**
2nd Value:
Value Percent:
Continuous Index:
Within 8" of Joint:
Remarks:

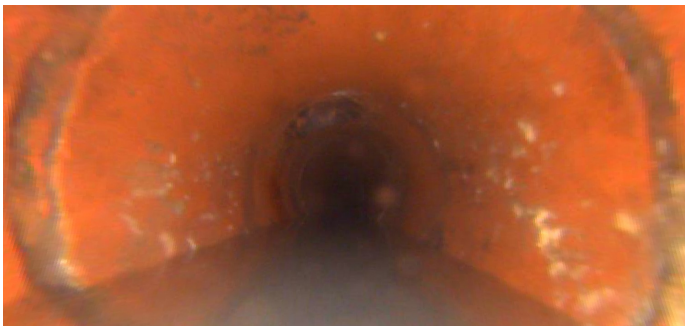
Code: **TF**
Description: **Tap Factory**

Distance (ft): **109.4**
Structural Grade: **0**
O&M Grade: **0**
Clock Start/From: **12**
Clock To:
1st Value: **4.000**
2nd Value:
Value Percent:
Continuous Index:
Within 8" of Joint:
Remarks:

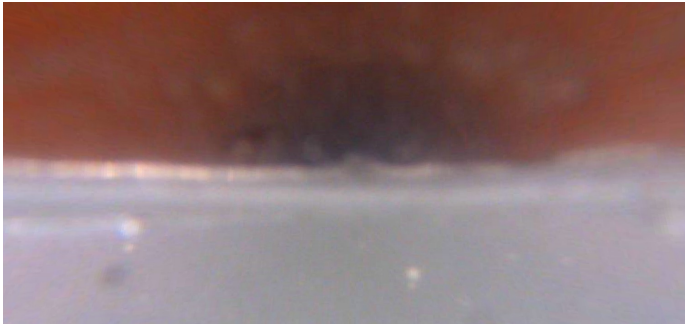
Code: **MWLS**
Description: **Water Level Sag**

Distance (ft): **151.4**
Structural Grade: **2**
O&M Grade: **3**
Clock Start/From:
Clock To:
1st Value:
2nd Value:
Value Percent: **10.000**
Continuous Index:
Within 8" of Joint: **NO**
Remarks:

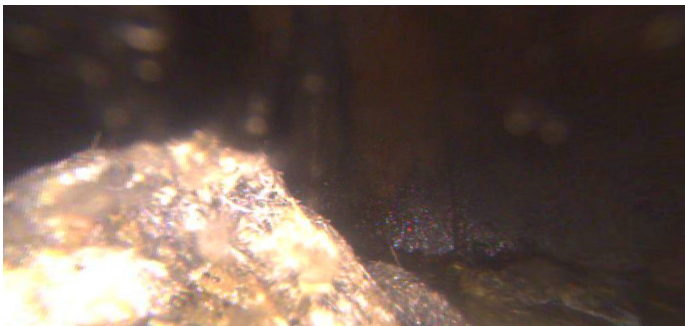
Code: **AMH**
Description: **Manhole**

Distance (ft): **156.4**
Structural Grade: **0**
O&M Grade: **0**
Clock Start/From:
Clock To:
1st Value:
2nd Value:
Value Percent:
Continuous Index:
Within 8" of Joint: **NO**
Remarks: **M-103-006**
