Profile/Photo Observation Report

Street:	HOWARD ST	Flow Control:	Not Controlled
City:	Hobart, IN	Year Renewed:	
Location:	Light Highway	Tape/Media #:	
Purpose:	Routine Assessment	Dia/Height:	10"
Use:	Sanitary	Material:	VCP
Drain Area:	NA	Lining:	
Category:	NA		
Comment:

Location Details:		Direction of Survey:	Upstream
US MH:	M-103-007	DS MH:	M-103-008
		Total Length Surveyed (ft):	171.1

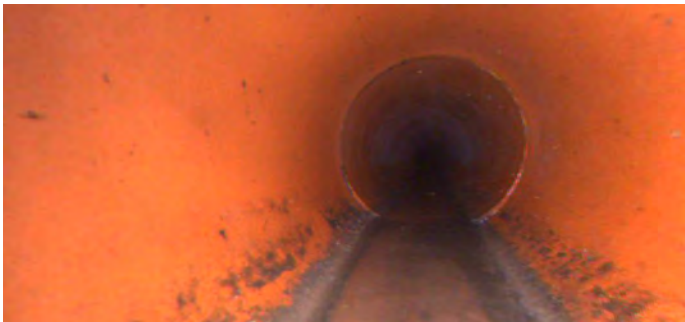
Code: **AMH**
Description: **Manhole**

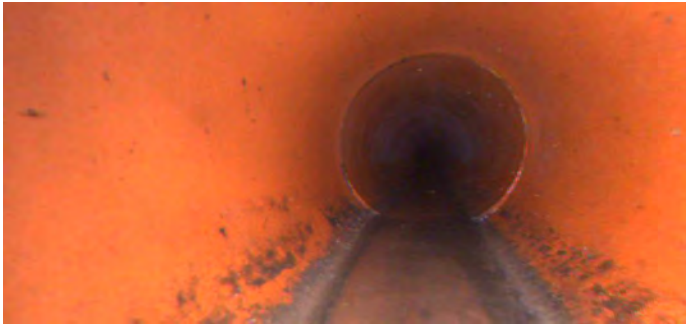
Code:	MWL
Description:	Water Level

Distance (ft):	.0
Structural Grade:	0
O&M Grade:	0
Clock Start/From:	
Clock To:	
1st Value:	
2nd Value:	
Value Percent:	5.000
Continuous Index:	
Within 8" of Joint:	NO
Remarks:

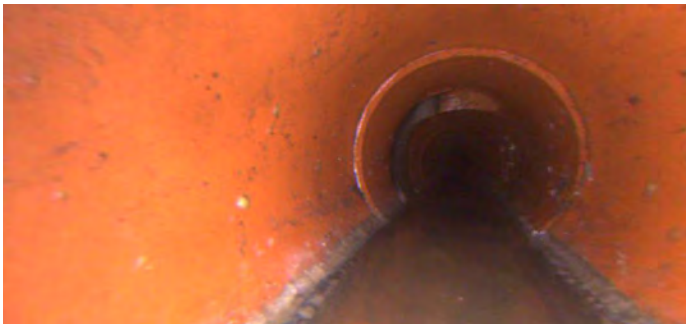
Code:	TF
Description:	Tap Factory

Distance (ft):	47.6
Structural Grade:	0
O&M Grade:	0
Clock Start/From:	12
Clock To:	
1st Value:	4.000
2nd Value:	
Value Percent:	
Continuous Index:	
Within 8" of Joint:	
Remarks:

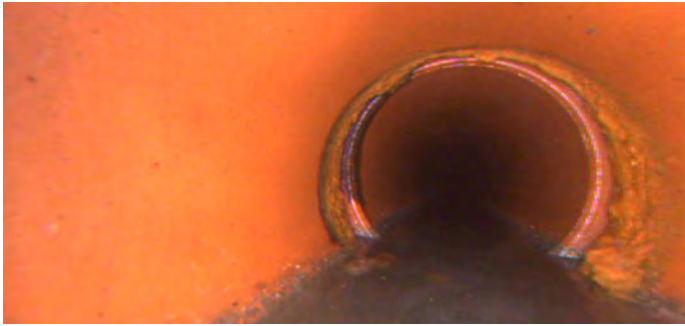
Code: **DAE**
Description: **Deposits Attached Encrustation**

Distance (ft): **54.9**
Structural Grade: **0**
O&M Grade: **2**
Clock Start/From: **8**
Clock To: **4**
1st Value:
2nd Value:
Value Percent: **10.000**
Continuous Index:
Within 8" of Joint: **YES**
Remarks:

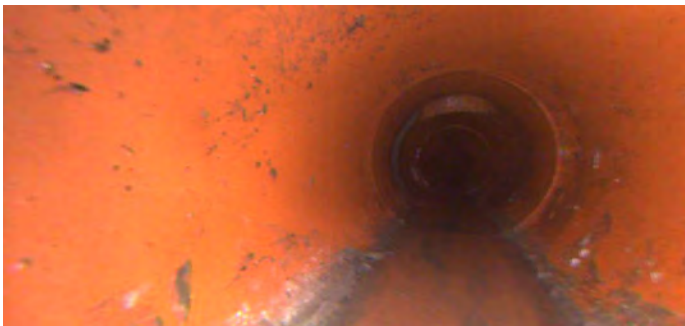
Code: **TF**
Description: **Tap Factory**

Distance (ft): **95.4**
Structural Grade: **0**
O&M Grade: **0**
Clock Start/From: **12**
Clock To:
1st Value: **4.000**
2nd Value:
Value Percent:
Continuous Index:
Within 8" of Joint:
Remarks:

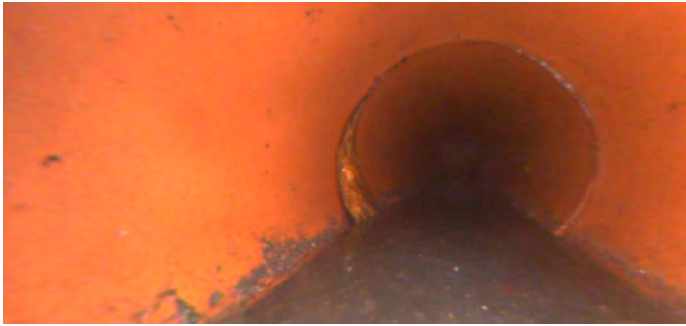
Code: **DAE**
Description: **Deposits Attached Encrustation**

Distance (ft): **164.3**
Structural Grade: **0**
O&M Grade: **3**
Clock Start/From: **8**
Clock To: **10**
1st Value:
2nd Value:
Value Percent: **15.000**
Continuous Index:
Within 8" of Joint: **YES**
Remarks:
