Profile/Photo Observation Report

Street:	ALLEY BETWEEN HOWARD ST & WIL	Flow Control:	Not Controlled
City:	Hobart, IN	Year Renewed:	
Location:	Other	Tape/Media #:	
Purpose:	Not Known	Dia/Height:	10"
Use:	Sanitary	Material:	VCP
Drain Area:	NA	Lining:	
Category:	NA		
Comment:

Location Details:		Direction of Survey:	Upstream
US MH:	M-103-008	DS MH:	M-103-009
		Total Length Surveyed (ft):	31.7

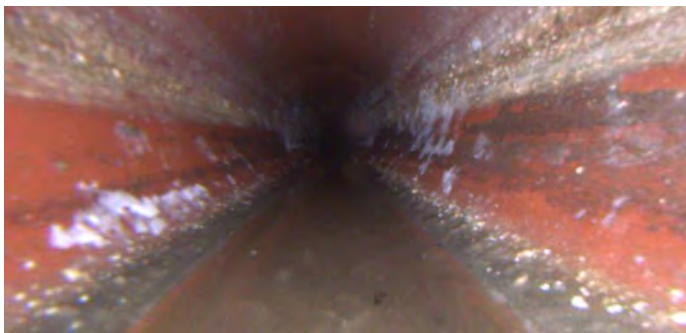
Code: **AMH**
Description: **Manhole**

Distance (ft): **.0**
Structural Grade: **0**
O&M Grade: **0**
Clock Start/From:
Clock To:
1st Value:
2nd Value:
Value Percent:
Continuous Index:
Within 8" of Joint: **NO**
Remarks: **M-103-009**

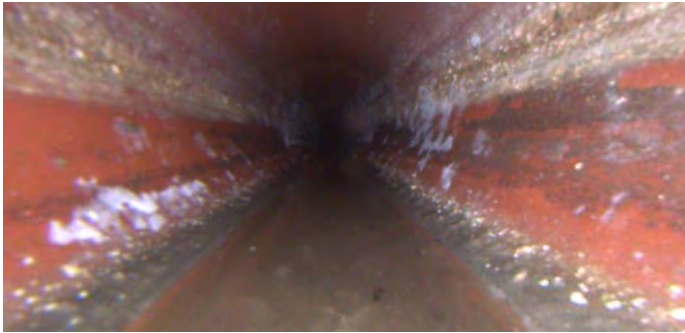
Code:	MWL
Description:	Water Level

Distance (ft):	.0
Structural Grade:	0
O&M Grade:	0
Clock Start/From:	
Clock To:	
1st Value:	
2nd Value:	
Value Percent:	5.000
Continuous Index:	
Within 8" of Joint:	NO
Remarks:

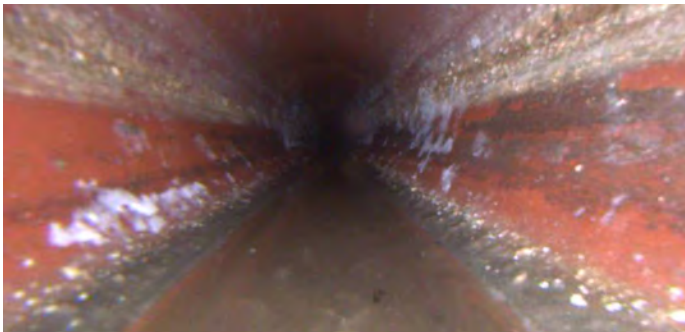
Code:	DAGS
Description:	Deposits Attached Grease

Distance (ft):	.0
Structural Grade:	0
O&M Grade:	2
Clock Start/From:	8
Clock To:	4
1st Value:	
2nd Value:	
Value Percent:	5.000
Continuous Index:	S01
Within 8" of Joint:	NO
Remarks:

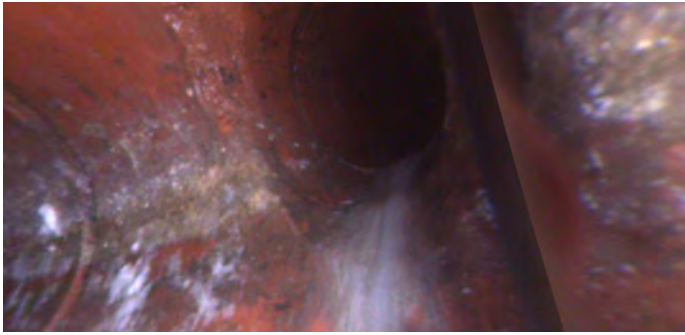
Code: **TFA**
Description: **Tap Factory Active**

Distance (ft): **9.3**
Structural Grade: **0**
O&M Grade: **0**
Clock Start/From: **10**
Clock To:
1st Value: **4.000**
2nd Value:
Value Percent:
Continuous Index:
Within 8" of Joint:
Remarks:

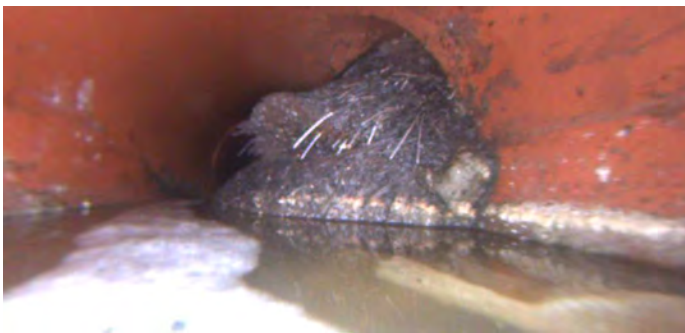
Code: **TFD**
Description: **Tap Factory Defective**

Distance (ft): **30.7**
Structural Grade: **0**
O&M Grade: **2**
Clock Start/From: **2**
Clock To:
1st Value: **4.000**
2nd Value:
Value Percent:
Continuous Index:
Within 8" of Joint:
Remarks: **RBL**

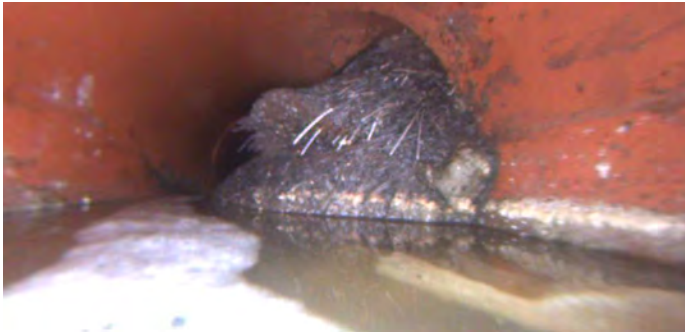
Code: **RBL**
Description: **Roots Ball Lateral**

Distance (ft): **30.7**
Structural Grade: **0**
O&M Grade: **4**
Clock Start/From: **1**
Clock To: **6**
1st Value:
2nd Value:
Value Percent: **70.000**
Continuous Index:
Within 8" of Joint: **NO**
Remarks:
