## Profile/Photo Observation Report

Date:	<b>03/30/2018</b>	Weather:		Coding:	<b>PACP 6.0</b>
Pipe Length (ft):	<b>231.0</b>	Owner:	<b>NA</b>	Pre Clean:	<b>Not Known</b>
P.O.#:		Surveyor:	<b>Jen Costello</b>	PSR:	<b>P-103-009-008</b>
Customer:		Clean Date:	<b>01/01/1900</b>	Shape:	<b>C</b>

Street:	<b>GILL ST</b>	Flow Control:	<b>Not Controlled</b>
City:	<b>Hobart, IN</b>	Year Renewed:	
Location:	<b>Other</b>	Tape/Media #:	
Purpose:	<b>Not Known</b>	Dia/Height:	<b>10"</b>
Use:	<b>Sanitary</b>	Material:	<b>VCP</b>
Drain Area:	<b>NA</b>	Lining:	
Category:	<b>NA</b>		
Comment:

Location Details:		Direction of Survey:	<b>Upstream</b>
US MH:	<b>M-103-008</b>	DS MH:	<b>M-103-009</b>
		Total Length Surveyed (ft):	<b>31.7</b>

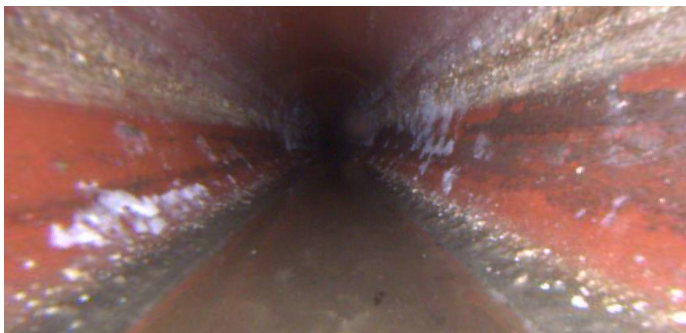
Code: **AMH**  
Description: **Manhole**

Distance (ft): **.0**  
Structural Grade: **0**  
O&M Grade: **0**  
Clock Start/From:  
Clock To:  
1st Value:  
2nd Value:  
Value Percent:  
Continuous Index:  
Within 8" of Joint: **NO**  
Remarks: **M-103-009**

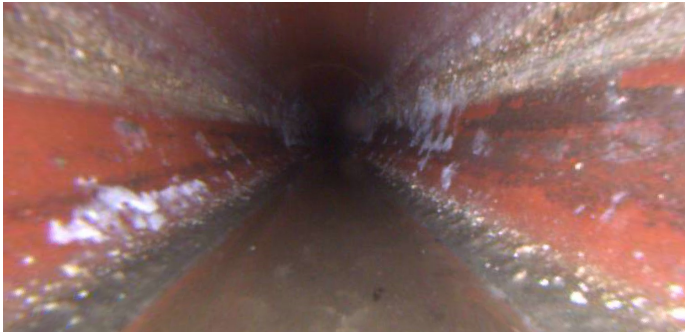
Code:	<b>MWL</b>
Description:	<b>Water Level</b>

Distance (ft):	<b>.0</b>
Structural Grade:	<b>0</b>
O&M Grade:	<b>0</b>
Clock Start/From:	
Clock To:	
1st Value:	
2nd Value:	
Value Percent:	<b>5.000</b>
Continuous Index:	
Within 8" of Joint:	<b>NO</b>
Remarks:

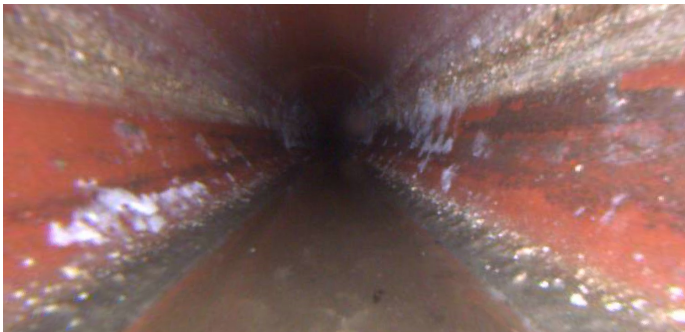
Code:	<b>DAGS</b>
Description:	<b>Deposits Attached Grease</b>

Distance (ft):	<b>.0</b>
Structural Grade:	<b>0</b>
O&M Grade:	<b>2</b>
Clock Start/From:	<b>8</b>
Clock To:	<b>4</b>
1st Value:	
2nd Value:	
Value Percent:	<b>5.000</b>
Continuous Index:	<b>S01</b>
Within 8" of Joint:	<b>NO</b>
Remarks:

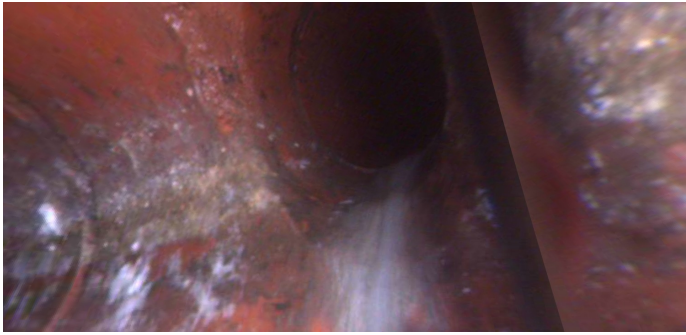
Code: **TFA**  
Description: **Tap Factory Active**

Distance (ft): **9.3**  
Structural Grade: **0**  
O&M Grade: **0**  
Clock Start/From: **10**  
Clock To:  
1st Value: **4.000**  
2nd Value:  
Value Percent:  
Continuous Index:  
Within 8" of Joint:  
Remarks:

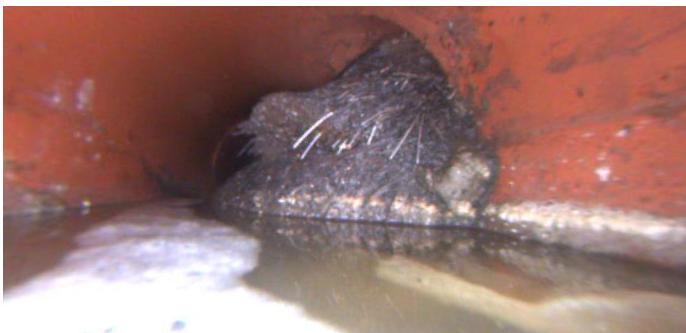
Code: **TFD**  
Description: **Tap Factory Defective**

Distance (ft): **30.7**  
Structural Grade: **0**  
O&M Grade: **2**  
Clock Start/From: **2**  
Clock To:  
1st Value: **4.000**  
2nd Value:  
Value Percent:  
Continuous Index:  
Within 8" of Joint:  
Remarks: **RBL**

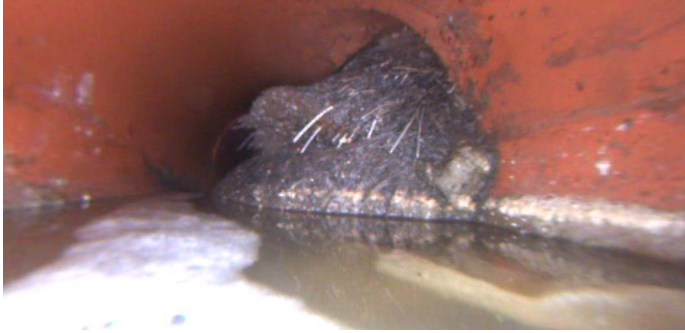
Code: **RBL**  
Description: **Roots Ball Lateral**

Distance (ft): **30.7**  
Structural Grade: **0**  
O&M Grade: **4**  
Clock Start/From: **1**  
Clock To: **6**  
1st Value:  
2nd Value:  
Value Percent: **70.000**  
Continuous Index:  
Within 8" of Joint: **NO**  
Remarks:

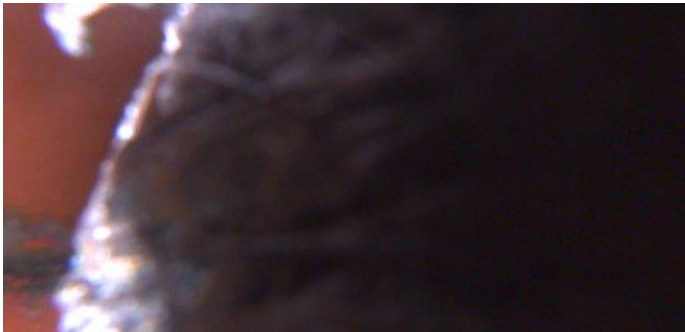
Code: **MSA**  
Description: **Abandoned Survey**

Distance (ft): **31.7**  
Structural Grade: **0**  
O&M Grade: **0**  
Clock Start/From:  
Clock To:  
1st Value:  
2nd Value:  
Value Percent:  
Continuous Index:  
Within 8" of Joint: **NO**  
Remarks: **ROOTS**

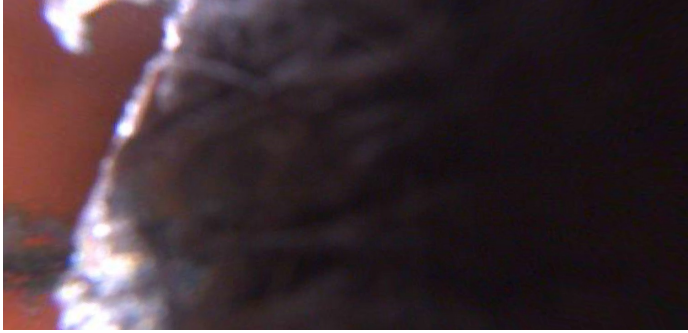
Code:	<b>DAGS</b>
Description:	<b>Deposits Attached Grease</b>
Distance (ft):	<b>31.7</b>
Structural Grade:	<b>0</b>
O&M Grade:	<b>2</b>
Clock Start/From:	<b>8</b>
Clock To:	<b>4</b>
1st Value:	
2nd Value:	
Value Percent:	<b>5.000</b>
Continuous Index:	<b>F01</b>
Within 8" of Joint:	<b>NO</b>
Remarks:
