Profile/Photo Observation Report

Date:	09/29/2018	Weather:		Coding:	PACP 6.0
Pipe Length (ft):	231.0	Owner:	NA	Pre Clean:	Not Known
P.O.#:		Surveyor:	Justin Gonzales	PSR:	P-103-009-008
Customer:		Clean Date:	01/01/1900	Shape:	C

Street:	Willow St.	Flow Control:	Not Controlled
City:	Hobart, IN	Year Renewed:	
Location:	Light Highway	Tape/Media #:	
Purpose:	Routine Assessment	Dia/Height:	10"
Use:	Sanitary	Material:	VCP
Drain Area:	NA	Lining:	
Category:	NA		
Comment:

Location Details:		Direction of Survey:	Upstream
US MH:	M-103-008	DS MH:	M-103-009
		Total Length Surveyed (ft):	225.2

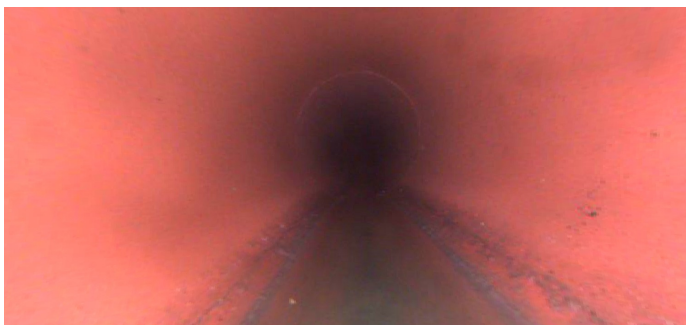
Code: **AMH**
Description: **Manhole**

Distance (ft): **.0**
Structural Grade: **0**
O&M Grade: **0**
Clock Start/From:
Clock To:
1st Value:
2nd Value:
Value Percent:
Continuous Index:
Within 8" of Joint: **NO**
Remarks: **M-103-009**

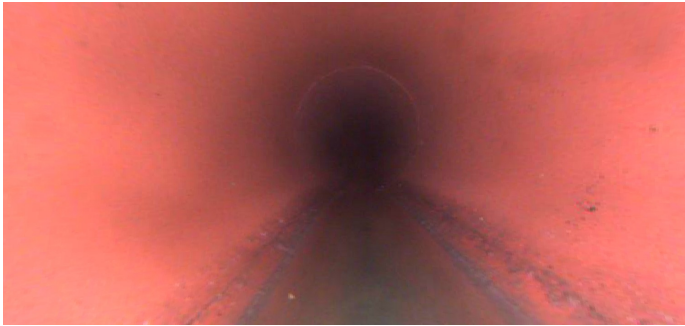
Code:	MWL
Description:	Water Level

Distance (ft):	.0
Structural Grade:	0
O&M Grade:	0
Clock Start/From:	
Clock To:	
1st Value:	
2nd Value:	
Value Percent:	5.000
Continuous Index:	
Within 8" of Joint:	NO
Remarks:

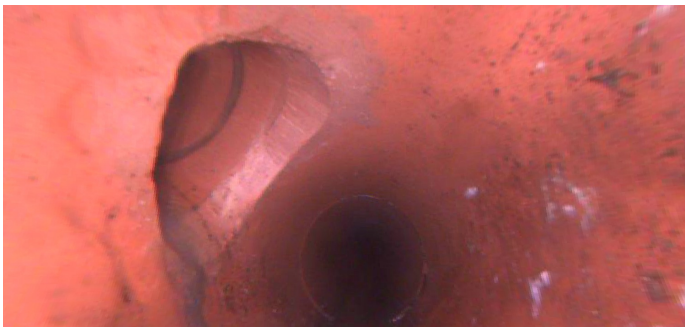
Code:	TF
Description:	Tap Factory

Distance (ft):	8.4
Structural Grade:	0
O&M Grade:	0
Clock Start/From:	10
Clock To:	
1st Value:	4.000
2nd Value:	
Value Percent:	
Continuous Index:	
Within 8" of Joint:	
Remarks:

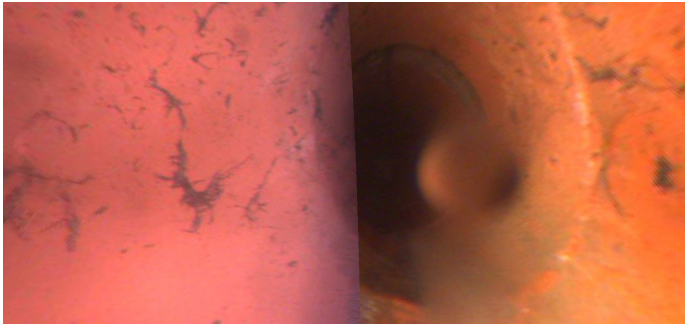
Code: **TF**
Description: **Tap Factory**

Distance (ft): **31.8**
Structural Grade: **0**
O&M Grade: **0**
Clock Start/From: **2**
Clock To:
1st Value: **4.000**
2nd Value:
Value Percent:
Continuous Index:
Within 8" of Joint:
Remarks:

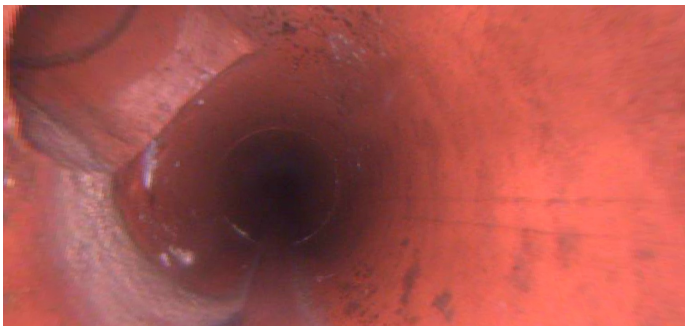
Code: **TF**
Description: **Tap Factory**

Distance (ft): **43.1**
Structural Grade: **0**
O&M Grade: **0**
Clock Start/From: **10**
Clock To:
1st Value: **4.000**
2nd Value:
Value Percent:
Continuous Index:
Within 8" of Joint:
Remarks:

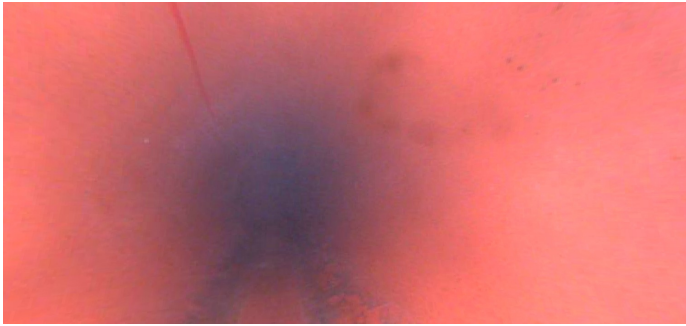
Code: **MGO**
Description: **General Observation**

Distance (ft): **72.7**
Structural Grade: **0**
O&M Grade: **0**
Clock Start/From:
Clock To:
1st Value:
2nd Value:
Value Percent:
Continuous Index:
Within 8" of Joint: **NO**
Remarks: **LIGHT FOG/STEAM**

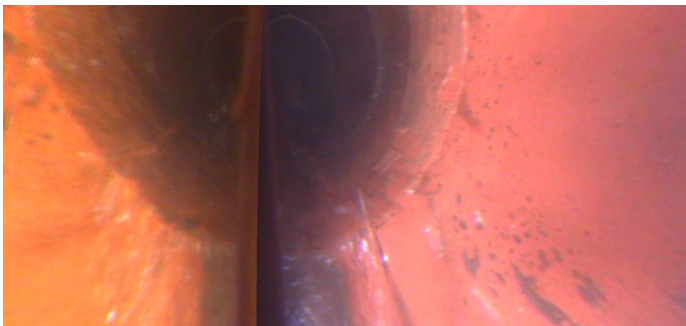
Code: **TFA**
Description: **Tap Factory Active**

Distance (ft): **86.4**
Structural Grade: **0**
O&M Grade: **0**
Clock Start/From: **10**
Clock To:
1st Value: **4.000**
2nd Value:
Value Percent:
Continuous Index:
Within 8" of Joint:
Remarks:

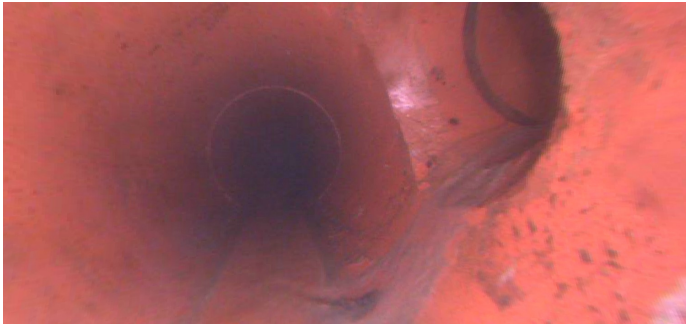
Code: **TF**
Description: **Tap Factory**

Distance (ft): **108.4**
Structural Grade: **0**
O&M Grade: **0**
Clock Start/From: **3**
Clock To:
1st Value: **4.000**
2nd Value:
Value Percent:
Continuous Index:
Within 8" of Joint:
Remarks:

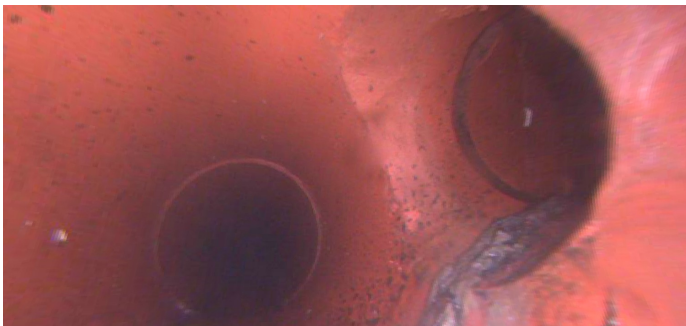
Code: **TF**
Description: **Tap Factory**

Distance (ft): **130.9**
Structural Grade: **0**
O&M Grade: **0**
Clock Start/From: **2**
Clock To:
1st Value: **4.000**
2nd Value:
Value Percent:
Continuous Index:
Within 8" of Joint:
Remarks:

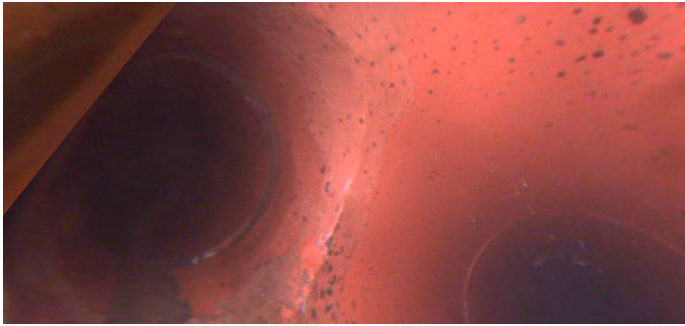
Code: **TF**
Description: **Tap Factory**

Distance (ft): **143.1**
Structural Grade: **0**
O&M Grade: **0**
Clock Start/From: **10**
Clock To:
1st Value: **4.000**
2nd Value:
Value Percent:
Continuous Index:
Within 8" of Joint:
Remarks:

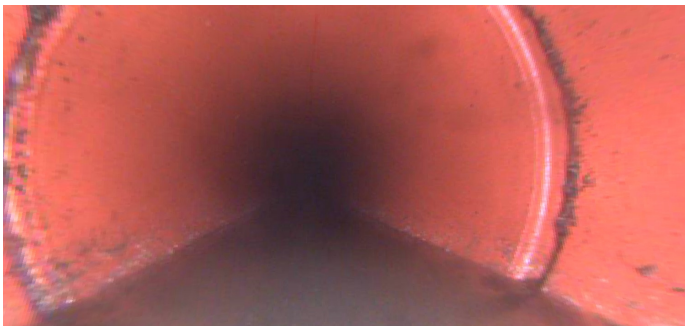
Code: **MWLS**
Description: **Water Level Sag**

Distance (ft): **159.3**
Structural Grade: **2**
O&M Grade: **3**
Clock Start/From:
Clock To:
1st Value:
2nd Value:
Value Percent: **10.000**
Continuous Index:
Within 8" of Joint: **NO**
Remarks:

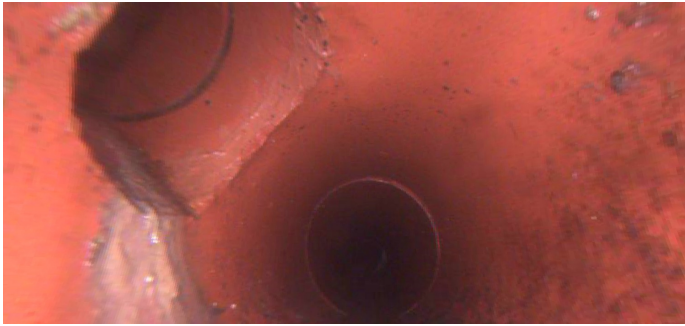
Code: **TF**
Description: **Tap Factory**

Distance (ft): **195.5**
Structural Grade: **0**
O&M Grade: **0**
Clock Start/From: **10**
Clock To:
1st Value: **4.000**
2nd Value:
Value Percent:
Continuous Index:
Within 8" of Joint:
Remarks:

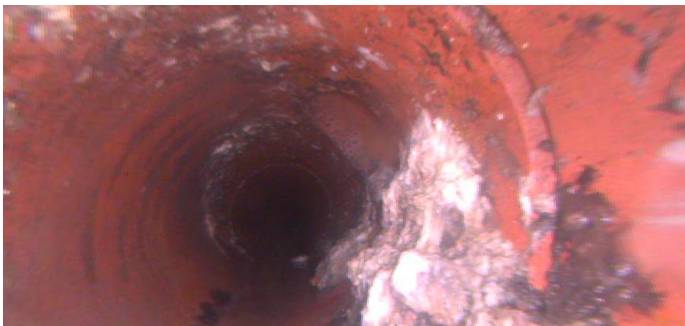
Code: **DAZ**
Description: **Deposits Attached Other**

Distance (ft): **201.9**
Structural Grade: **0**
O&M Grade: **2**
Clock Start/From: **7**
Clock To: **5**
1st Value:
2nd Value:
Value Percent: **5.000**
Continuous Index:
Within 8" of Joint: **NO**
Remarks:

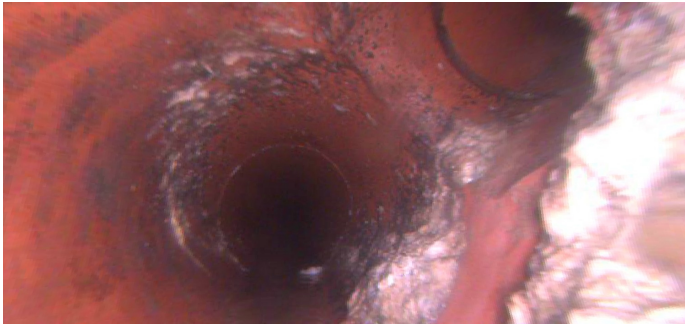
Code: **TF**
Description: **Tap Factory**

Distance (ft): **202.5**
Structural Grade: **0**
O&M Grade: **0**
Clock Start/From: **2**
Clock To:
1st Value: **4.000**
2nd Value:
Value Percent:
Continuous Index:
Within 8" of Joint:
Remarks:

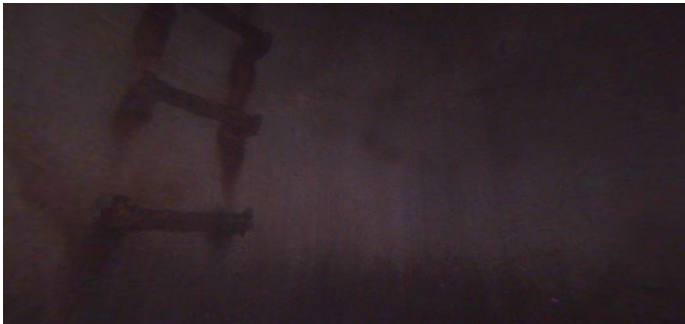
Code: **AMH**
Description: **Manhole**

Distance (ft): **225.2**
Structural Grade: **0**
O&M Grade: **0**
Clock Start/From:
Clock To:
1st Value:
2nd Value:
Value Percent:
Continuous Index:
Within 8" of Joint: **NO**
Remarks: **M-103-008**
