Profile/Photo Observation Report

| Street: | GILL ST | Flow Control: | Not Controlled |
| City: | Hobart, IN | Year Renewed: | |

| US MH: | M-103-009 | DS MH: | M-103-010 |

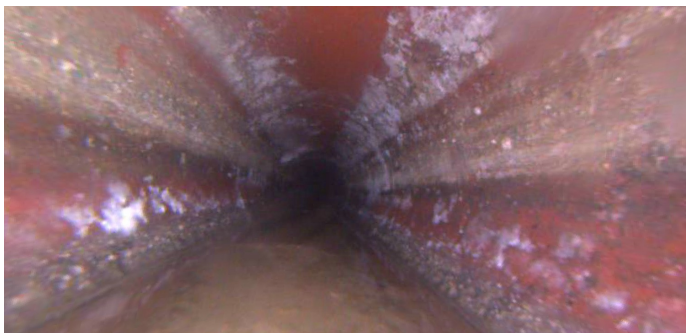
Code: **AMH**
Description: **Manhole**

Distance (ft): **.0**
Structural Grade: **0**
O&M Grade: **0**
Clock Start/From:
Clock To:
1st Value:
2nd Value:
Value Percent:
Continuous Index:
Within 8" of Joint: **NO**
Remarks: **M-103-009**

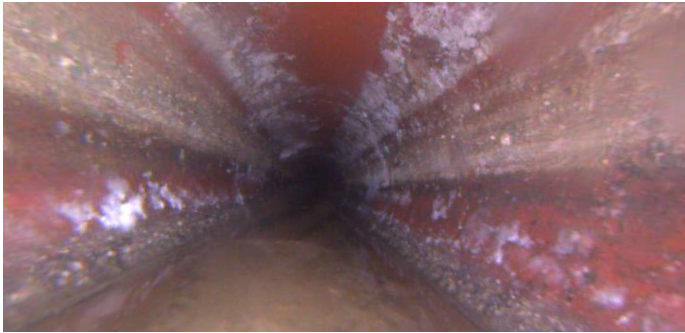
| Code: | MWL |
| Description: | Water Level |

| Value Percent: | 10.000 |

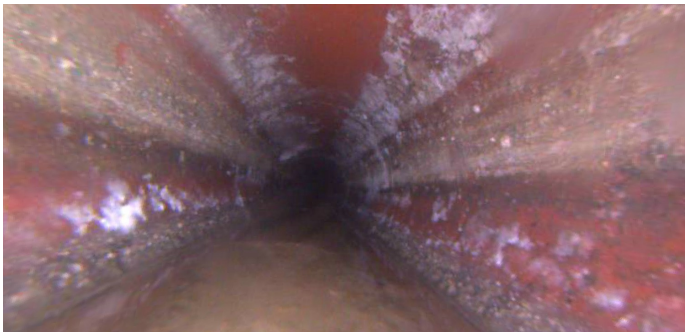
| Code: | DAGS |
| Description: | Deposits Attached Grease |

| O&M Grade: | 2 |
| Clock Start/From: | 8 |
| Clock To: | 4 |
| Value Percent: | 5.000 |

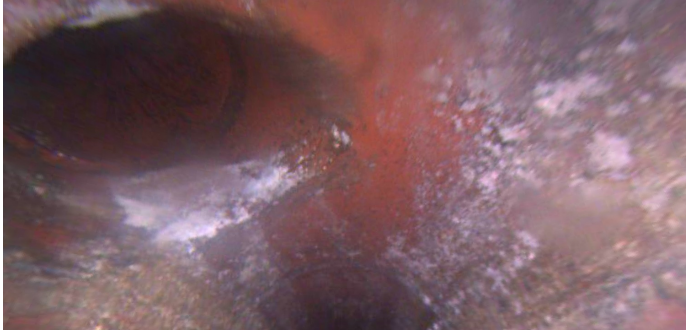
Code: **TF**
Description: **Tap Factory**

Distance (ft): **3.6**
Structural Grade: **0**
O&M Grade: **0**
Clock Start/From: **11**
Clock To:
1st Value: **4.000**
2nd Value:
Value Percent:
Continuous Index:
Within 8" of Joint:
Remarks:

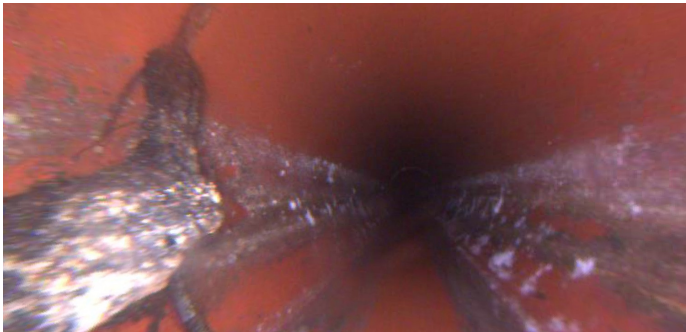
| | Position | Code | Observation | Video (sec) | Grade |
|--|---|---|---|---|---|
| | 19.4 | RMJ | Roots Medium Joint | 95 | M 3 |

Code: **RMJ**
Description: **Roots Medium Joint**

Distance (ft): **19.4**
Structural Grade: **0**
O&M Grade: **3**
Clock Start/From: **8**
Clock To: **9**
1st Value:
2nd Value:
Value Percent: **5.000**
Continuous Index:
Within 8" of Joint: **YES**
Remarks:

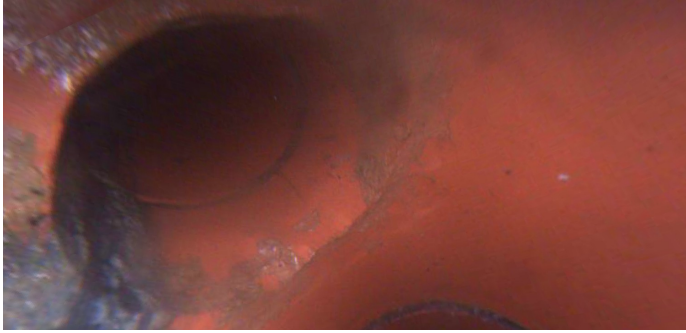
Code: **TF**
Description: **Tap Factory**

Distance (ft): **41.1**
Structural Grade: **0**
O&M Grade: **0**
Clock Start/From: **11**
Clock To:
1st Value: **4.000**
2nd Value:
Value Percent:
Continuous Index:
Within 8" of Joint:
Remarks:

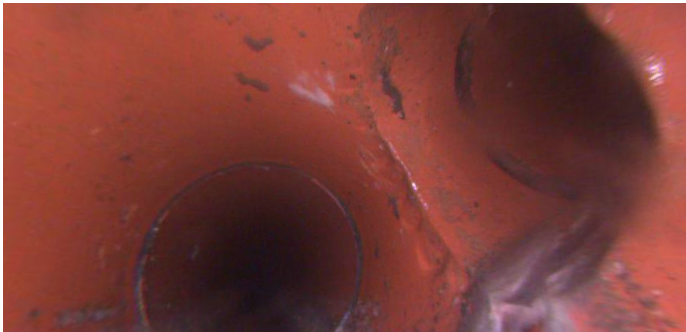
Code: **TFA**
Description: **Tap Factory Active**

Distance (ft): **58.2**
Structural Grade: **0**
O&M Grade: **0**
Clock Start/From: **2**
Clock To:
1st Value: **4.000**
2nd Value:
Value Percent:
Continuous Index:
Within 8" of Joint:
Remarks:

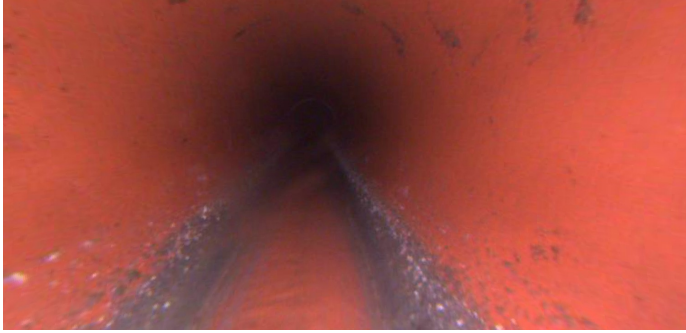
Code: **DAGS**
Description: **Deposits Attached Grease**

Distance (ft): **64.7**
Structural Grade: **0**
O&M Grade: **2**
Clock Start/From: **8**
Clock To: **4**
1st Value:
2nd Value:
Value Percent: **5.000**
Continuous Index: **F01**
Within 8" of Joint: **NO**
Remarks:

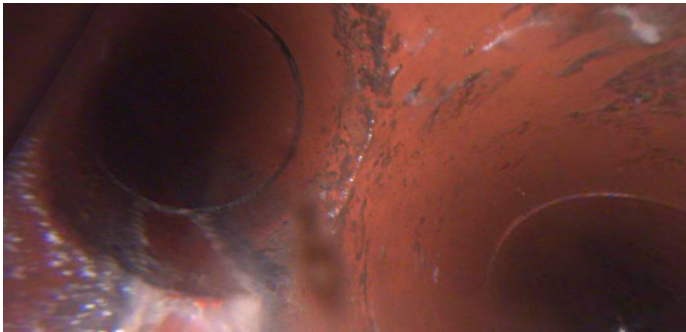
Code: **TFA**
Description: **Tap Factory Active**

Distance (ft): **96.7**
Structural Grade: **0**
O&M Grade: **0**
Clock Start/From: **2**
Clock To:
1st Value: **4.000**
2nd Value:
Value Percent:
Continuous Index:
Within 8" of Joint:
Remarks:

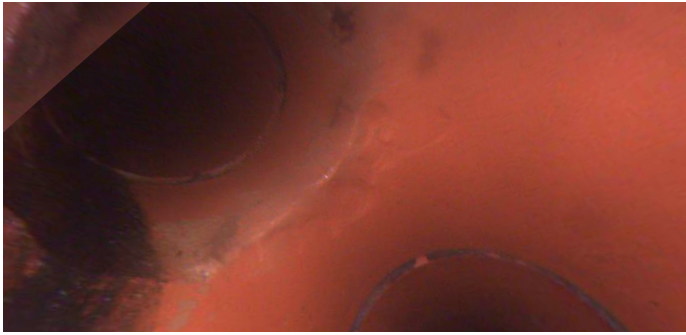
Code: **TF**
Description: **Tap Factory**

Distance (ft): **108.5**
Structural Grade: **0**
O&M Grade: **0**
Clock Start/From: **10**
Clock To:
1st Value: **4.000**
2nd Value:
Value Percent:
Continuous Index:
Within 8" of Joint:
Remarks:

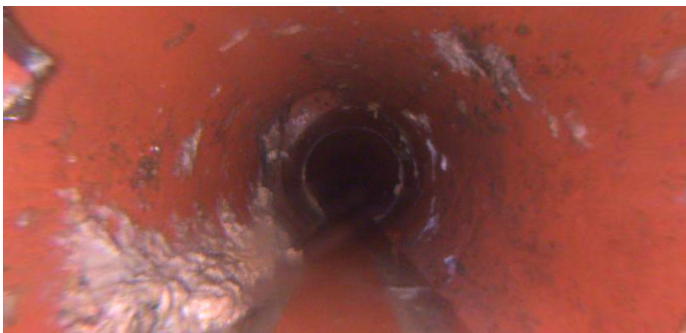
Code: **DAGS**
Description: **Deposits Attached Grease**

Distance (ft): **150.2**
Structural Grade: **0**
O&M Grade: **2**
Clock Start/From: **8**
Clock To: **4**
1st Value:
2nd Value:
Value Percent: **5.000**
Continuous Index:
Within 8" of Joint: **NO**
Remarks:

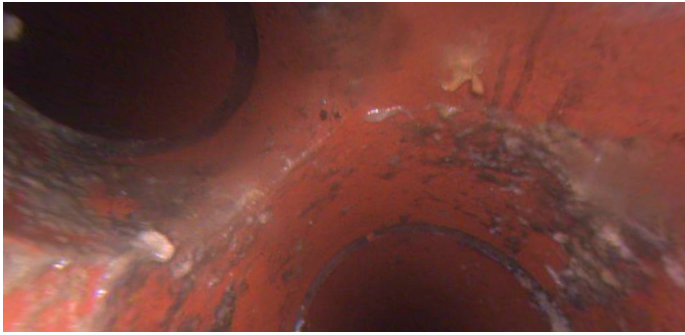
Code: **TF**
Description: **Tap Factory**

Distance (ft): **151.5**
Structural Grade: **0**
O&M Grade: **0**
Clock Start/From: **10**
Clock To:
1st Value: **4.000**
2nd Value:
Value Percent:
Continuous Index:
Within 8" of Joint:
Remarks:

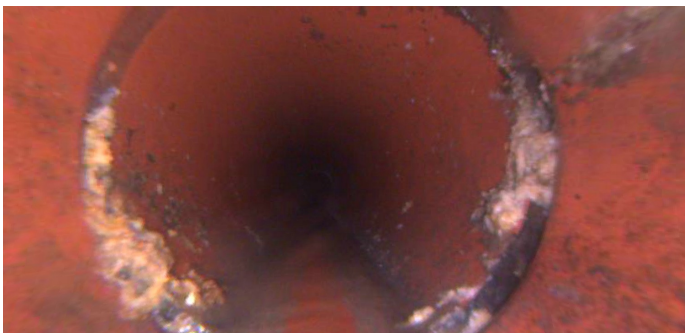
Code: **DAGS**
Description: **Deposits Attached Grease**

Distance (ft): **152.1**
Structural Grade: **0**
O&M Grade: **2**
Clock Start/From: **8**
Clock To: **4**
1st Value:
2nd Value:
Value Percent: **5.000**
Continuous Index:
Within 8" of Joint: **YES**
Remarks:

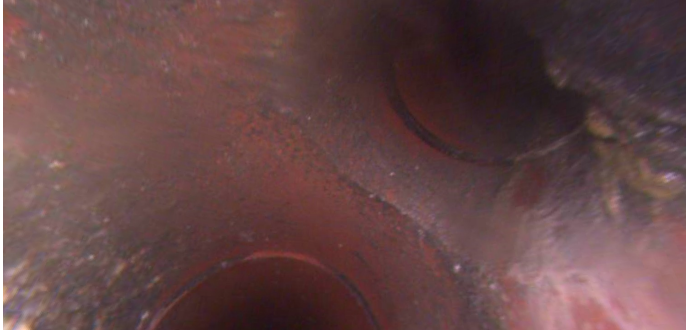
Code: **TF**
Description: **Tap Factory**

Distance (ft): **158.6**
Structural Grade: **0**
O&M Grade: **0**
Clock Start/From: **2**
Clock To:
1st Value: **4.000**
2nd Value:
Value Percent:
Continuous Index:
Within 8" of Joint:
Remarks:

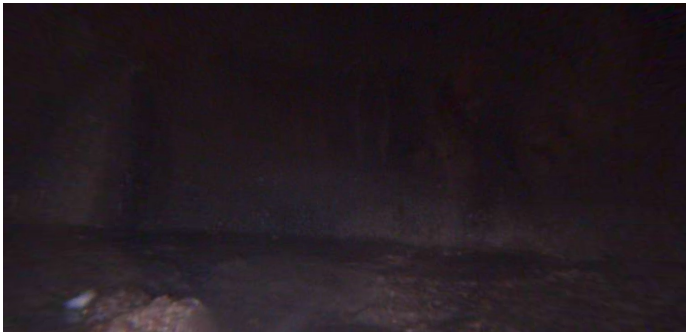
Code: **AMH**
Description: **Manhole**

Distance (ft): **180.9**
Structural Grade: **0**
O&M Grade: **0**
Clock Start/From:
Clock To:
1st Value:
2nd Value:
Value Percent:
Continuous Index:
Within 8" of Joint: **NO**
Remarks: **M-103-010**
