## Profile/Photo Observation Report

Street:	<b>E 40TH AVE</b>	Flow Control:	<b>Not Controlled</b>
City:	<b>Hobart, IN</b>	Year Renewed:	
Location:	<b>Light Highway</b>	Tape/Media #:	
Purpose:	<b>Routine Assessment</b>	Dia/Height:	<b>10"</b>
Use:	<b>Sanitary</b>	Material:	<b>VCP</b>
Drain Area:	<b>NA</b>	Lining:	
Category:	<b>NA</b>		
Comment:

Location Details:		Direction of Survey:	<b>Upstream</b>
US MH:	<b>M-103-010</b>	DS MH:	<b>M-103-011</b>
		Total Length Surveyed (ft):	<b>6.6</b>

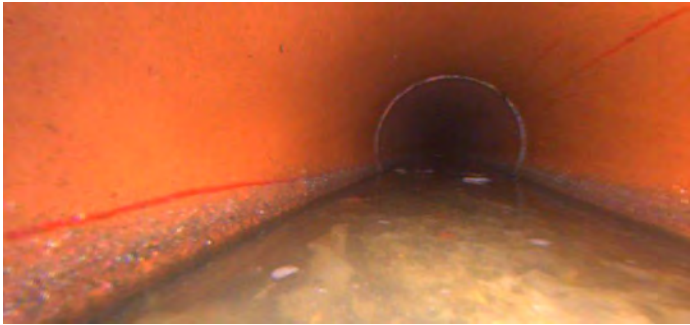
Code: AMH

Description: Manhole

Remarks: M-103-011

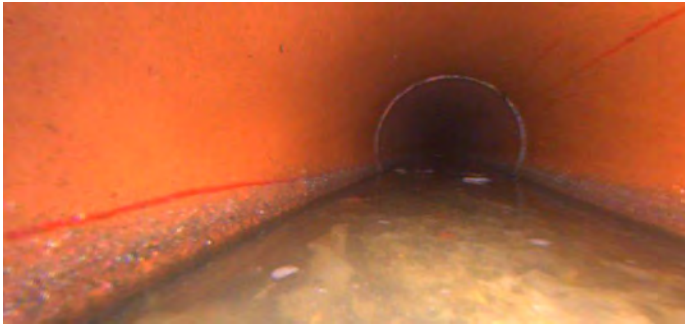
Code:	<b>MWL</b>
Description:	<b>Water Level</b>

Distance (ft):	<b>.0</b>
Structural Grade:	<b>0</b>
O&M Grade:	<b>0</b>
Clock Start/From:	
Clock To:	
1st Value:	
2nd Value:	
Value Percent:	<b>5.000</b>
Continuous Index:	
Within 8" of Joint:	<b>NO</b>
Remarks:

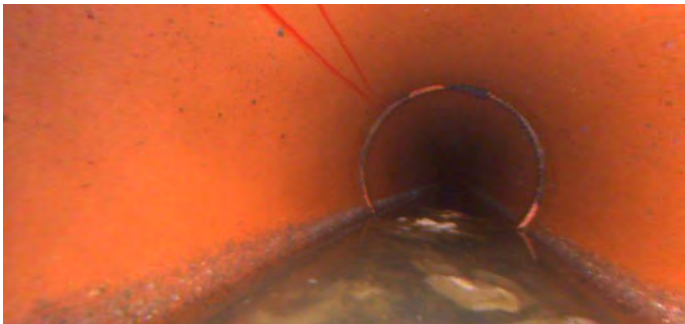
Code:	<b>MSA</b>
Description:	<b>Abandoned Survey</b>

Distance (ft):	<b>6.6</b>
Structural Grade:	<b>0</b>
O&M Grade:	<b>0</b>
Clock Start/From:	
Clock To:	
1st Value:	
2nd Value:	
Value Percent:	
Continuous Index:	
Within 8" of Joint:	<b>NO</b>
Remarks:	<b>camera stopped</b>
