Profile/Photo Observation Report

Date: 09/07/2021 Weather: **PACP 7.0** Coding: Pipe Length (ft): 160.2 Owner: **City of Hobart** Pre Clean: **Light Cleaning** P.O.#: YES502259 S. Bucklin PSR: P-504-113-112 Surveyor:

Street: 41st Avenue Flow Control: Not Controlled

US MH: M-503-032 DS MH: M-504-112 Total Length Surveyed (ft): 160.2

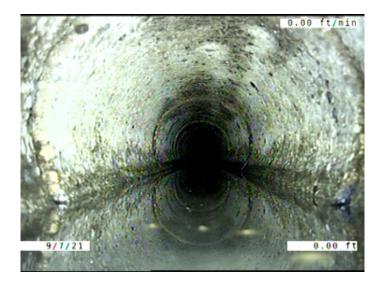
Code: MWL

Description: Miscellaneous Water Level

Distance (ft): .0
Structural Grade: 0
O&M Grade: 0

Value Percent: 10.000

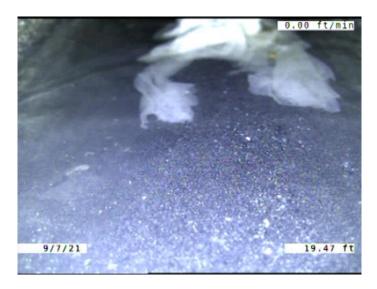
Code: **DSF**

Description: Deposits Settled Fine

Distance (ft): 19.5
Structural Grade: 0
O&M Grade: 2
Clock Start/From: 5
Clock To: 7
1st Value:

Value Percent: 5.000
Continuous Index: S01
Within 8" of Joint: YES

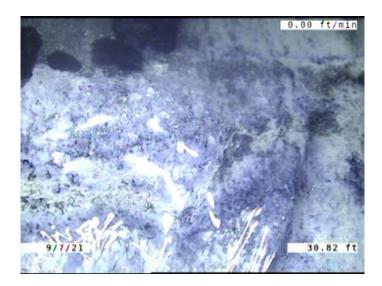
Code: DAE

Description: **Deposits Attached Encrustation**

Distance (ft): 30.8 Structural Grade: 0 2 O&M Grade: Clock Start/From: 5 Clock To: 7

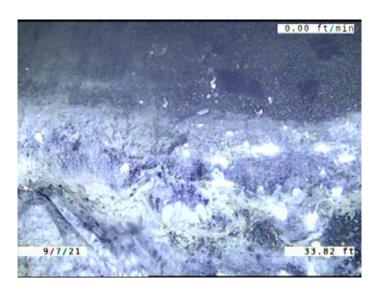
Code: DAE

Description: **Deposits Attached Encrustation**

Distance (ft): 33.8 Structural Grade: 0 O&M Grade: 2 Clock Start/From: 5 7 Clock To: 1st Value: 2nd Value:

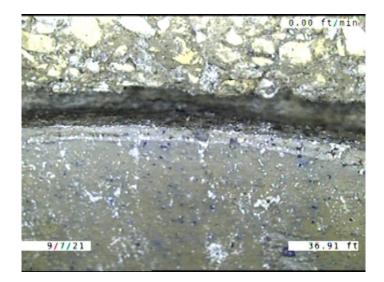
Code: MMC

Description: Miscellaneous Material Change

Distance (ft): 36.9
Structural Grade: 0

Remarks: CONCRETE TO VCP

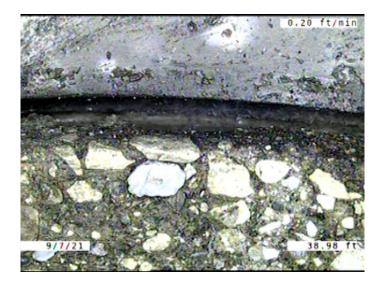
Code: MMC

Description: **Miscellaneous Material Change**

Distance (ft): 39.0 Structural Grade: 0 0 O&M Grade:

Remarks: **VCP TO CONCRETE**

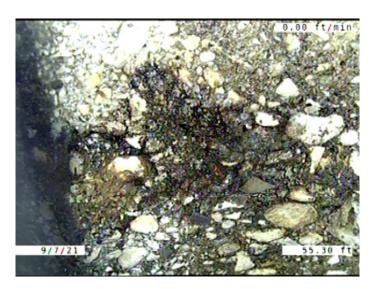
ISB Code:

Description: **Infiltration Stain Barrel**

Distance (ft): 55.3 Structural Grade: 0 O&M Grade: 1 Clock Start/From: 9 Clock To:

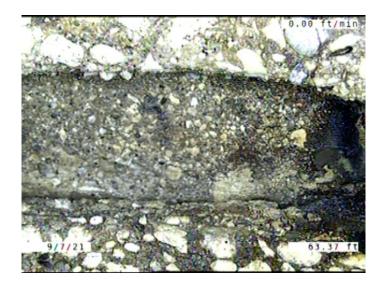
Code: JAM

Description: Joint Angular Medium

Distance (ft): 63.4
Structural Grade: 3
O&M Grade: 0

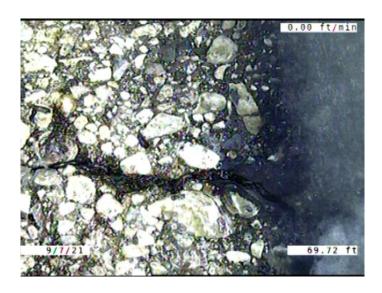
Code: FS

Description: Fracture Spiral

Distance (ft): 69.7
Structural Grade: 3
O&M Grade: 0
Clock Start/From: 2
Clock To: 10
1st Value:
2nd Value:

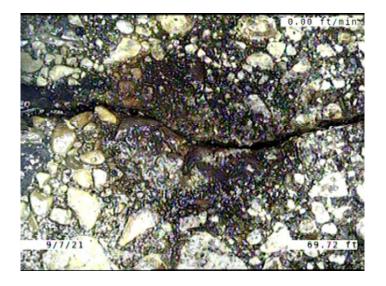
Description: Infiltration Stain Barrel

Distance (ft): 69.7
Structural Grade: 0

O&M Grade: 1

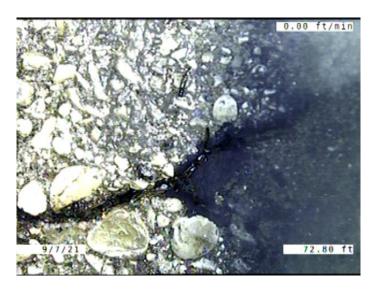
Code: FM

Description: Fracture Multiple

Distance (ft): 72.8
Structural Grade: 4

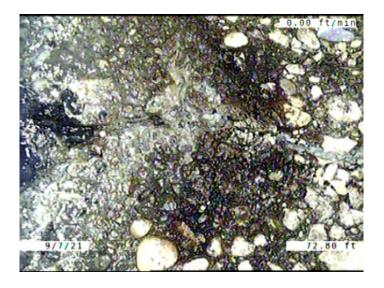
Description: Infiltration Stain Barrel

Distance (ft): 72.8
Structural Grade: 0

O&M Grade: 1

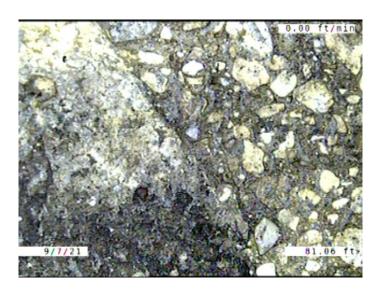
Code: CS

Description: Crack Spiral

Distance (ft): 81.1
Structural Grade: 2
O&M Grade: 0
Clock Start/From: 9
Clock To: 11
1st Value:
2nd Value:
Value Percent:

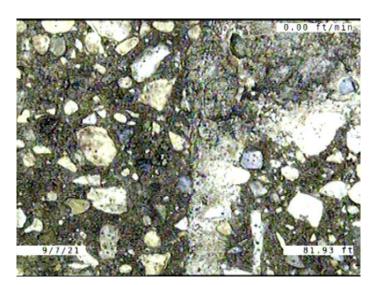
Code: CM

Description: Crack Multiple

Distance (ft): 81.9
Structural Grade: 3
O&M Grade: 0
Clock Start/From: 1
Clock To: 3
1st Value:
2nd Value:
Value Percent:
Continuous Index:

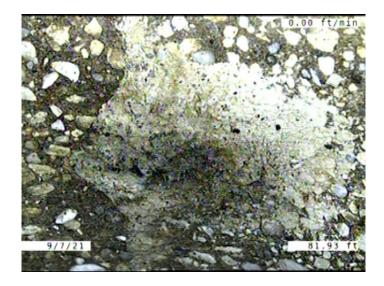
Description: Infiltration Stain Barrel

Distance (ft): 81.9
Structural Grade: 0
O&M Grade: 1
Clock Start/From: 1
Clock To: 4

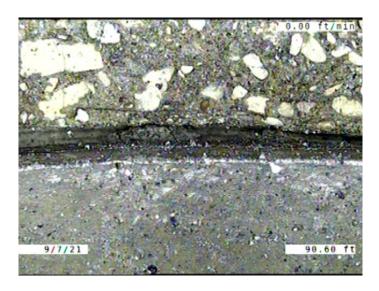
Code: MMC

Description: Miscellaneous Material Change

Distance (ft): 90.6
Structural Grade: 0

Remarks: CONCRETE TO VCP

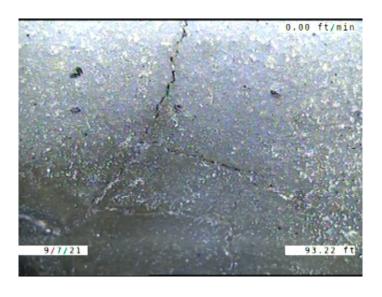
Code: FM

Description: Fracture Multiple

Distance (ft): 93.2
Structural Grade: 4

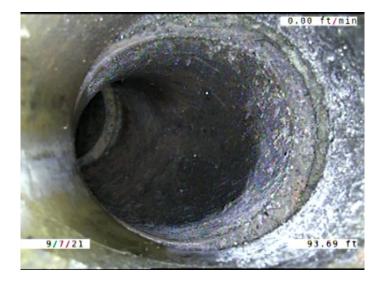
Code: **TFD**

Description: Tap Factory Defective

Distance (ft): 93.7
Structural Grade: 0

O&M Grade: 3

Remarks: **Defective**

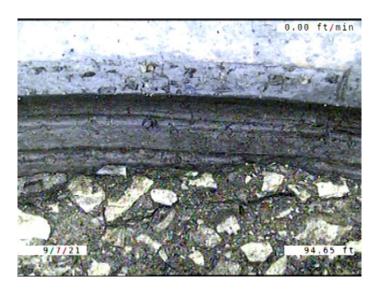
Code: MMC

Description: Miscellaneous Material Change

Distance (ft): 94.6
Structural Grade: 0

Remarks: VCP TO CONCRETE

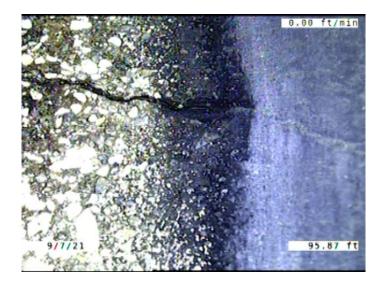
Code: FM

Description: Fracture Multiple

Distance (ft): 95.9
Structural Grade: 4
O&M Grade: 0
Clock Start/From: 12
Clock To: 12

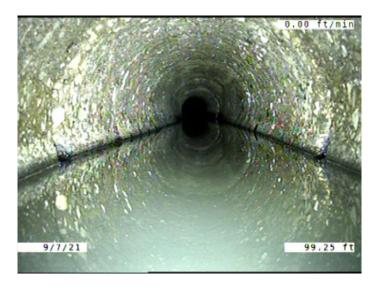
Code: MWLS

Description: Miscellaneous Water Level Sag

Distance (ft): 99.2
Structural Grade: 2
O&M Grade: 0

Value Percent: 15.000
Continuous Index: S02
Within 8" of Joint: NO

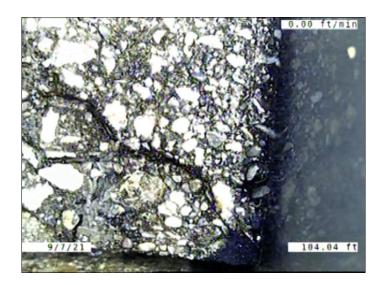
Code: FM
Description: Fracture Multiple

Distance (ft): 104.0 Structural Grade: 4 O&M Grade: 0 Clock Start/From: 7 Clock To: 5 1st Value: 2nd Value: Value Percent: Continuous Index: Within 8" of Joint: YES

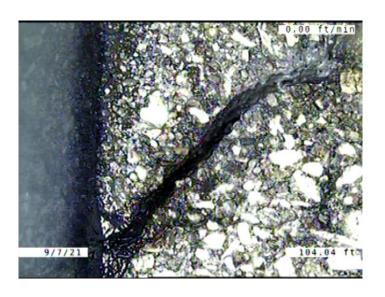
Code: B
Description: Broken

Distance (ft): 104.0
Structural Grade: 4

O&M Grade: 0
Clock Start/From: 3
Clock To: 12

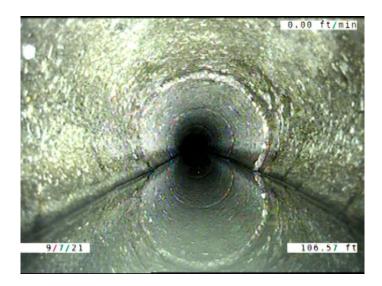
Code: MWLS

Description: Miscellaneous Water Level Sag

Distance (ft): 106.6
Structural Grade: 2
O&M Grade: 0

Value Percent: 15.000
Continuous Index: F02
Within 8" of Joint: NO

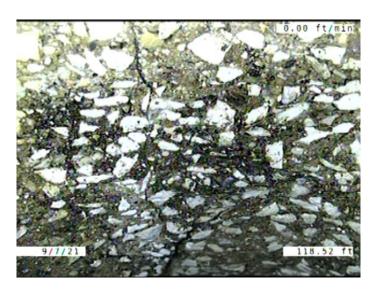
Code: FM

Description: Fracture Multiple

Distance (ft): 118.5
Structural Grade: 4
O&M Grade: 0
Clock Start/From: 8
Clock To: 4
1st Value:
2nd Value:
Value Percent:

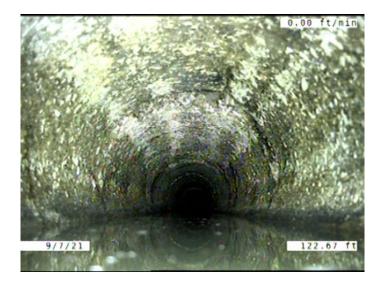
Code: MWLS

Description: Miscellaneous Water Level Sag

Distance (ft): 122.7
Structural Grade: 2
O&M Grade: 0

Value Percent: 15.000

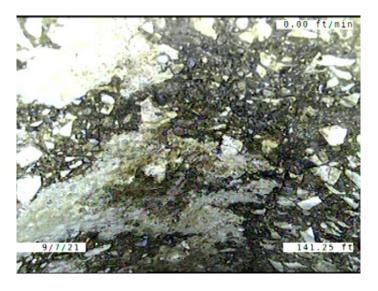
Code: ISB

Description: Infiltration Stain Barrel

Distance (ft): 141.2
Structural Grade: 0
O&M Grade: 1
Clock Start/From: 8
Clock To: 11
1st Value:

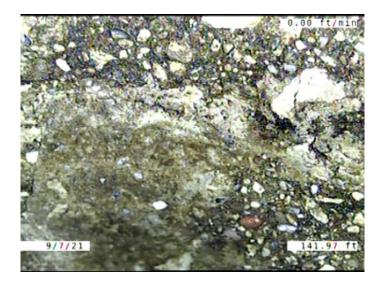
Description: **Infiltration Stain Barrel**

Distance (ft): 142.0 Structural Grade: 0 O&M Grade: 1 Clock Start/From: 2 5

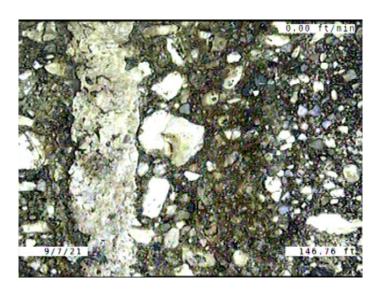
Code: DAE

Description: **Deposits Attached Encrustation**

Distance (ft): 146.8 Structural Grade: 0 O&M Grade: 2 Clock Start/From: 7 9 Clock To: 1st Value:

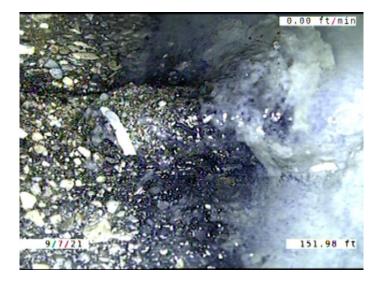
Code: DAE

Description: **Deposits Attached Encrustation**

Distance (ft): 152.0 Structural Grade: 0 2 O&M Grade: Clock Start/From: 4 Clock To: 8

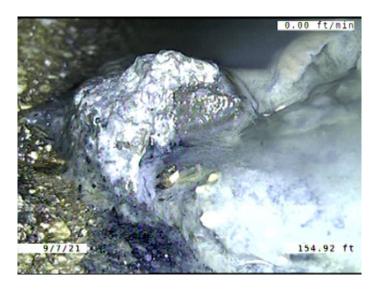
Code: DAE

Description: **Deposits Attached Encrustation**

Distance (ft): 154.9 Structural Grade: 0 O&M Grade: 2 Clock Start/From: 5 8 Clock To: 1st Value:

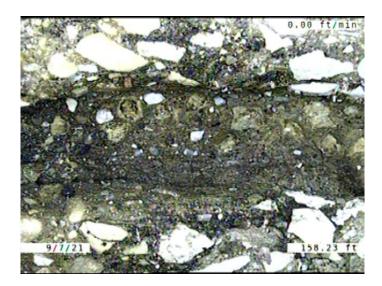
Code: JAM

Description: Joint Angular Medium

Distance (ft): 158.2 Structural Grade: 3 0 O&M Grade:

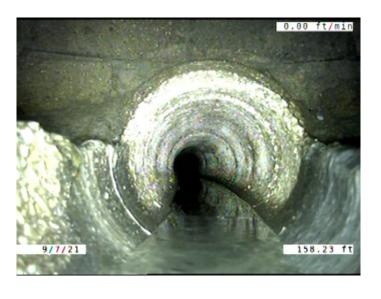
Code: FΜ

Description: **Fracture Multiple**

Distance (ft): 158.2 Structural Grade: 4 O&M Grade: 0 Clock Start/From: 8 Clock To: 4 1st Value:

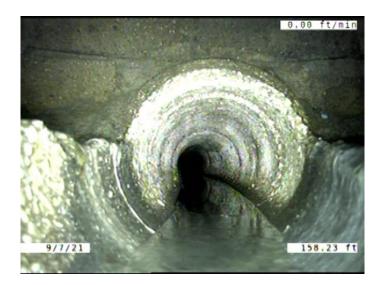
Code: **DSF**

Description: Deposits Settled Fine

Distance (ft): 158.2
Structural Grade: 0
O&M Grade: 2
Clock Start/From: 5
Clock To: 7
