Profile/Photo Observation Report

Street:	W 41ST AVE	Flow Control:	Not Controlled
City:	Hobart, IN	Year Renewed:	
Location:	Light Highway	Tape/Media #:	
Purpose:	Routine Assessment	Dia/Height:	10"
Use:	Sanitary	Material:	VCP
Drain Area:	NA	Lining:	
Category:	NA		
Comment:

Location Details:		Direction of Survey:	Downstream
US MH:	M-103-012	DS MH:	M-103-013
		Total Length Surveyed (ft):	105.2

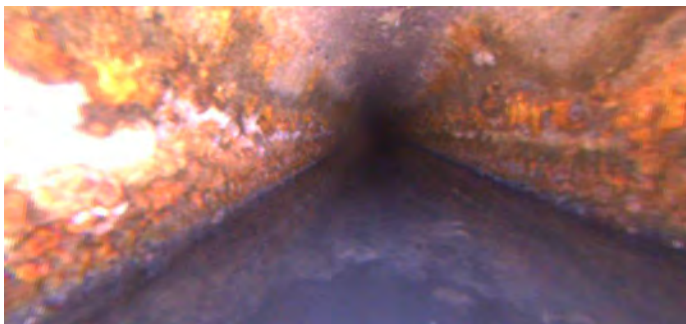
Code: **AMH**
Description: **Manhole**

Distance (ft): **.0**
Structural Grade: **0**
O&M Grade: **0**
Clock Start/From:
Clock To:
1st Value:
2nd Value:
Value Percent:
Continuous Index:
Within 8" of Joint: **NO**
Remarks: **M-103-012**

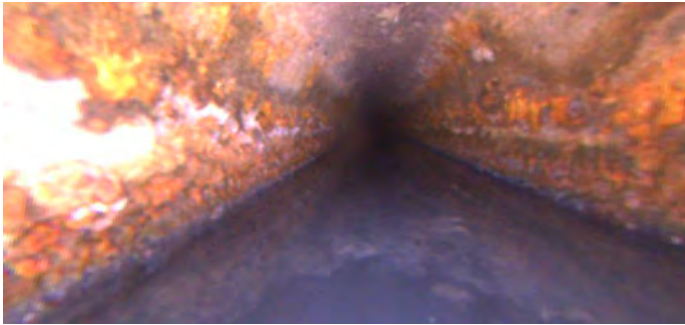
Code:	MWL
Description:	Water Level

Distance (ft):	.0
Structural Grade:	0
O&M Grade:	0
Clock Start/From:	
Clock To:	
1st Value:	
2nd Value:	
Value Percent:	5.000
Continuous Index:	
Within 8" of Joint:	NO
Remarks:

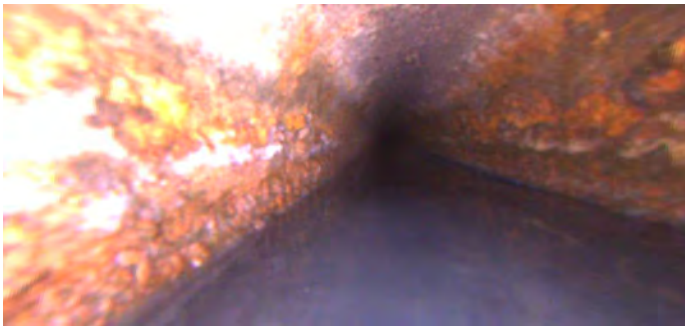
Code:	SRI
Description:	Surface Roughness Increased

Distance (ft):	1.6
Structural Grade:	1
O&M Grade:	0
Clock Start/From:	8
Clock To:	4
1st Value:	
2nd Value:	
Value Percent:	
Continuous Index:	S01
Within 8" of Joint:	
Remarks:

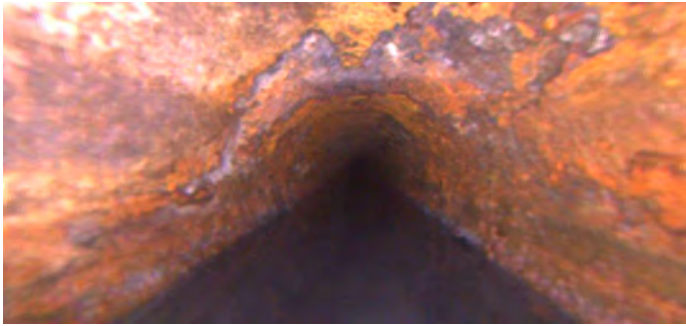
Code: **SRI**
Description: **Surface Roughness Increased**

Distance (ft): **7.9**
Structural Grade: **1**
O&M Grade: **0**
Clock Start/From: **8**
Clock To: **4**
1st Value:
2nd Value:
Value Percent:
Continuous Index: **F01**
Within 8" of Joint:
Remarks:

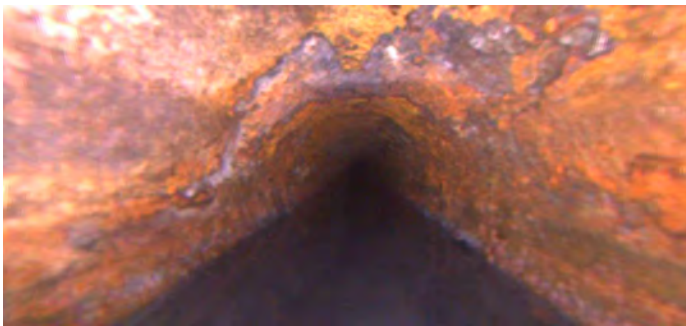
Code: **SAP**
Description: **Surface Aggregate Projecting**

Distance (ft): **7.9**
Structural Grade: **3**
O&M Grade: **0**
Clock Start/From: **8**
Clock To: **4**
1st Value:
2nd Value:
Value Percent:
Continuous Index: **S02**
Within 8" of Joint:
Remarks:

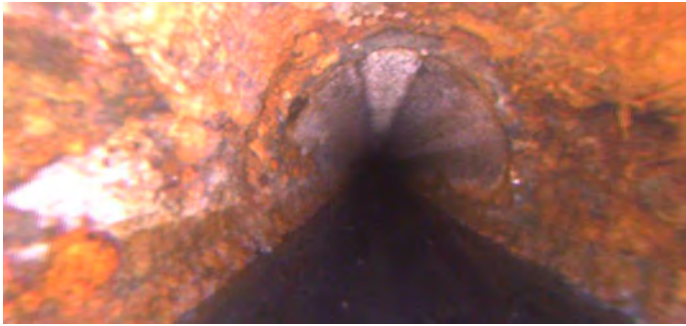
Code: **SAP**
Description: **Surface Aggregate Projecting**

Distance (ft): **26.5**
Structural Grade: **3**
O&M Grade: **0**
Clock Start/From: **8**
Clock To: **4**
1st Value:
2nd Value:
Value Percent:
Continuous Index: **F02**
Within 8" of Joint:
Remarks:

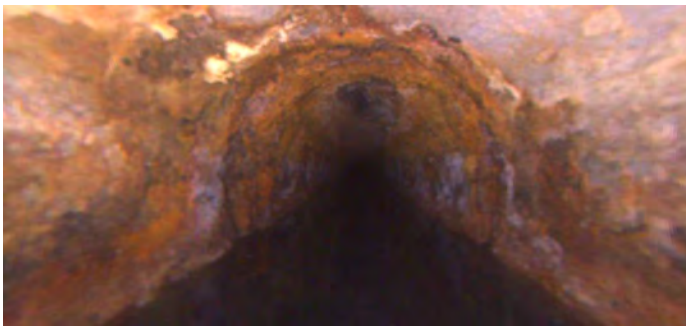
Code: **SAP**
Description: **Surface Aggregate Projecting**

Distance (ft): **44.6**
Structural Grade: **3**
O&M Grade: **0**
Clock Start/From: **8**
Clock To: **4**
1st Value:
2nd Value:
Value Percent:
Continuous Index: **S03**
Within 8" of Joint:
Remarks:

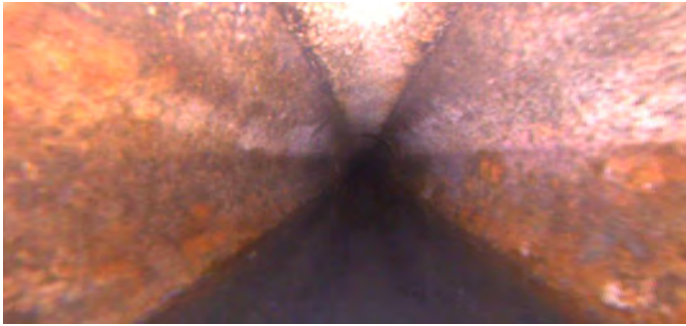
Code: **SAP**
Description: **Surface Aggregate Projecting**

Distance (ft): **59.2**
Structural Grade: **3**
O&M Grade: **0**
Clock Start/From: **8**
Clock To: **4**
1st Value:
2nd Value:
Value Percent:
Continuous Index: **F03**
Within 8" of Joint:
Remarks:

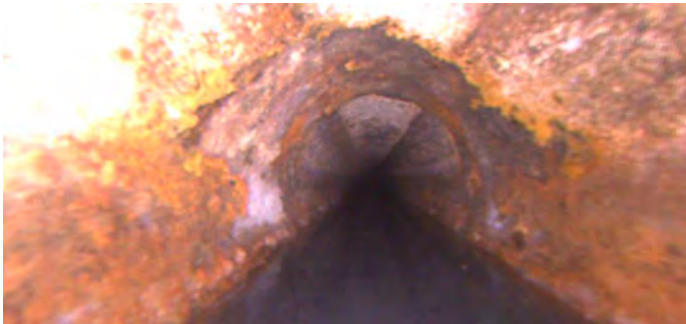
Code: **DAE**
Description: **Deposits Attached Encrustation**

Distance (ft): **62.2**
Structural Grade: **0**
O&M Grade: **3**
Clock Start/From: **7**
Clock To: **5**
1st Value:
2nd Value:
Value Percent: **20.000**
Continuous Index:
Within 8" of Joint: **YES**
Remarks:

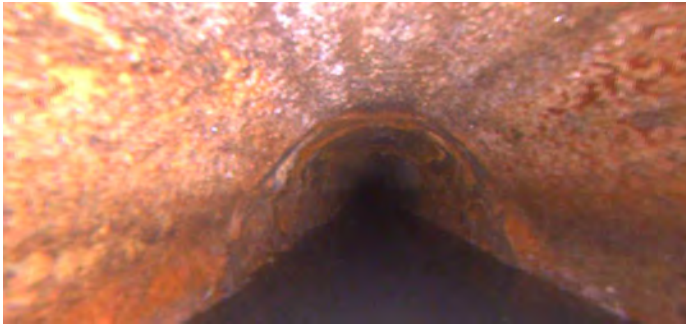
Code: **DAE**
Description: **Deposits Attached Encrustation**

Distance (ft): **97.9**
Structural Grade: **0**
O&M Grade: **3**
Clock Start/From: **8**
Clock To: **4**
1st Value:
2nd Value:
Value Percent: **20.000**
Continuous Index:
Within 8" of Joint: **YES**
Remarks:

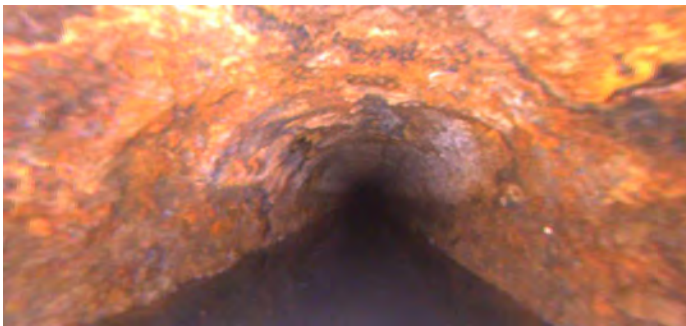
Code: **SAP**
Description: **Surface Aggregate Projecting**

Distance (ft): **99.2**
Structural Grade: **3**
O&M Grade: **0**
Clock Start/From: **8**
Clock To: **4**
1st Value:
2nd Value:
Value Percent:
Continuous Index:
Within 8" of Joint:
Remarks:

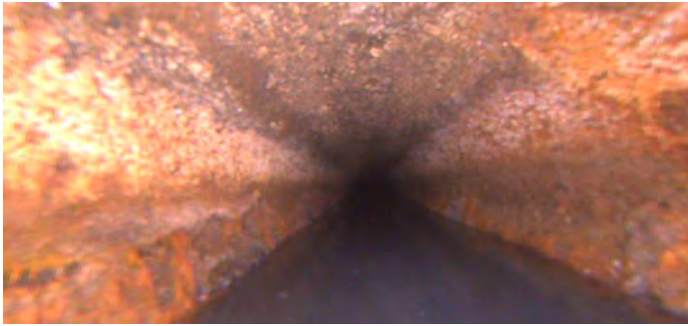
Code:	MSA
Description:	Abandoned Survey
Distance (ft):	105.2
Structural Grade:	0
O&M Grade:	0
Clock Start/From:	
Clock To:	
1st Value:	
2nd Value:	
Value Percent:	
Continuous Index:	
Within 8" of Joint:	NO
Remarks:	camera stopped
