Profile/Photo Observation Report

Date:	09/27/2018	Weather:		Coding:	PACP 6.0
Pipe Length (ft):	333.3	Owner:	NA	Pre Clean:	Not Known
P.O.#:		Surveyor:	Selasie Honu	PSR:	P-103-013-012
Customer:		Clean Date:	01/01/1900	Shape:	C

Street:	41st. Ave.	Flow Control:	Not Controlled
City:	Hobart, IN	Year Renewed:	
Location:	Light Highway	Tape/Media #:	
Purpose:	Routine Assessment	Dia/Height:	10"
Use:	Sanitary	Material:	VCP
Drain Area:	NA	Lining:	
Category:	NA		
Comment:

Location Details:		Direction of Survey:	Downstream
US MH:	M-103-012	DS MH:	M-103-013
		Total Length Surveyed (ft):	105.2

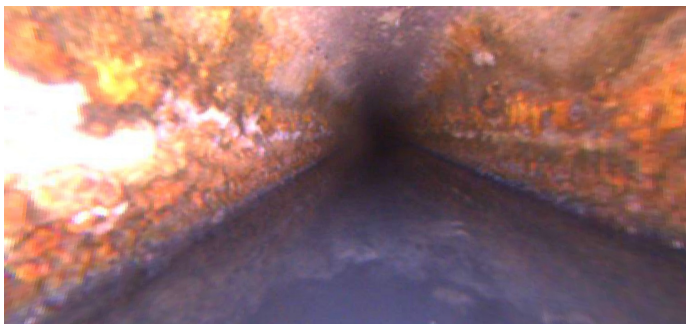
Code: **AMH**
Description: **Manhole**

Distance (ft): **.0**
Structural Grade: **0**
O&M Grade: **0**
Clock Start/From:
Clock To:
1st Value:
2nd Value:
Value Percent:
Continuous Index:
Within 8" of Joint: **NO**
Remarks: **M-103-012**

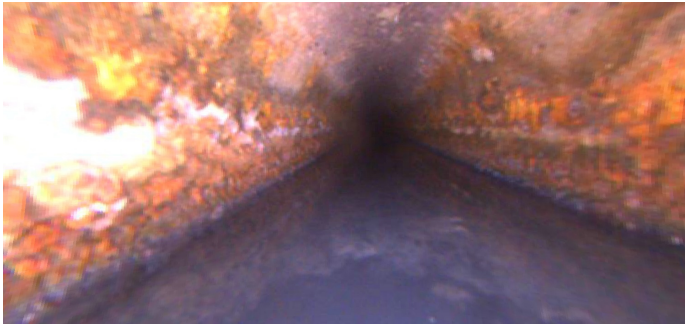
Code:	MWL
Description:	Water Level

Distance (ft):	.0
Structural Grade:	0
O&M Grade:	0
Clock Start/From:	
Clock To:	
1st Value:	
2nd Value:	
Value Percent:	5.000
Continuous Index:	
Within 8" of Joint:	NO
Remarks:

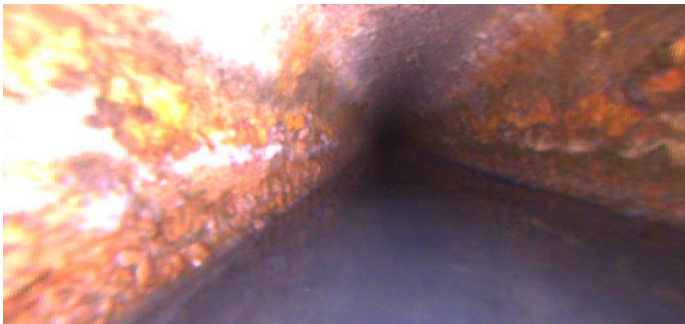
Code:	SRI
Description:	Surface Roughness Increased

Distance (ft):	1.6
Structural Grade:	1
O&M Grade:	0
Clock Start/From:	8
Clock To:	4
1st Value:	
2nd Value:	
Value Percent:	
Continuous Index:	S01
Within 8" of Joint:	
Remarks:

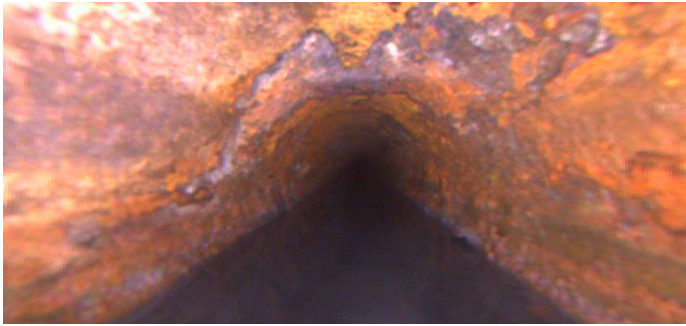
Code: **SRI**
Description: **Surface Roughness Increased**

Distance (ft): **7.9**
Structural Grade: **1**
O&M Grade: **0**
Clock Start/From: **8**
Clock To: **4**
1st Value:
2nd Value:
Value Percent:
Continuous Index: **F01**
Within 8" of Joint:
Remarks:

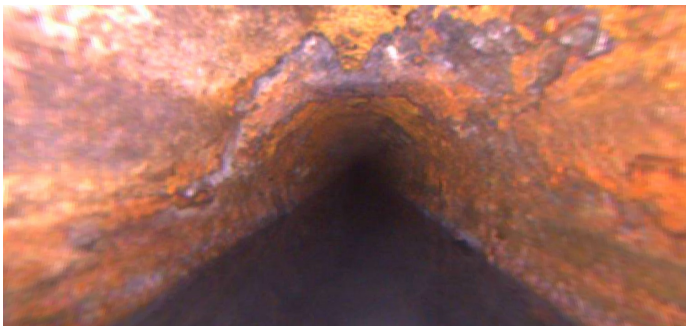
Code: **SAP**
Description: **Surface Aggregate Projecting**

Distance (ft): **7.9**
Structural Grade: **3**
O&M Grade: **0**
Clock Start/From: **8**
Clock To: **4**
1st Value:
2nd Value:
Value Percent:
Continuous Index: **S02**
Within 8" of Joint:
Remarks:

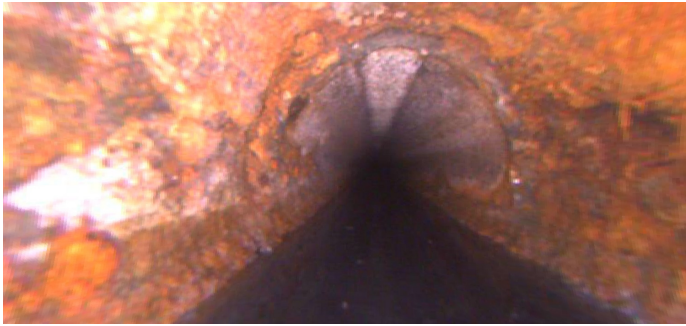
Code: **SAP**
Description: **Surface Aggregate Projecting**

Distance (ft): **26.5**
Structural Grade: **3**
O&M Grade: **0**
Clock Start/From: **8**
Clock To: **4**
1st Value:
2nd Value:
Value Percent:
Continuous Index: **F02**
Within 8" of Joint:
Remarks:

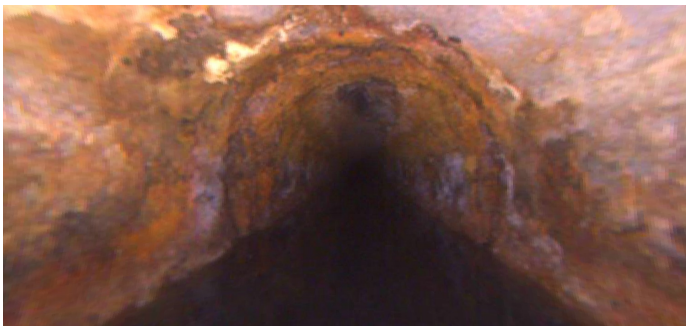
Code: **SAP**
Description: **Surface Aggregate Projecting**

Distance (ft): **44.6**
Structural Grade: **3**
O&M Grade: **0**
Clock Start/From: **8**
Clock To: **4**
1st Value:
2nd Value:
Value Percent:
Continuous Index: **S03**
Within 8" of Joint:
Remarks:

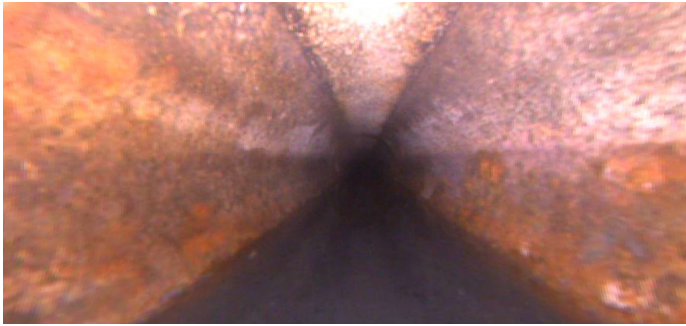
Code: **SAP**
Description: **Surface Aggregate Projecting**

Distance (ft): **59.2**
Structural Grade: **3**
O&M Grade: **0**
Clock Start/From: **8**
Clock To: **4**
1st Value:
2nd Value:
Value Percent:
Continuous Index: **F03**
Within 8" of Joint:
Remarks:

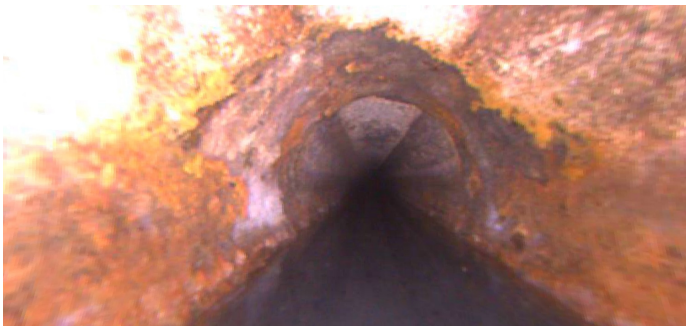
Code: **DAE**
Description: **Deposits Attached Encrustation**

Distance (ft): **62.2**
Structural Grade: **0**
O&M Grade: **3**
Clock Start/From: **7**
Clock To: **5**
1st Value:
2nd Value:
Value Percent: **20.000**
Continuous Index:
Within 8" of Joint: **YES**
Remarks:

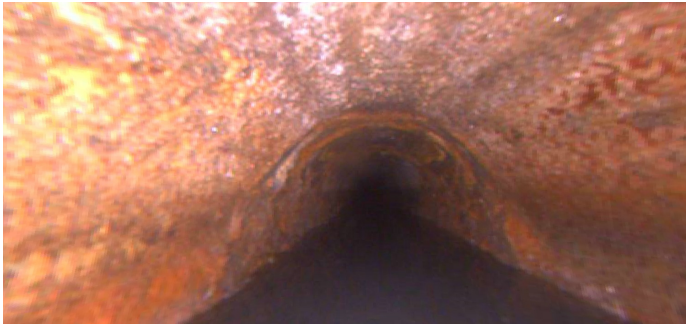
Code: **DAE**
Description: **Deposits Attached Encrustation**

Distance (ft): **97.9**
Structural Grade: **0**
O&M Grade: **3**
Clock Start/From: **8**
Clock To: **4**
1st Value:
2nd Value:
Value Percent: **20.000**
Continuous Index:
Within 8" of Joint: **YES**
Remarks:

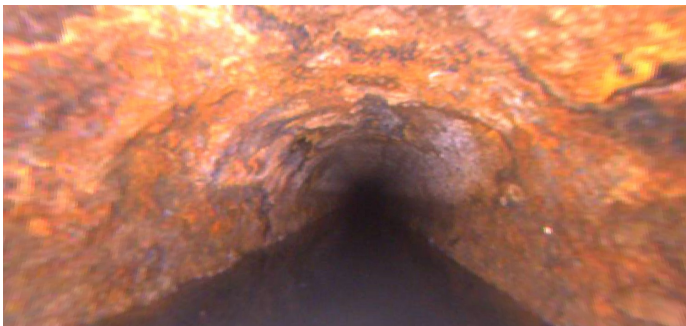
Code: **SAP**
Description: **Surface Aggregate Projecting**

Distance (ft): **99.2**
Structural Grade: **3**
O&M Grade: **0**
Clock Start/From: **8**
Clock To: **4**
1st Value:
2nd Value:
Value Percent:
Continuous Index:
Within 8" of Joint:
Remarks:

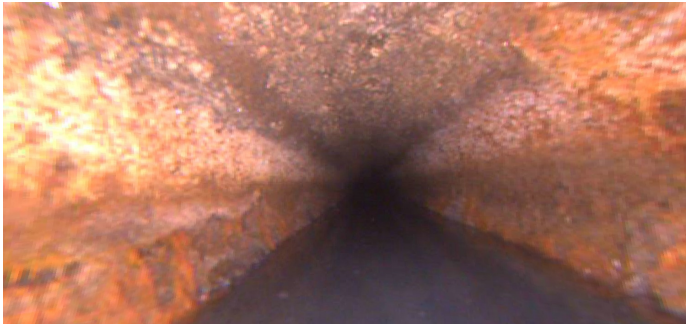
Code:	MSA
Description:	Abandoned Survey
Distance (ft):	105.2
Structural Grade:	0
O&M Grade:	0
Clock Start/From:	
Clock To:	
1st Value:	
2nd Value:	
Value Percent:	
Continuous Index:	
Within 8" of Joint:	NO
Remarks:	camera stopped
